Technical Service Bulletin

34 Oil leak from the ATF sump area

34 19 40 2050215/4 April 2, 2019. Supersedes Technical Service Bulletin Group 34 number 18-36 dated July 10, 2018 for reasons listed below.

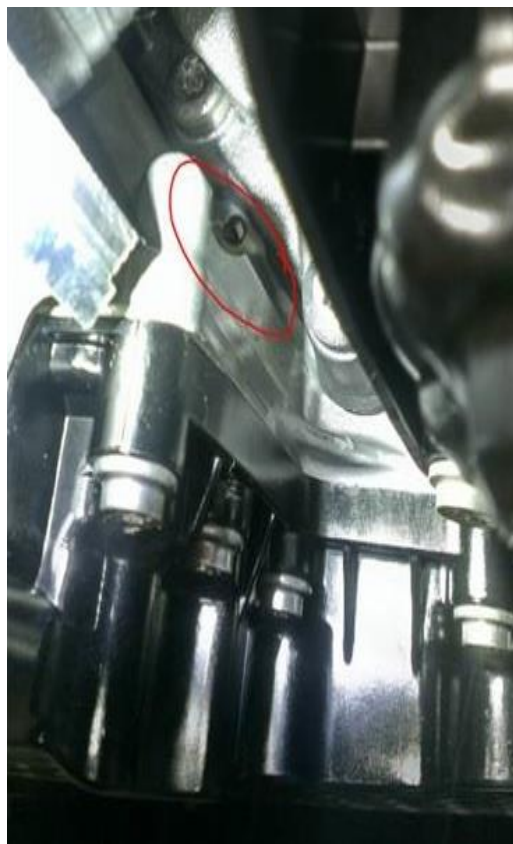
Tip: If there are drips after the test drive as shown (Figure 3) you should be able to determine if the leak is from the ATF sump gasket or if the leak is from elsewhere. Make sure to check for leaks above the sump gasket. Check the seam of the transmission case split and the weep hole of the double seal (Figure 4). Both of these leaks can be confused for an ATF sump gasket leak.

Figure 4. Double seal weep hole location.

If the oil leak is not from the ATF sump gasket please open an Audi Technical Assistance contact with the pictures of the leak attached to the ticket and contact Audi Technical Assistance for repair authorization.
