March 20, 2019
Subject: Recall R19931
TO: All U.S. and Canadian Volvo Retailers

Recall R19931: Front Seat Rail Flange Nuts

Title	Front Seat Rail Flange Nuts	Page	1 (4)
Action	Inspection	Operation number:	98600-2

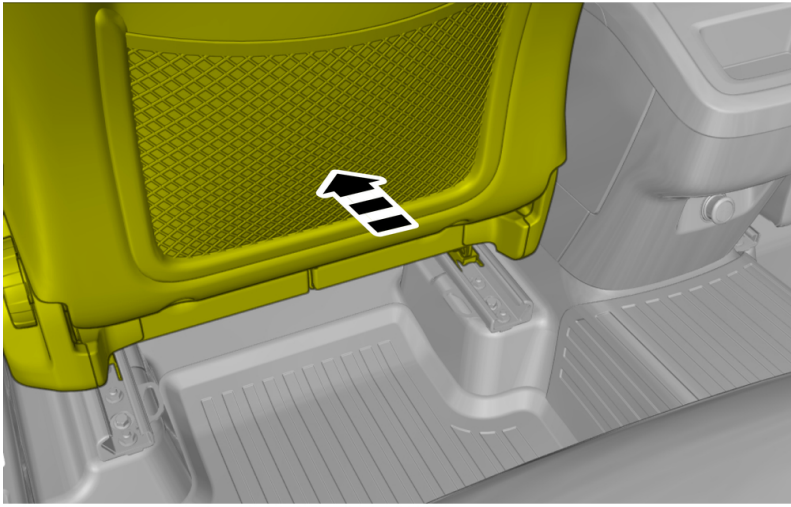
Adjust the seats to the front position.

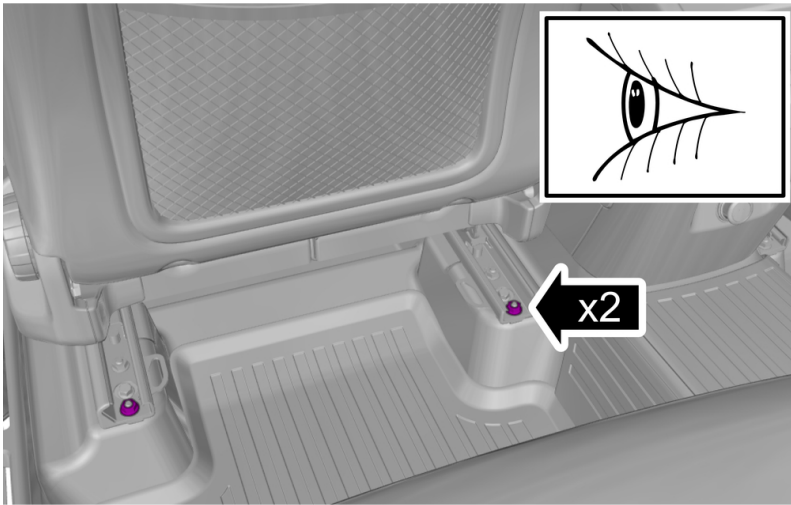
Check

Make sure that the rear flange nuts are installed on both front seats.
