Model(s)	Year	Eng. Code	Trans. Code	VIN Range From	VIN Range To
Tiguan LWB	2018-2019	All	All	AX_JM000001	AX_KM088514

60 19 04 April 1, 2019 2054353 Supersedes Technical Bulletin 60-19-02 (V601902) dated 3/27/19 to adjust metadata.

Sunroof Water Leak, Reduced Adhesion Causing Loose Seal

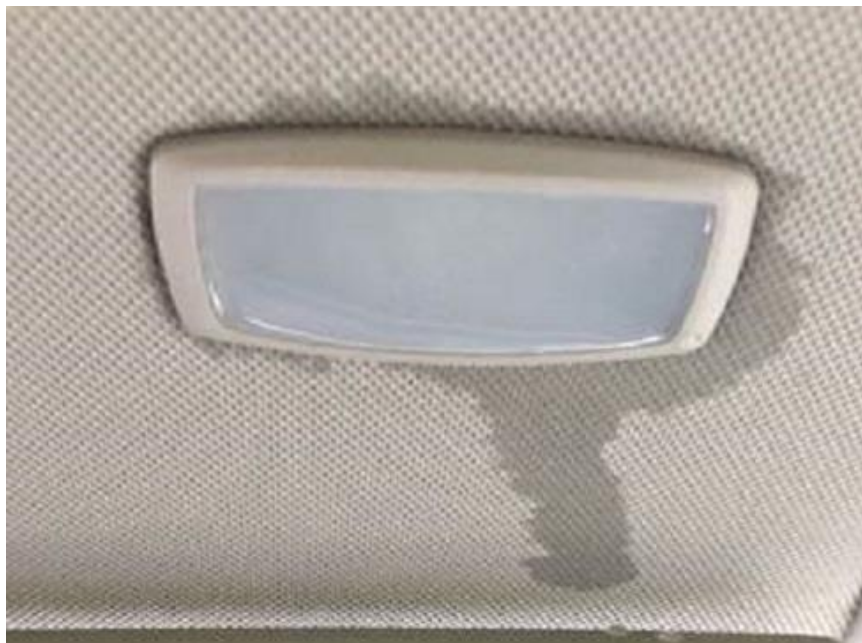
Front headliner area is wet around the vanity light(s), sunroof, and overhead console area due to water entering via the sunroof.

Figure 1: Example of water leak coming from the front vanity light.

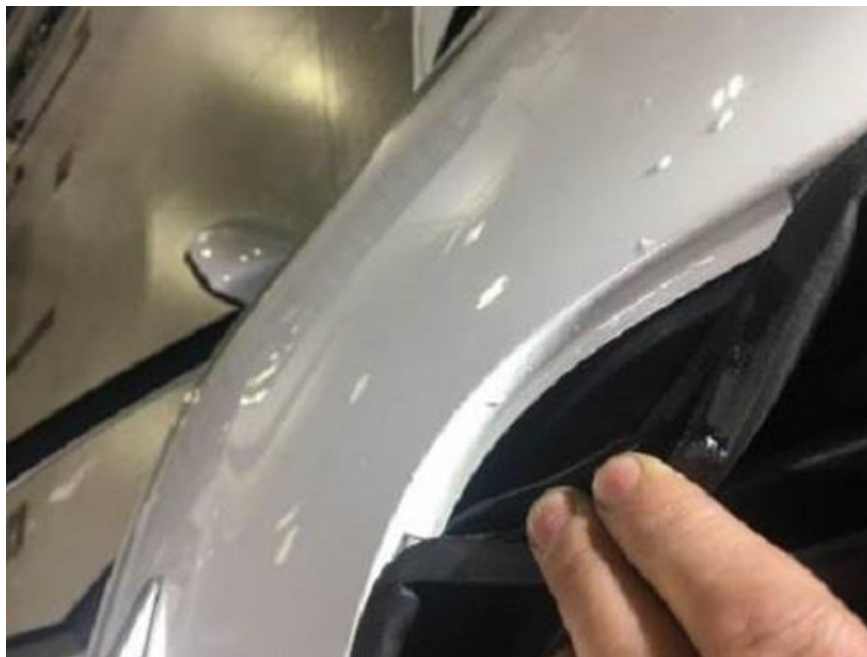
Water leak is due to poor adhesion of the sunroof body side seal to the body.

Figure 2: Example of the sunroof body side seal not having proper adhesion to the body.

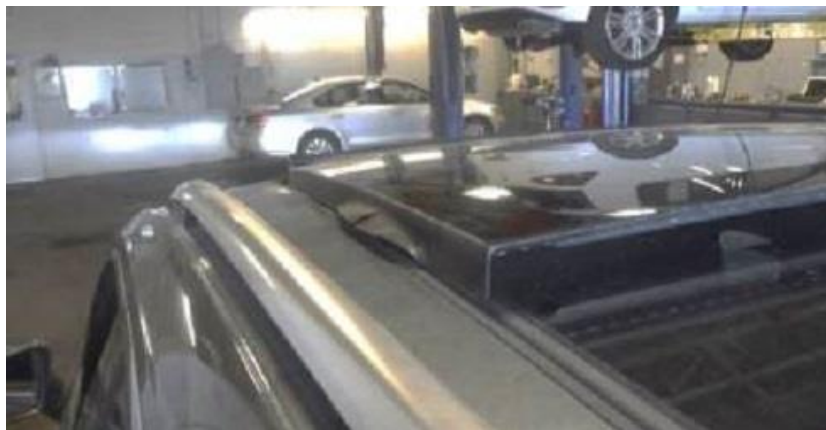
- Visually ensure sunroof panel molded seal and body side seal have no deformation.

Figure 3: Example of the sunroof panel molded seal warped/deformation.

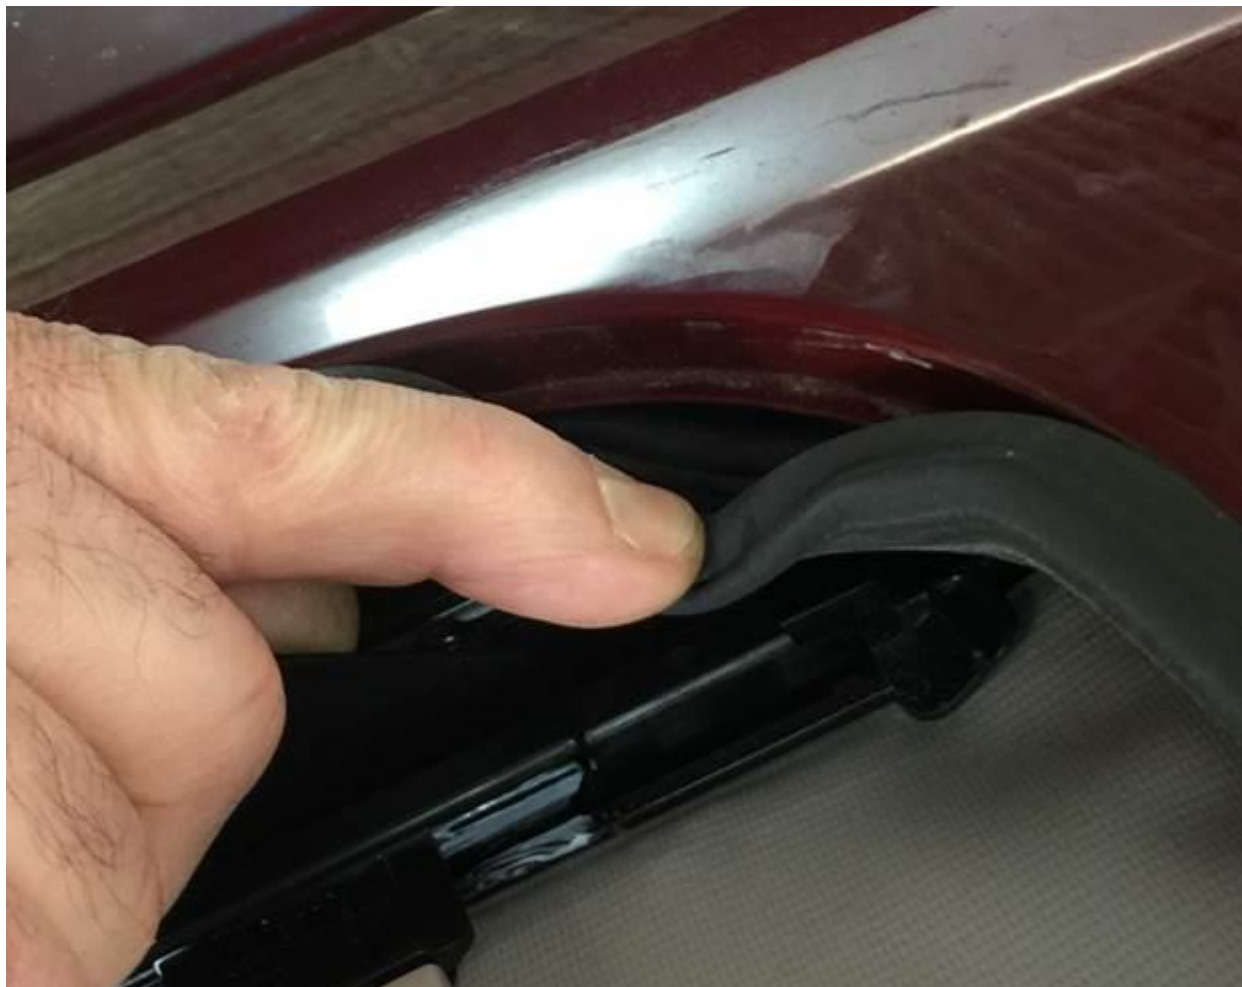
Figure 4: Example of a adhesion issue photo for uploading into WISE.

Take photos of the seal and body sections that were not adhered to the body and upload to WISE for a valid warranty claim.
