Technical Service Bulletin

PSS 92 Washer system sprays automatically and uses an excessive amount of fluid

92 19 19 2054527/1 April 3, 2019.

Model(s)	Year	VIN Range	Vehicle-Specific Equipment
A6, A7, A8, and Q8	2019	All	With Laserscanner

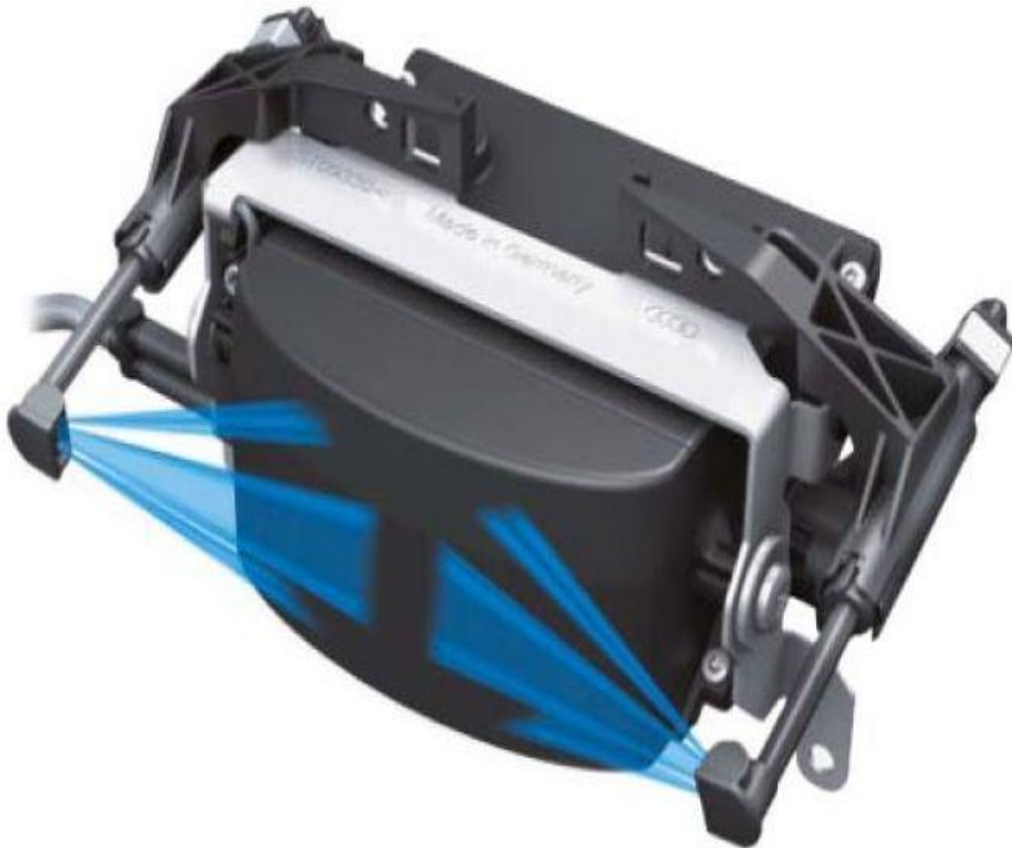
Figure 1. Laserscanner cleaning system.

1. The laserscanner is only cleaned while driving (Figure 1).

As a result, the customer can get the impression that the headlight washer system activates itself.

Depending on weather and road conditions (like snow, slush or dirt roads) the laserscanner might clean itself frequently.

If the sensor is very dirty, for example, due to driving over dirt roads or through slush, the laserscanner might be unable to clean itself. After three tries, the cleaning function goes into a 45-minute timeout which is reset by an ignition cycle.

2. Explain to the customer that a solution is forthcoming and that no repairs are necessary at this point. Do not replace any components for this condition since this will not resolve the customer's concern.
3. Create a PSS record in the PSS application through the Pending Service Solutions (PSS) link in AccessAudi (under *Related Links* >> *Service*), or through the Technical Assistance page in Elsa.

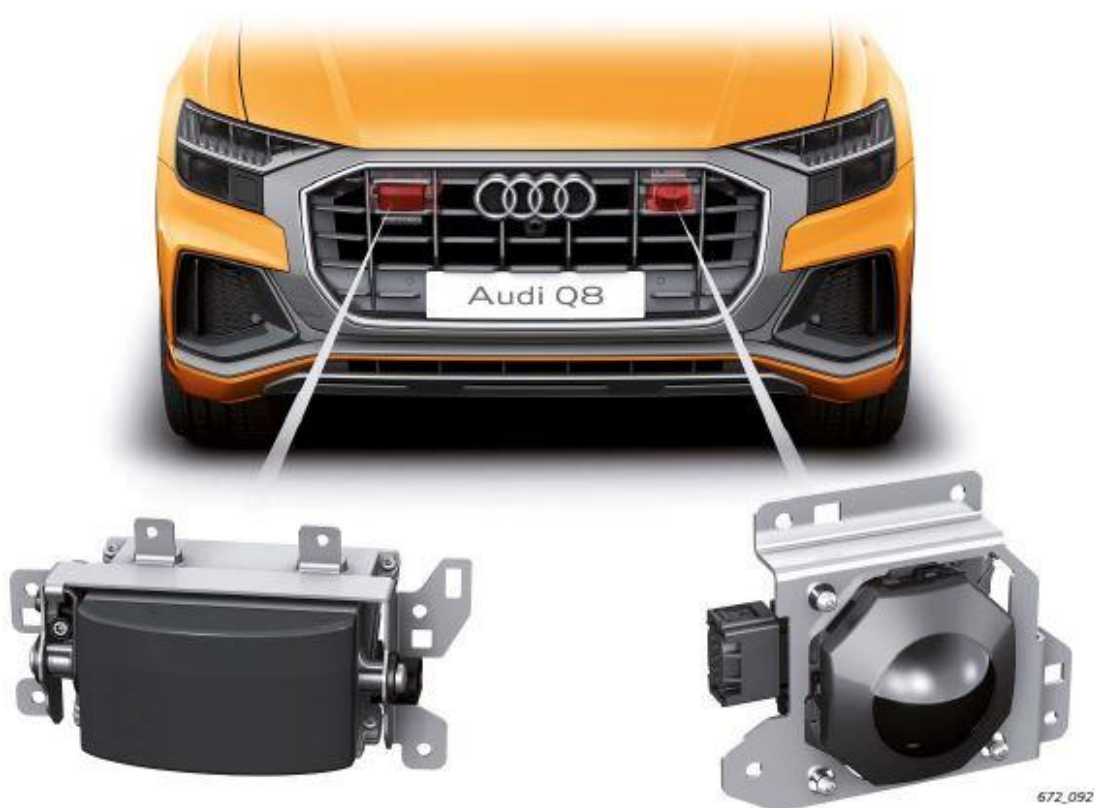
Figure 2. Laserscanner locations (A6, A7, and Q8).

On the A6, A7, and Q8 vehicles the laser scanner is located in the right upper single frame area (Figure 2).
