Technical Service Bulletin

97 Electrical concerns in rear trunk area

97 19 63 2043968/3 April 12, 2019. Supersedes Technical Service Bulletin Group 97 number 17-58 dated October 12, 2017 for reasons listed below.

Model(s)	Year	VIN Range	Vehicle-Specific Equipment
A3	2015 - 2016	All	Not Applicable

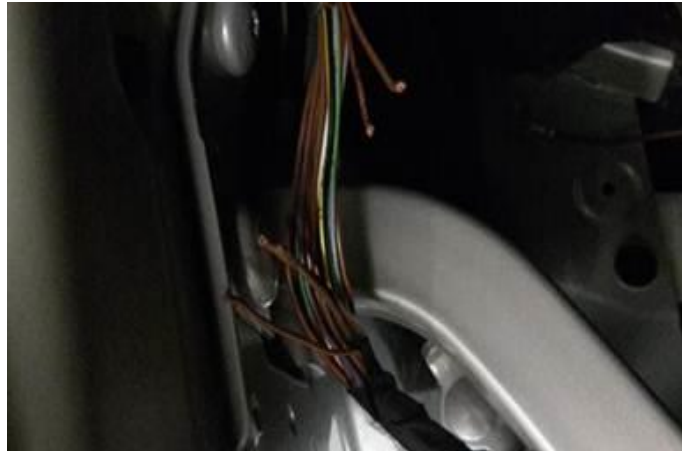
When the rear lid is opened or closed, a wire (or wires) can break in the area of the trunk hinge of the left or right rear lid wiring harness.

Figure 1. Wire damage at trunk hinge.

1. Check the rear lid wiring for damage in the area of the trunk hinge (Figure 1 - Figure 3).
If the wiring harness is damaged in the area of the trunk hinge, it must be replaced.
Follow the instructions below.

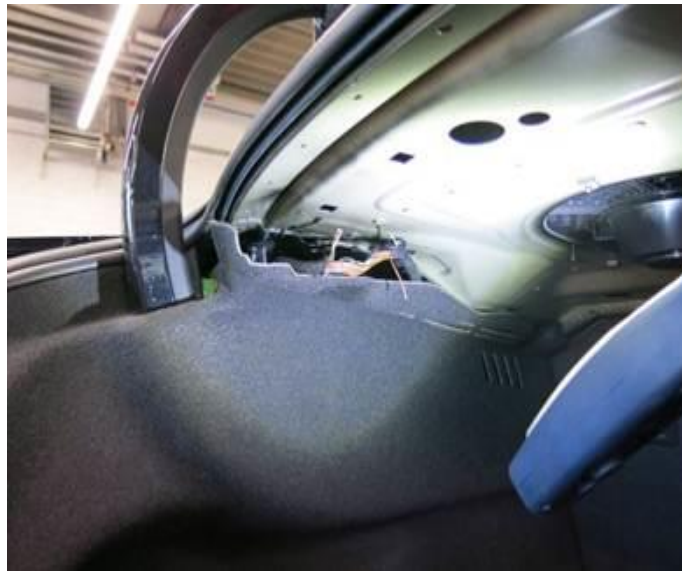
Figure 2. Wire damage at trunk hinge.

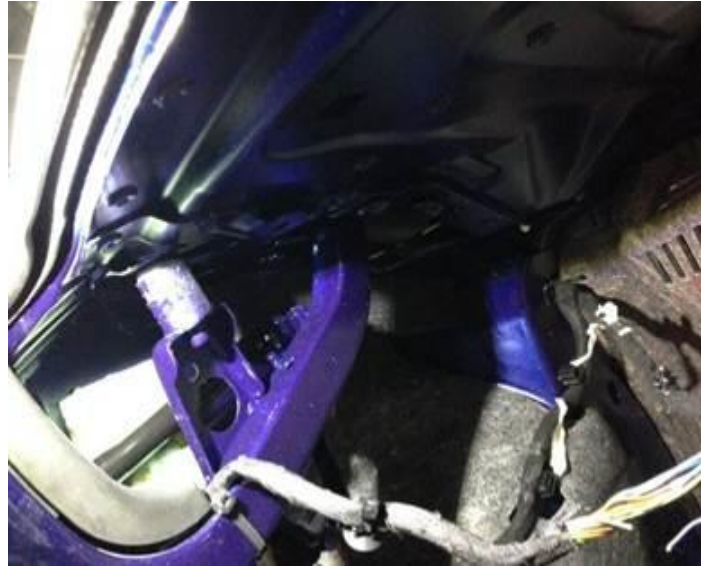
Figure 3. *Incorrect wire routing at trunk hinge.*

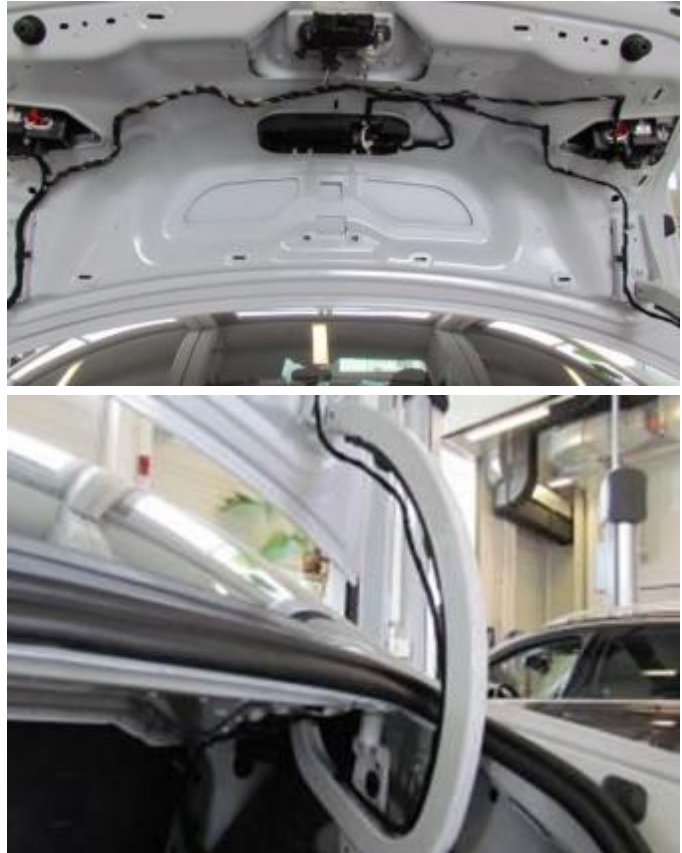
Figure 4. Examples of photographs of the routing of the wiring harness. The routing may differ depending on the vehicle.

3. Take photographs of the routing of the wiring harness reversing camera from the rear lid to the right reversing camera control module (Figure 4). These photographs will be used for reference later.

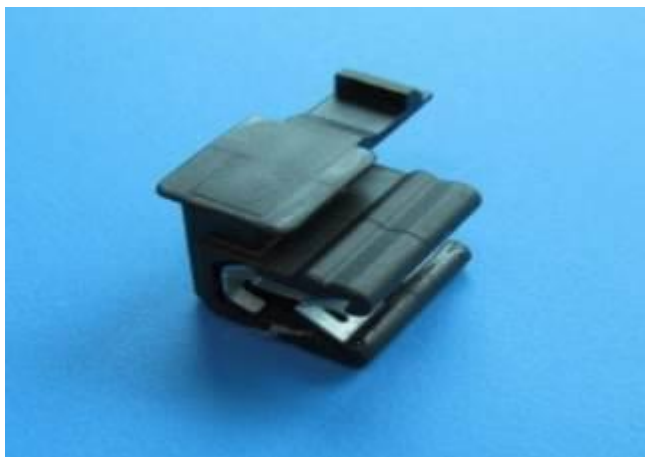
Figure 6. Clip supplied with wiring harness.

5. Before fitting the service wiring harness, place the clips supplied with the wiring harness (Figure 6) on the body in such a way that the wiring harness does not touch any edges or could be trapped by the mountings of the trim.

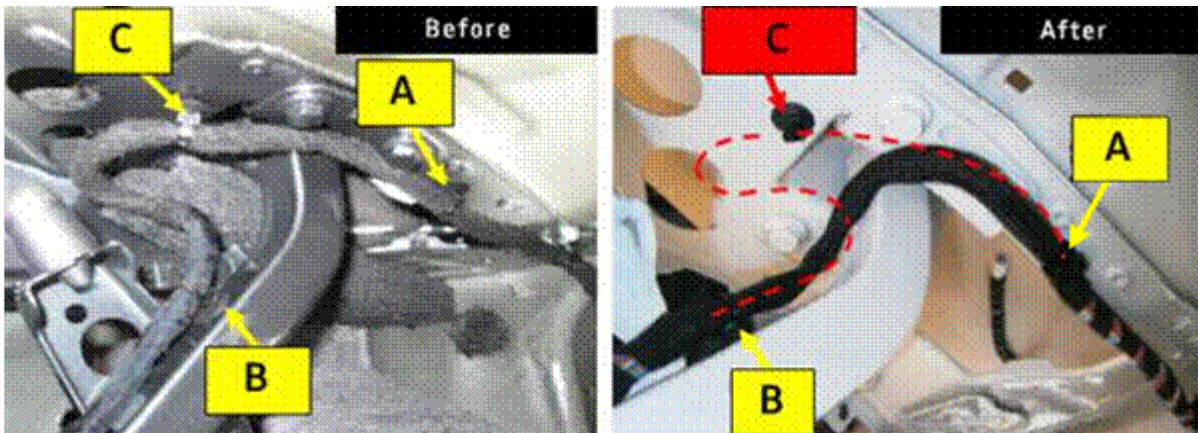
Figure 7. Note that clip “C” in the image above is not needed when the service wiring harness is fitted.

6. Fit the service wiring harness. For correct routing, refer to the photographs taken in step 3. Note that one of the clips from the previously-fitted harness is no longer needed (Figure 7).

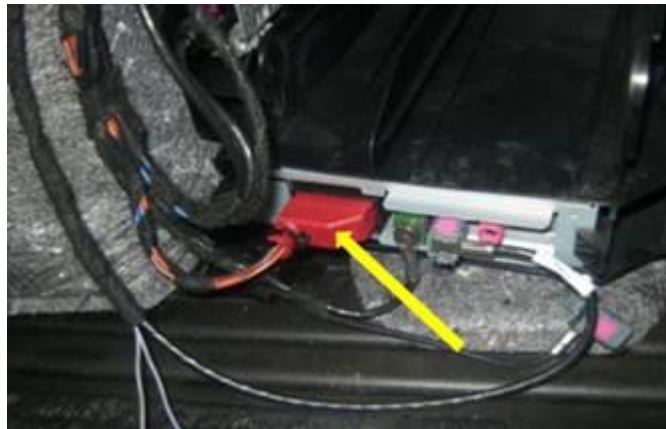
Figure 8. Loosen red connector T20i.

7. Loosen the red connector T20i on the reversing camera control module (Figure 8). Remove the cable tie on the connector.

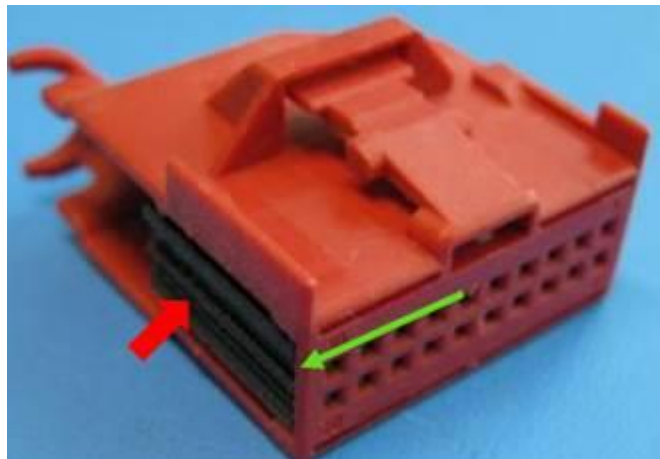
Figure 9. Pull black bar (red arrow) out of housing in direction of the green arrow.

8. Pull black bar out of the housing (Figure 9).

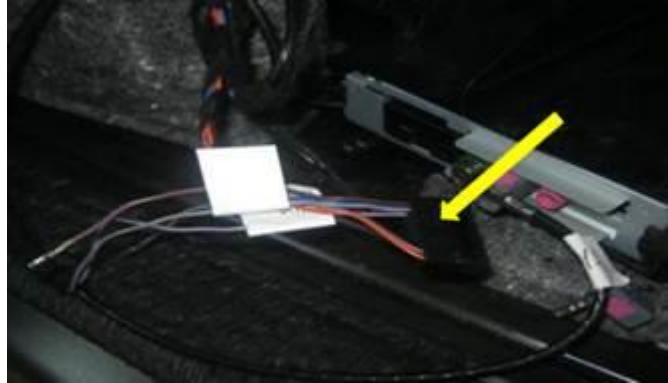
Figure 10. To unlock the contacts, position VAS 1978/29 on the side.

9. Use VAS 1978/29 to remove the contacts (pin 9 (grey/brown) and pin 19 (grey/red)). To unlock the contacts, position VAS 1978/29 on the side (Figure 10), then the contacts can be removed.

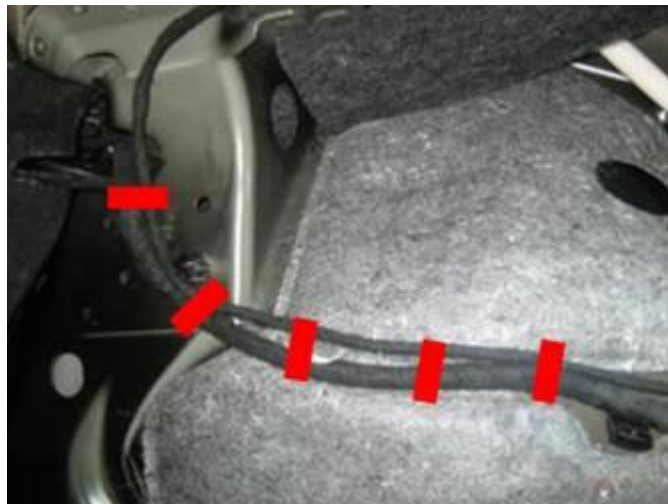
Figure 11. Wrap the wiring harness with textile adhesive tapes at red marks.

10. Cut off the removed cables and insulate ends with textile adhesive tape.
11. Lock the contacts of the new wiring harness in chamber 9 (grey/brown) and chamber 19 (grey/red). Then, lock the black bar in connector T20i and secure the cable with a cable tie on the connector collar.
12. Unplug and cut the grey aerial plug off of the reversing camera cable. Insulate the cut-off aerial cable with textile adhesive tape.
13. Connect the grey aerial plug of the service wiring harness on the reversing camera control module.
14. Connect the battery and check the function of the reversing camera.
15. Wrap the wiring harness with textile adhesive tape on the main wiring harness (Figure 11).

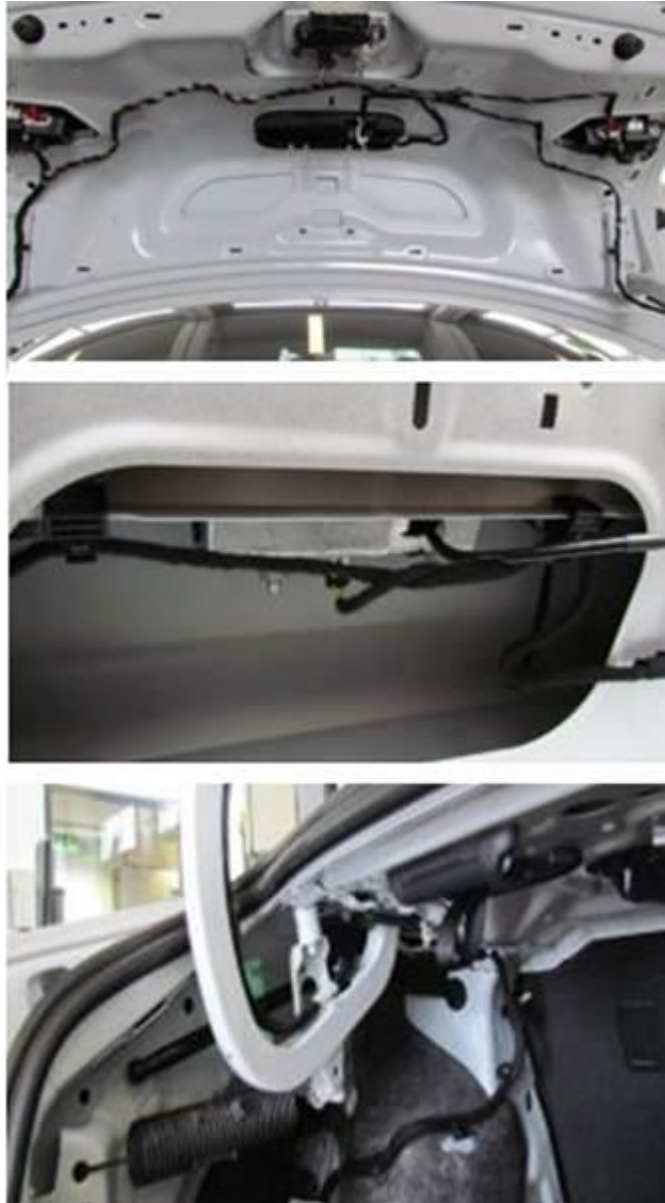
Figure 12. Examples of photographs of the routing of the wiring harness. The routing may differ depending on the vehicle.

4. Take photographs of the routing of the rear lid wiring harness (Figure 12). These photographs will be used for reference later.

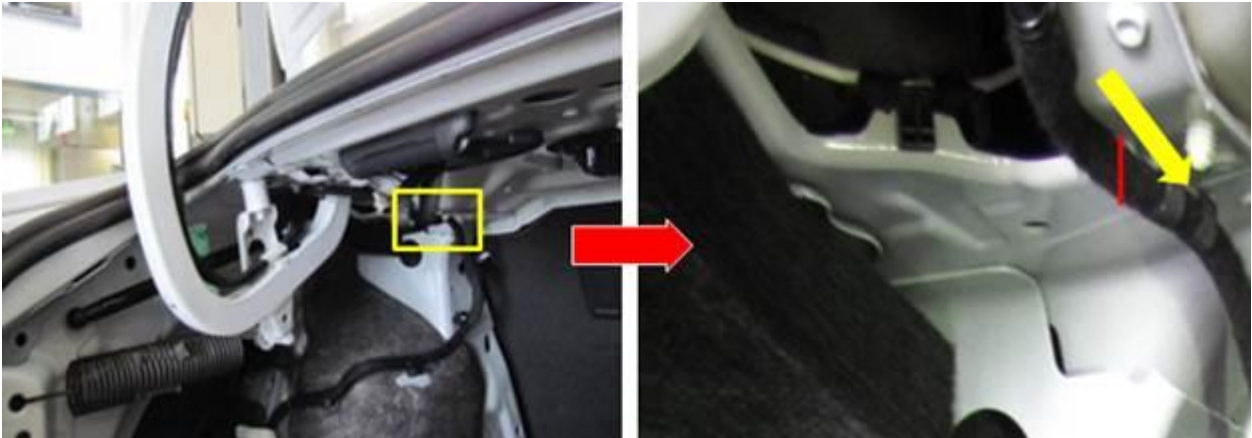
Figure 13. Cut the cable at before the last unlevered clip (at red separation line, before clip marked by yellow arrow).

5. Remove the left rear lid wiring harness and cut the cable off before the last unlevered clip (Figure 13).

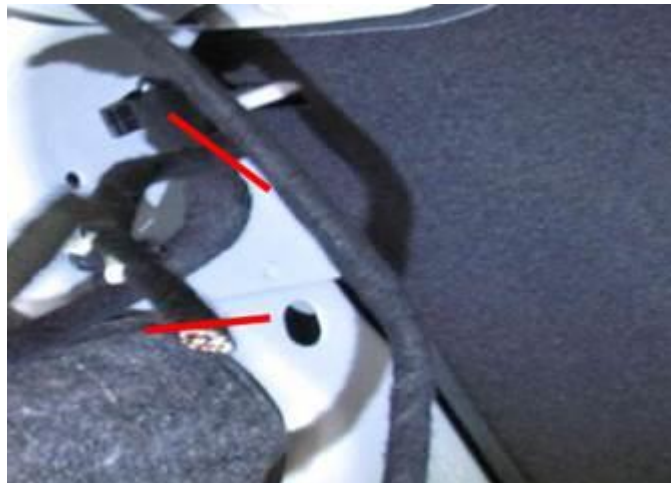
Figure 14. Open the winding of the cut-off vehicle wiring harness to the junction of the main harness on the separable area (red marks).

6. Open the winding of the cut-off vehicle wiring harness to the junction of the main wiring harness on the separable area (Figure 14).

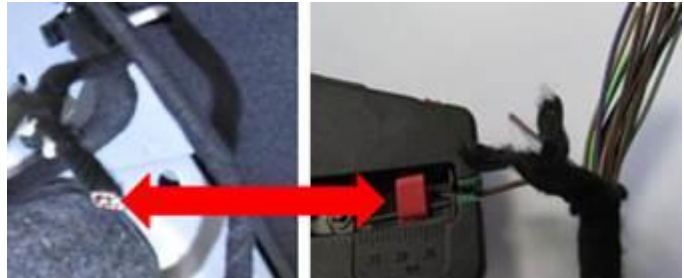
Figure 15. Remove the insulation on both brown/red cables on the vehicle wiring harness.

Remove the insulation on both brown/red cables on the vehicle wiring harness (Figure 15).

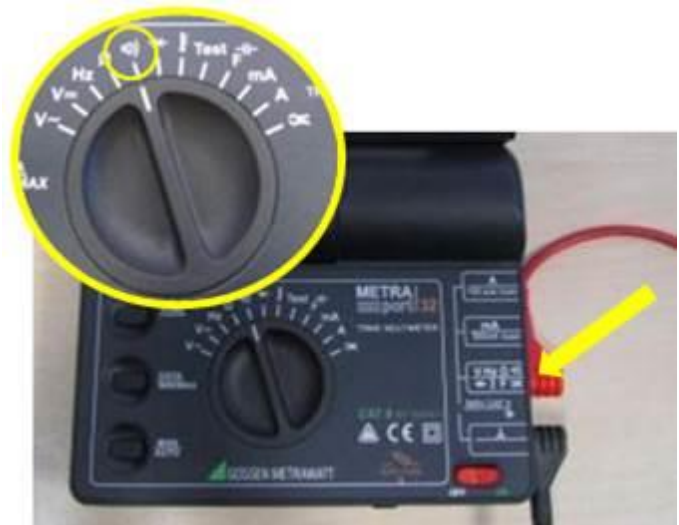
Figure 16. Set the VAG 1526 C to current flow check and connect the probe cables.

9. Set the VAG 1526 C to current flow check and connect the probe cables to the VAG 1526 C (Figure 16).

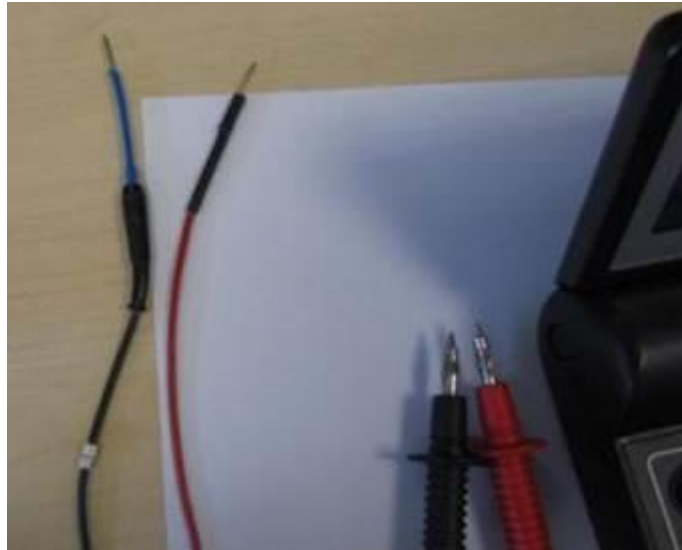
Figure 17. Required meter probes from VAG 1594 C.

10. Connect the meter probes of the VAG 1594 C to the probe cables of the VAG 1526 C. The required meter probes from VAG 1594 C are number 18 and number 12 (Figure 17).

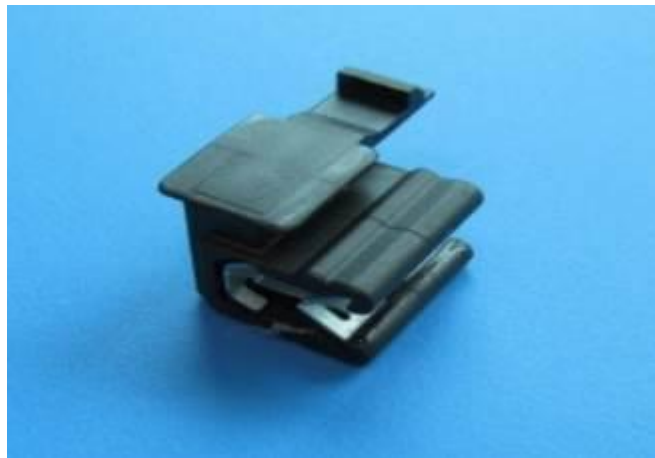
Figure 19. Clip supplied with wiring harness.
