# Service Bulletin

Bulletin No.: 18-NA-383

**Subject:** Water Found in Rear Interior of Cab, Water Leak at Rear Sliding Window

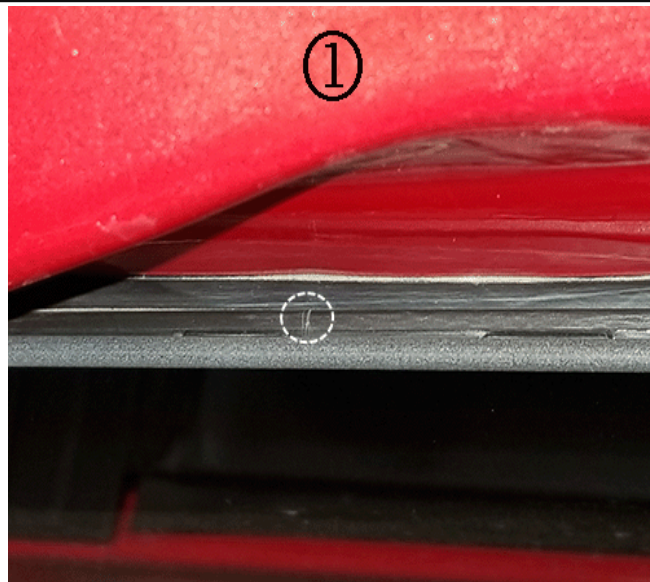
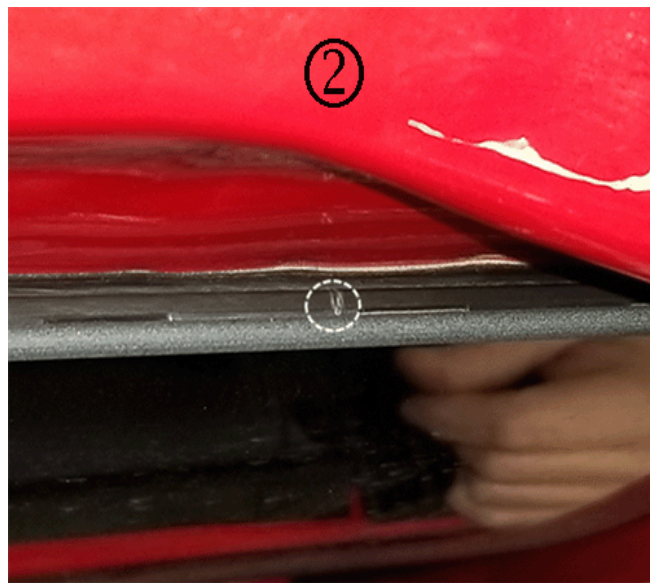
**Note:** The cracks can be in the left and/or right side of the rear sliding window plastic upper rail glass guide which is covered by the roof rear spoiler. Examples of a left (1), then right side (2) visual crack (with the spoiler removed) are shown in the graphics above.

The cause of the condition may be cracking in the rear sliding window plastic upper rail glass guide. The plastic upper rail glass guide may develop small fractures/cracking which allows water to pass through on the glass side of the urethane that attaches to the vehicle body.

R & R the roof rear spoiler and apply seam sealer to the rear sliding window top encapsulate, following the steps in the Service Procedure below.
