# Service Bulletin

Bulletin No.: 16-NA-051

**Subject:** Active Shutters Inoperative, Malfunction Indicator Lamp (MIL) Illuminated - DTCs P05AE, P059F, P151F, P0071, P0072, P0073, P0074, P3056, U1345, U1501, U1510, U1511 Set

Brand:	Model:	Model Year:		VIN:		Engine:	Transmission:
				from	to		
Buick	LaCrosse	2017	2019				
Chevrolet	Malibu (VIN Z)	2016	2019

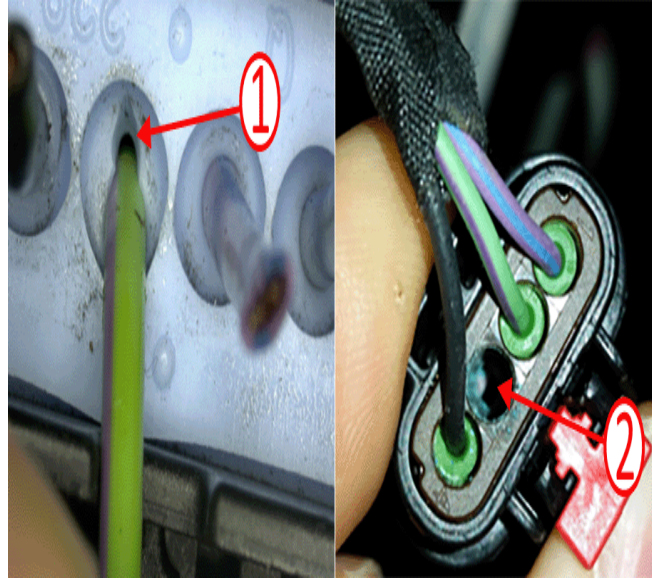
4787001

- Moisture intrusion past damaged (1) and/or missing (2) seals located in the B9, M60B and/or X119 connectors for the ambient air temperature sensor wiring harness.
- Snow and/or ice buildup in the front lower grille area of the vehicle, which could prevent the active aero shutters from opening or closing.

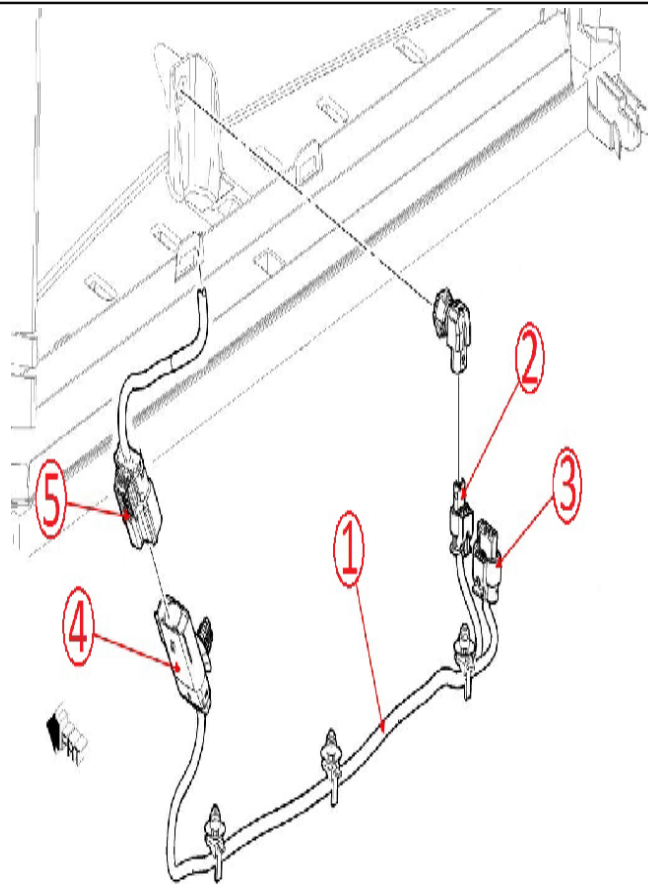
4527562

Inspect the ambient air temperature sensor wiring harness connectors B9 (2), M60B (3) and the X119 (4, 5) for any signs of corrosion.

**Notice:** The Ambient Air Temperature Sensor Wiring Harness must be replaced and dielectric grease must be applied to all of the connectors for any of the following repairs.

- If any signs of water and/or corrosion was found on the Ambient Air Temperature Sensor Wiring Harness (1), it must be replaced.
- If water and/or corrosion was found at the X119 connector (5), the main body wiring harness connector must be replaced.
- If water and/or corrosion was found at the B9 connector (2), the ambient air temperature sensor must be replaced.
- If water and/or corrosion was found at the M60B connector (3), the active shutter must be replaced.
