# Service Bulletin

Bulletin No.: 16-NA-405

Date: April, 2019

**Subject:** Poor Engine Performance in Extremely Cold Weather Conditions, PCV Bypass Hose and Charge Air Cooler Icing for LUV Engines, Malfunction Indicator Lamp (MIL) Illuminated - DTC P0299, P0236, P2227, P00C7 Set

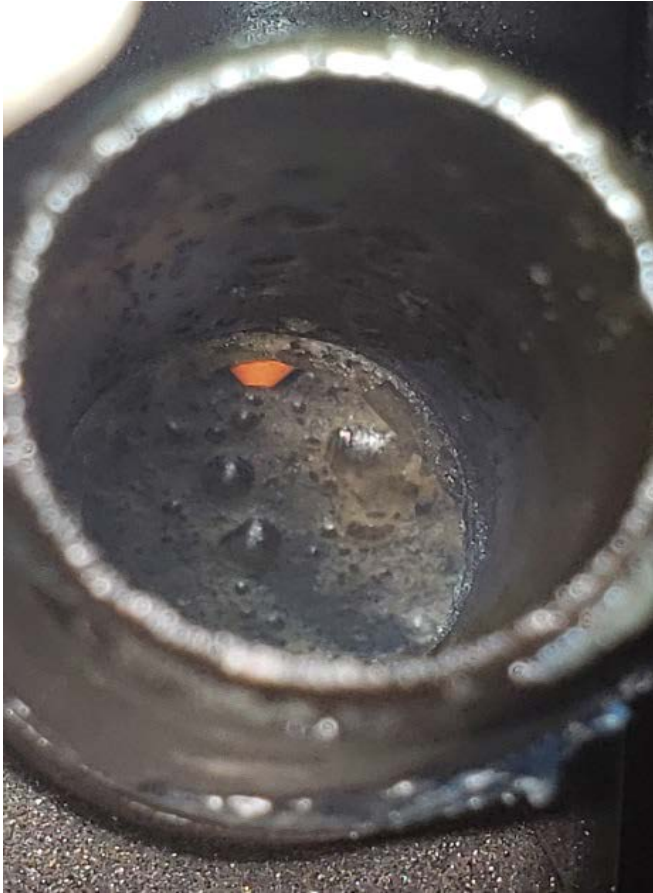
5286434

2. Inspect the vacuum ports of the intake manifold for ice accumulation.

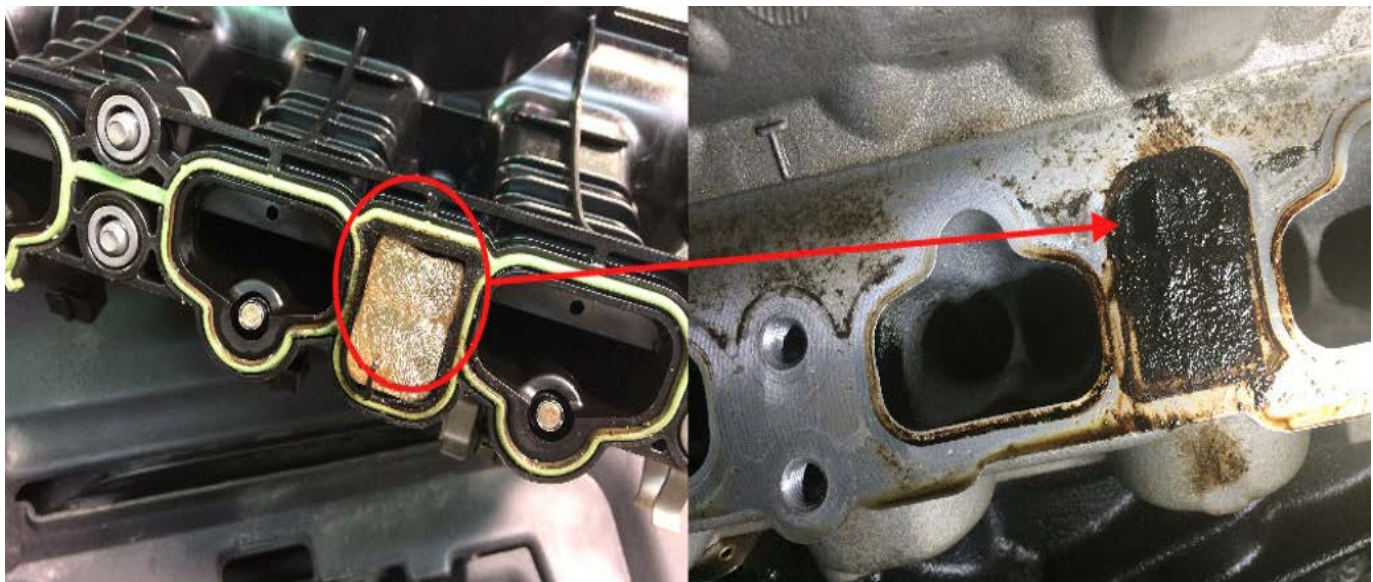
5286457

3. Inspect the PCV intake runner for ice build-up blocking the cylinder head as shown above.

4. Clean any ice/sludge/water/carbon out of the PCV pipes/hoses, the PCV nipple on the intake manifold, the PCV intake runners and the orifice between the #2 and #3 intake ports.
5. Install the intake manifold.
