Service Bulletin

Bulletin No.: 18-NA-114

Subject: Service All Wheel Drive (AWD)/Service Stability Messages Displayed on Driver Information Center (DIC), Erratic Speedometer Readings, Malfunction Indicator Lamp (MIL) Illuminated - DTC P0641, U0073, U0100, U0101, U0121, U0131 and/or U0136 Set

Brand:	Model:	Model Year:		VIN:		Engine:	Transmission:
		from	to	from	to		
Chevrolet	Trax	2018	2019			1.4L (LUV)

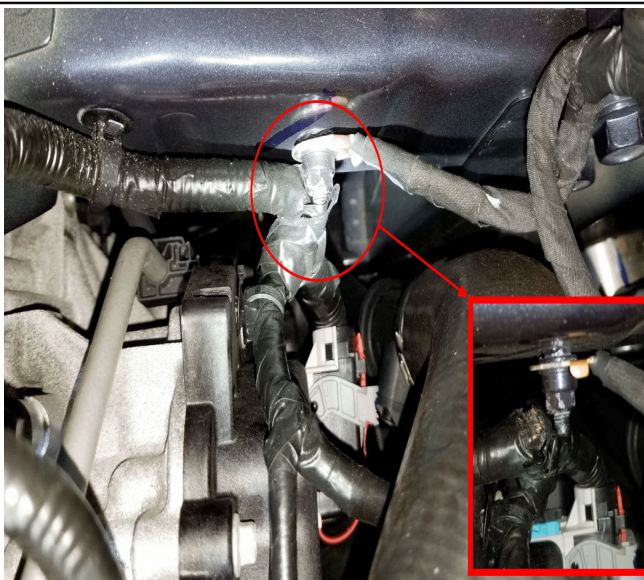
5040432

Cause	<p>Note: This is a multi-wire bundled harness and, depending on which wire is damaged, can set a variety of DTCs.</p> <p>This condition may be caused by the engine harness chaffing against the G100 Ground stud.</p>

If the above condition has been validated, inspection of the engine wiring harness must be done.

1. With a suitable light, inspect the wiring harness point of contact at the G100 ground stud.

2. Repair the harness as needed.
