Service Bulletin

Bulletin No.: 18-NA-144

Subject: Multiple Electrical Concerns, Intermittent Multiple Instrument Panel Cluster (IPC)

Warning Lamps Illuminated, Intermittent Multiple Message on Drivers Information Center (DIC), Malfunction Indicator Lamp (MIL) Illuminated

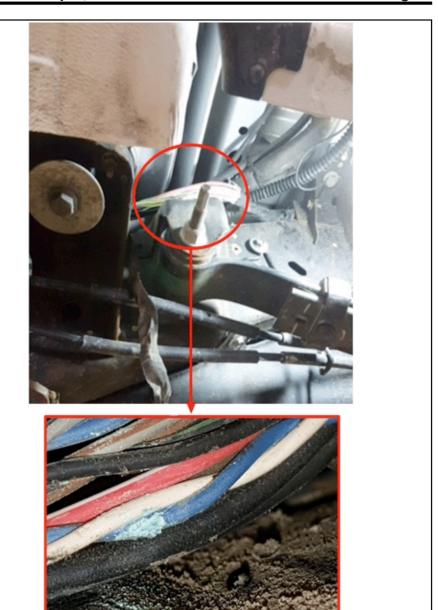
rage Z	Aprii, 2019 Buileuri No.: 16-NA-144
	• U0077
	• U0100
	• U0101
	• U0121
	• U0126
	• U0137
	• U0140
	• U0151
	• U0415
	• U0428
	• U1556
	• U18A2
	This condition may be caused by high resistance, opens, shorts and/or damage circuits in the chassis and electronic brake controller wiring harness.
	⇒ Shown below are some areas to pay particular attention to:
Cause	2
	5049626

- Body (1)
- Rear Crossmember (2)

Labor Operation	Description	Labor Time	
5430902	Wire to Wire Repair	Use the Published Labor Operations Time
