# Service Bulletin

Bulletin No.: 18-NA-200

**Subject:** Diagnostic Tip for Rattle Type Noise Heard From the Instrument Panel (IP) Area

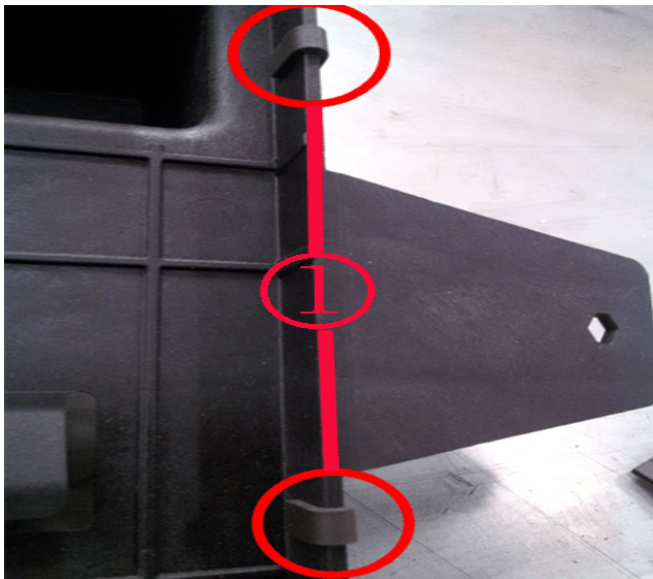
4421628

| Condition | Some customers may comment on a rattle type noise heard from the instrument panel (IP) area. |

1. The ECM may be loose in the mounting bracket. If you can move the ECM in the bracket remove it from the mount and apply 2 foam strips, 2mm thick, 20mm by 15mm (1) to the body of the bracket and reinstall the ECM. Use 3M 4696 adhesive backed foam or equivalent and place the foam strips, as shown in the photo above.
2. The harness retainer tab on the heater pipes may be contacting the bulkhead. This noise is heard from the center / lower part of the IP usually when in reverse. This can be viewed from underneath the vehicle from the right side looking over the exhaust flex pipe and over the bell housing. The tab can be bent back away from the bulkhead with a pry bar.
3. The air box snorkel rattles on the inner fender. This can be heard at idle or driving. If you press on the wheel liner the noise will stop. Replace the air inlet duct. Refer to Front Intake Air Duct Replacement in SI.
