# Service Bulletin

Bulletin No.: 18-NA-338

**Subject: Rear Infotainment Performance Issues**

Brand:	Model:	Model Year:		VIN:		Engine:	Transmission:
		from	to	from	to		
Buick	Enclave	2018	2019				
Chevrolet	Equinox	2018					
	Silverado 1500 (New Model)	2019					
	Traverse	2018					
GMC	Acadia	2019					
	Sierra 1500 (New Model)	2019					
	Terrain	2018

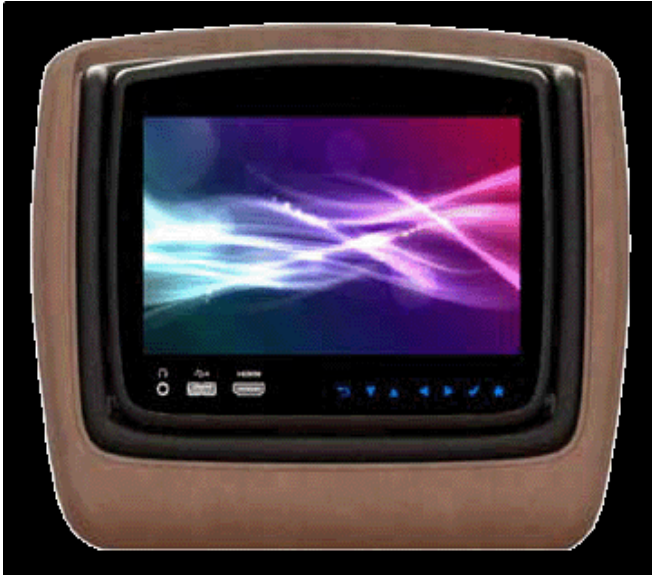
5163549

- The software update only supports one type of Rear Seat Entertainment accessory system as shown above.

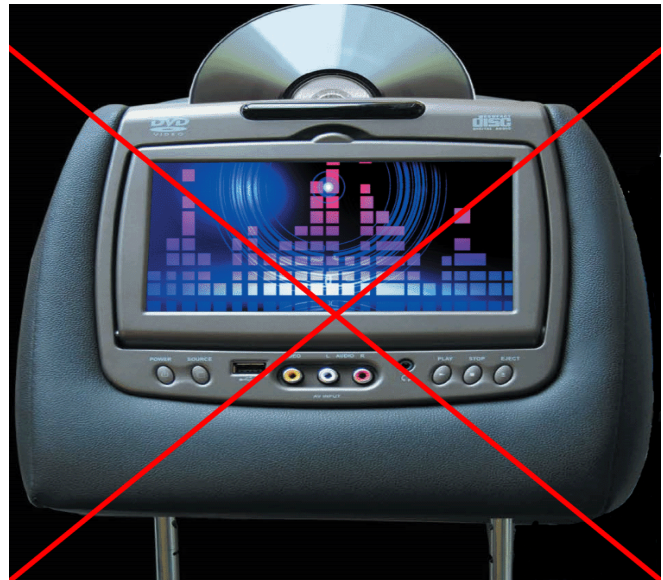
5163552

- The Rear Seat Entertainment system shown above, cannot be updated with the software version indicated in this bulletin.

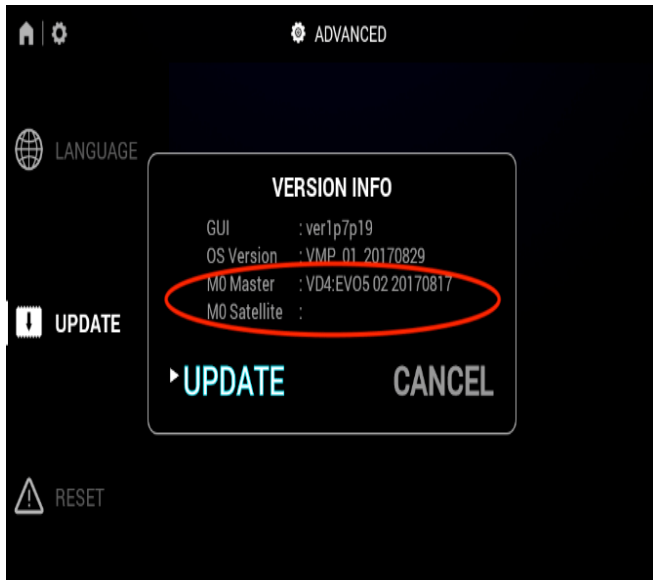
5163574

- ⇒ If one of them does not have information shown, the monitors are not properly connected to each other. Try turning off power, checking all connections, then reboot.
- ⇒ Updates will be to GUI version ver1p7p19.
