# Service Bulletin

Bulletin No.: 19-NA-002

**Subject: Steering Wheel Locked, Steering Wheel Locked after Charging and/or Replacing Battery**

Brand:	Model:	Model Year:		VIN:		Engine:	Transmission:
		from	to	from	to		
Cadillac	CT6	2018	2019

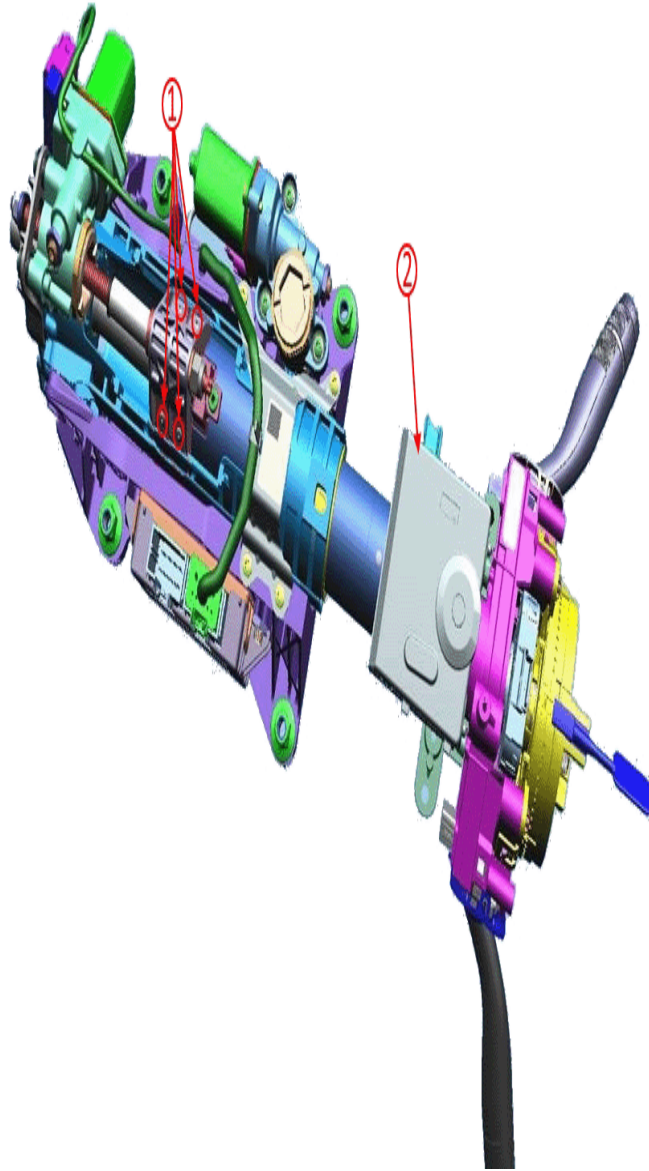
5128063

This condition may be caused by forcing the steering wheel to turn while the SCFC module (2) is engaged.

- ⇒ Galling between the CSAV (Super Cruise) components internal to the column prevents the column clutch mechanism from slipping when the SCFC module is engaged.
- ⇒ A rotational Torque applied at the steering wheel through the column's crash tube above 60 Nm will shear or partially shear the 4 rivets (1).

If any of the conditions have been validated, replace the steering column and the SCFC module.
