Service Bulletin

Bulletin No.: 19-NA-035

Subject: 8L45, 8L90 Park System Does Not Engage

This Bulletin replaces PIP5526. Please discard PIP5526.

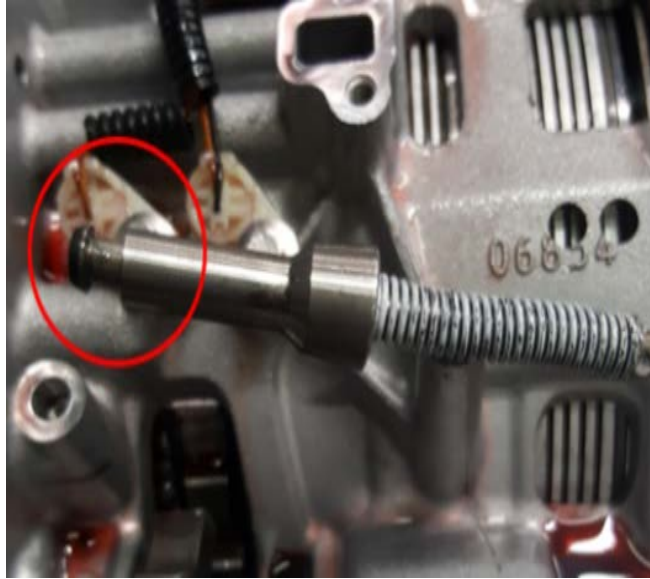
5247414

7. Inspect for damage, bent rod or incomplete travel of the actuator.

⇒ If damage to the Park Pawl Actuator and Park Pawl is present as described above, replace the following components:

- Park Pawl Actuator
- Park Pawl
- Main Shaft Detent Lever Hub Pin
- Park Pawl Actuator Bracket
- Park Pawl Actuator Bracket Bolts
- Output Carrier

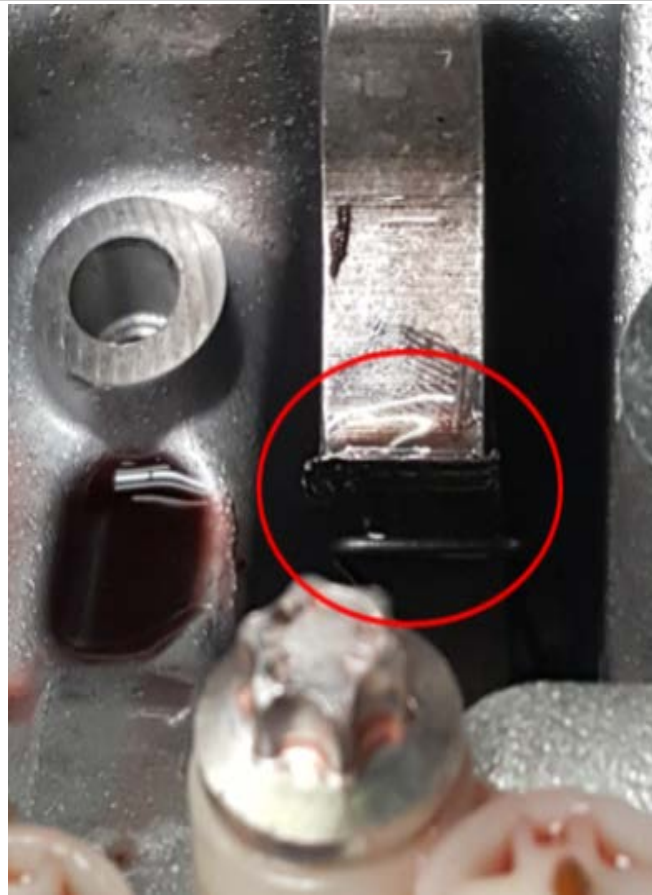
5247435

8. Inspect the park pawl for damage.
