# Service Bulletin

Bulletin No.: 19-NA-050

**Subject:** Information on Driver Seat Cushion Design Changes, Driver and Passenger Cushion Appear Different Thickness

Brand:	Model:	Model Year:		VIN:		Engine:	Transmission:
		from	to	from	to		
Chevrolet	Colorado	2019	2019			All	All
GMC	Canyon	2019	2019

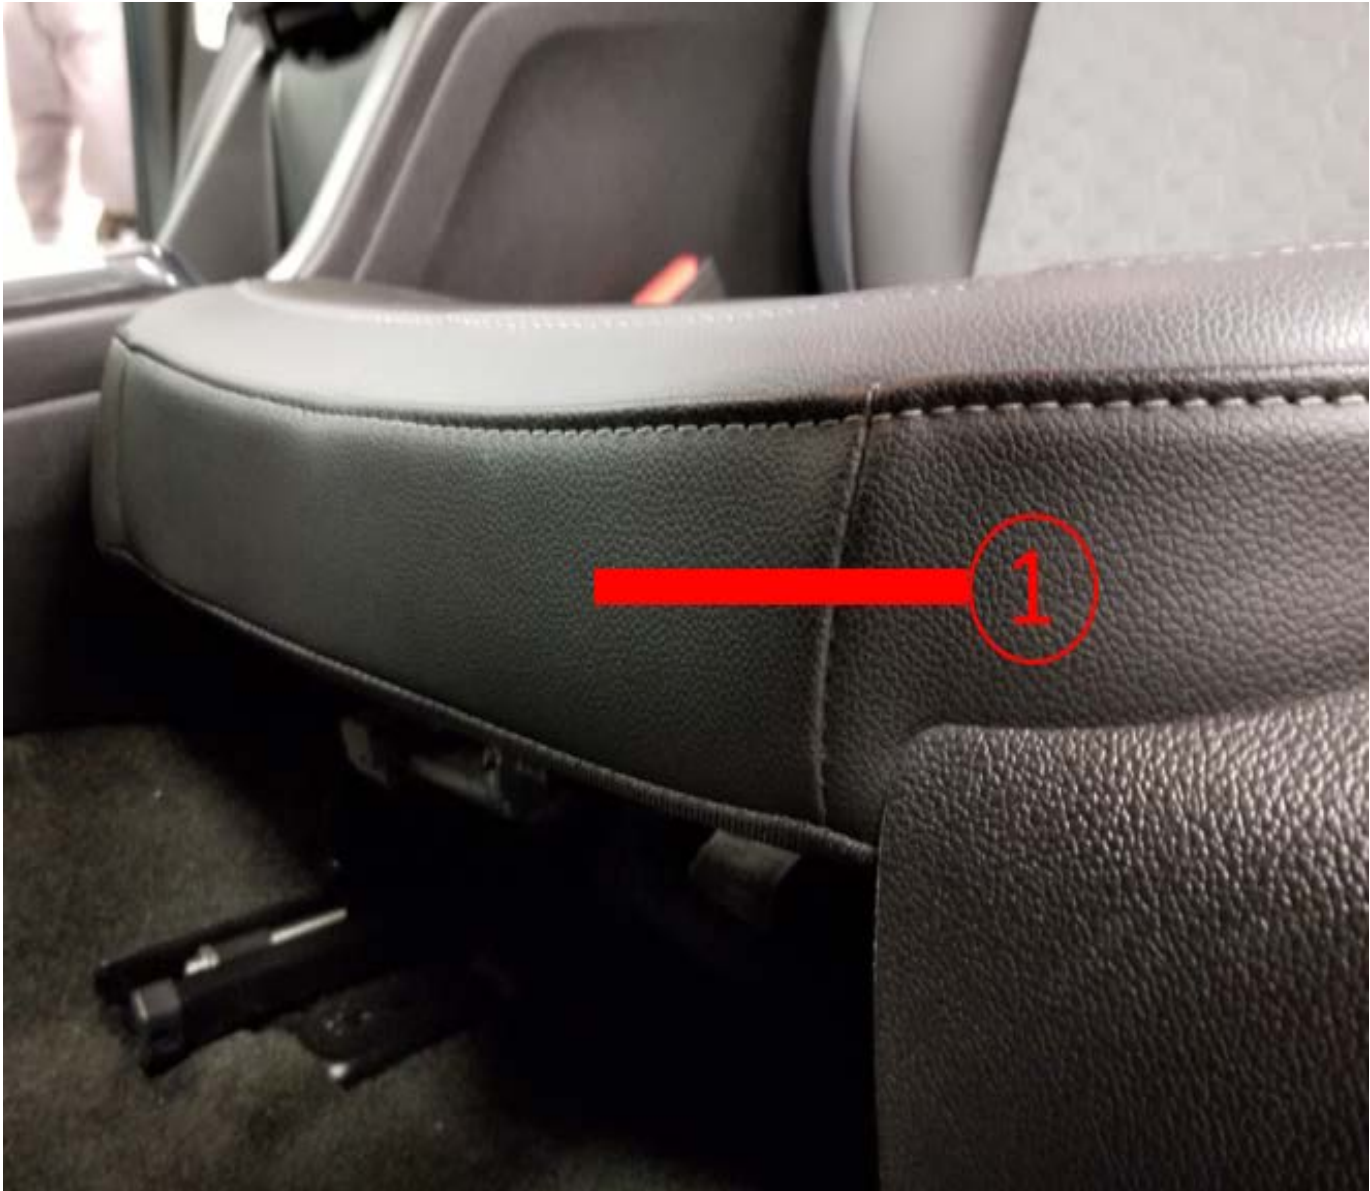
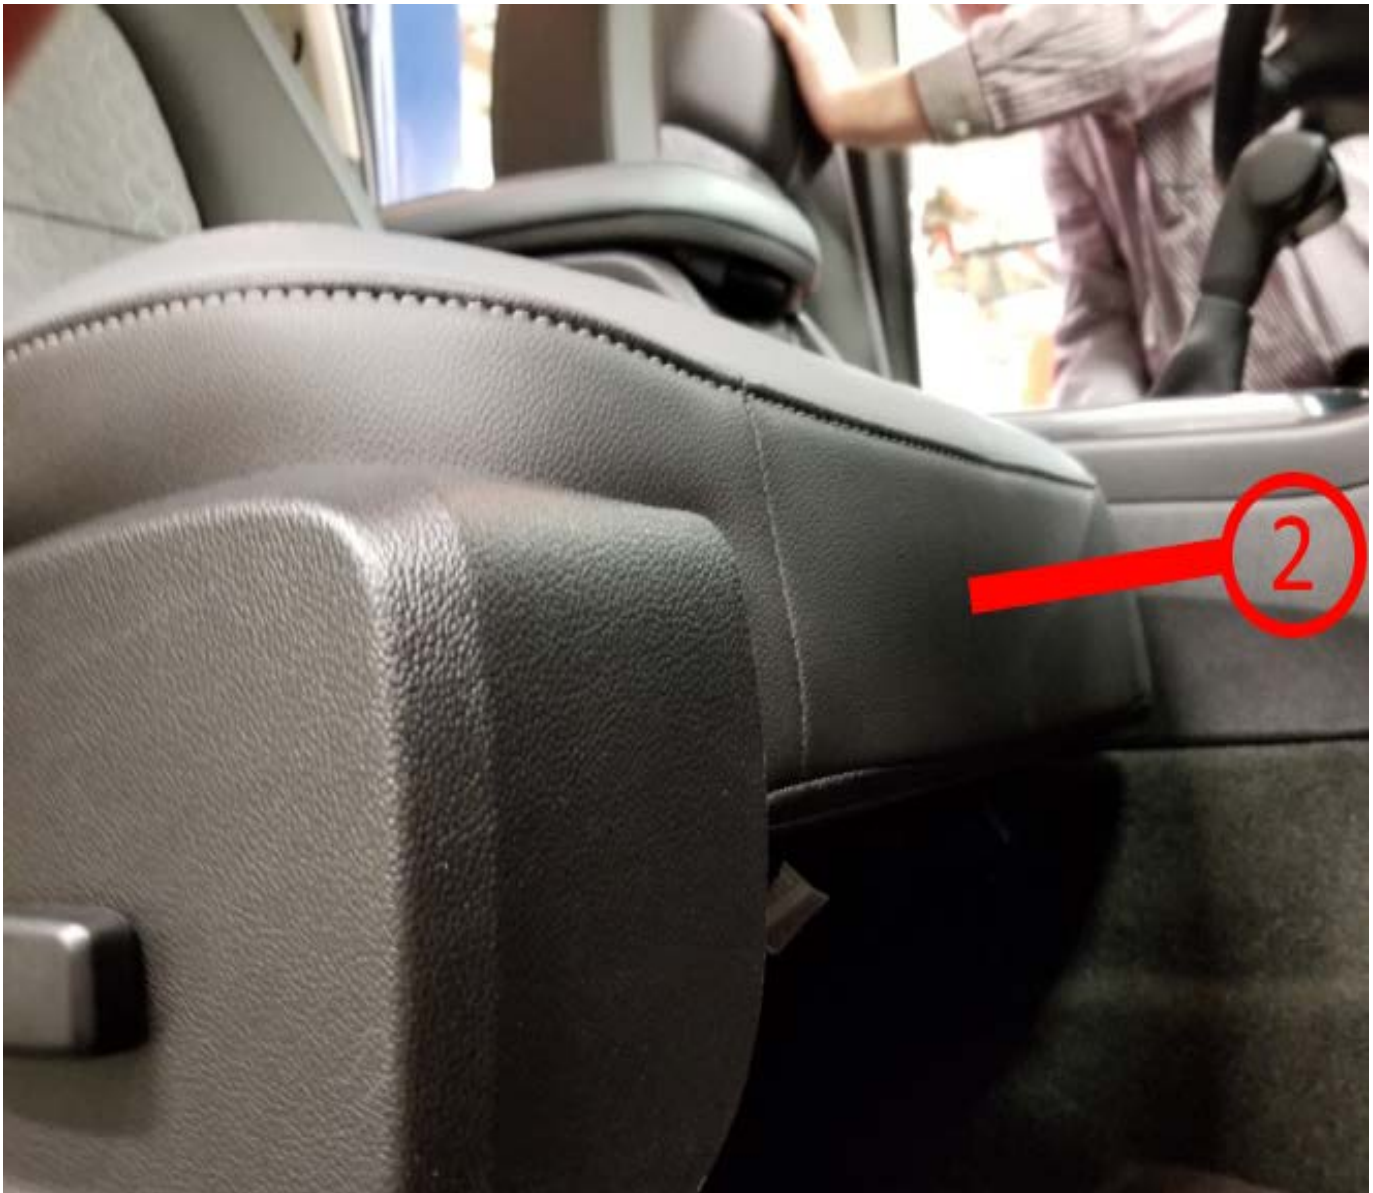
5284459

The graphic examples above shows the different appearance in thickness of the driver seat cushion (1) and the passenger seat cushion (2).

Please communicate to the customer this condition is normal design intent for their vehicle. Please share this information with the customer, including a copy of this bulletin.

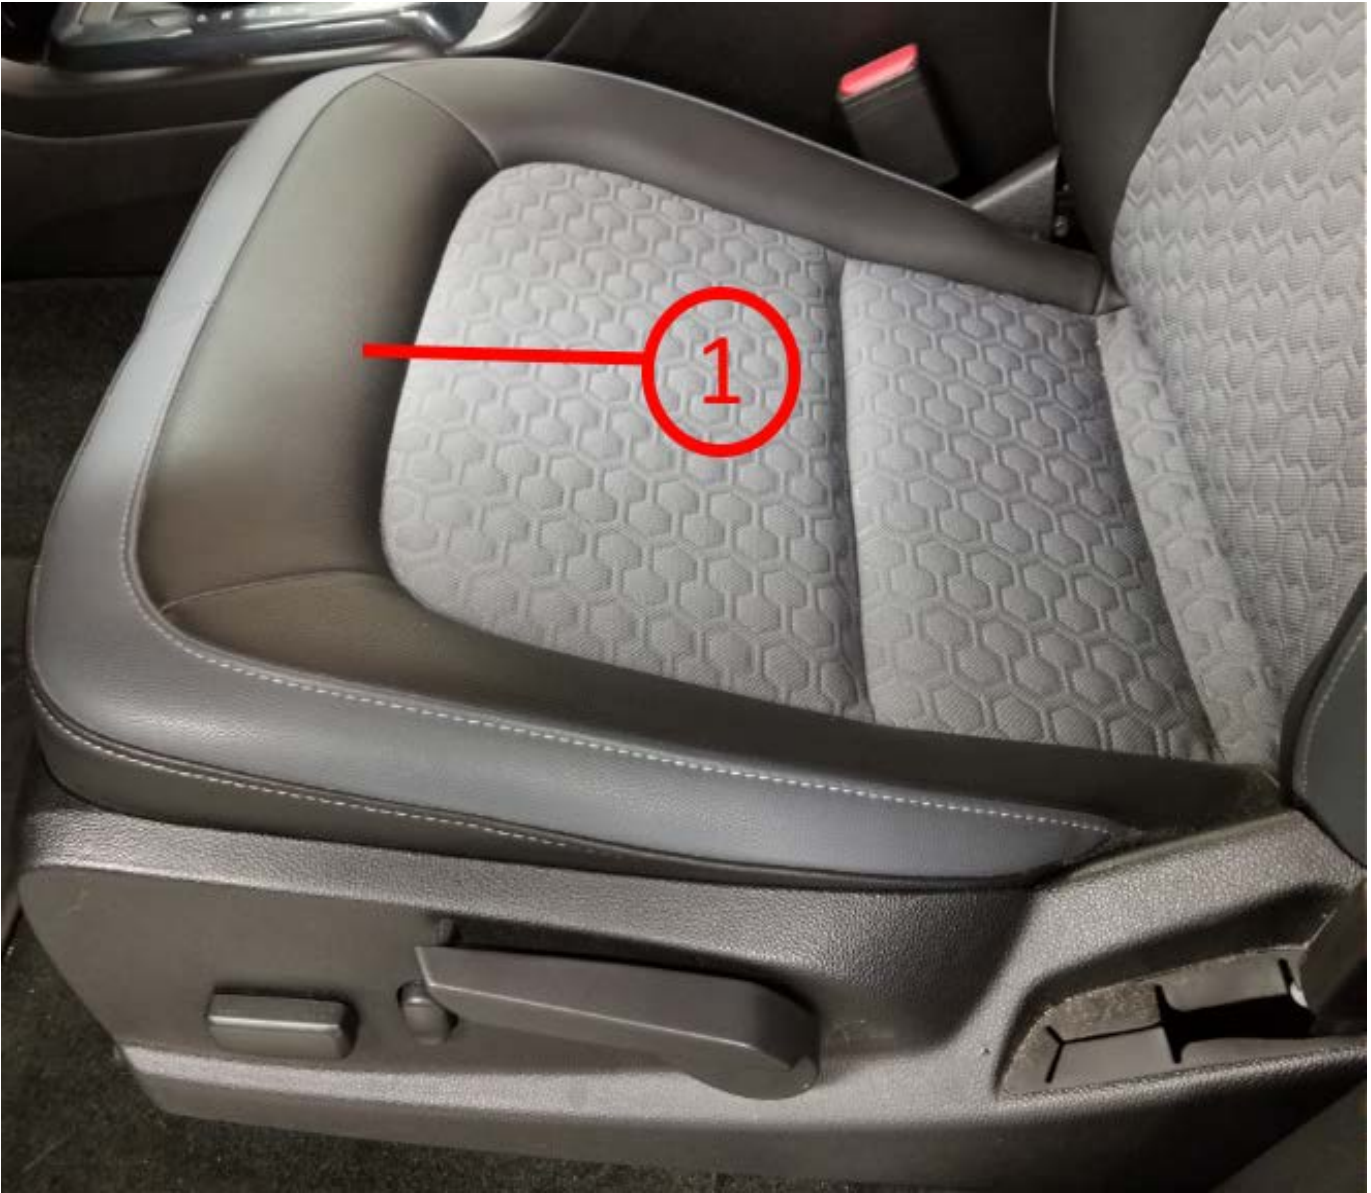
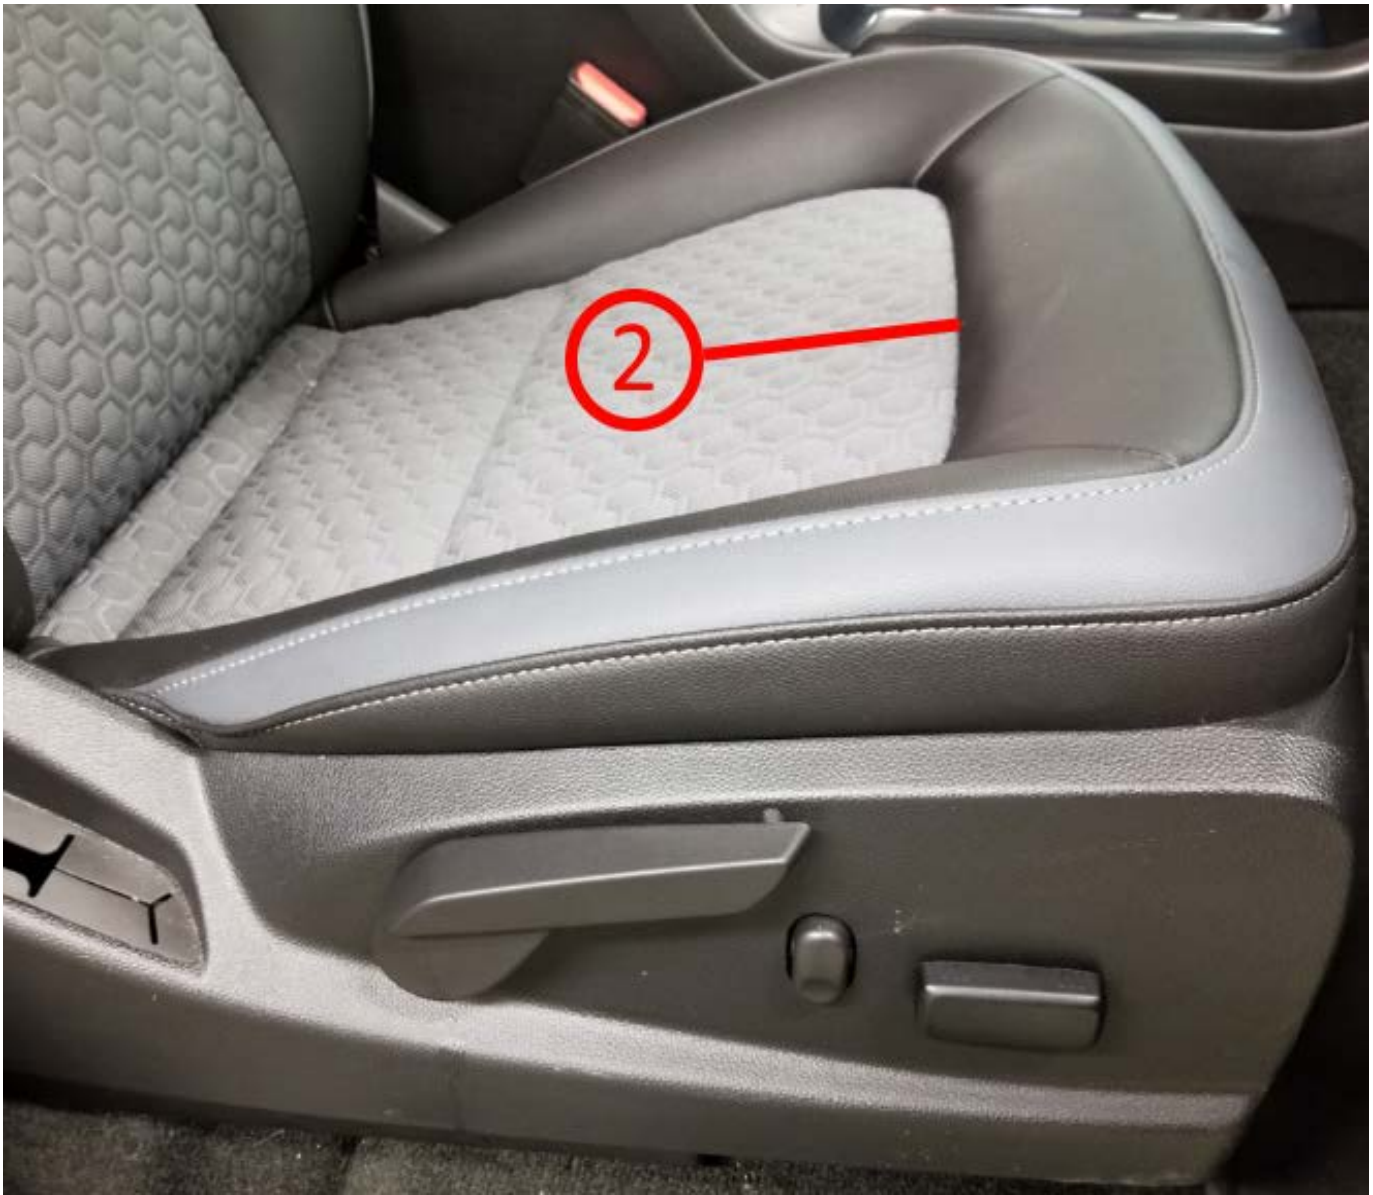
5284481

The graphic examples above shows the different thickness in the bolster area between the driver seat cushion (1) and the passenger seat cushion (2).

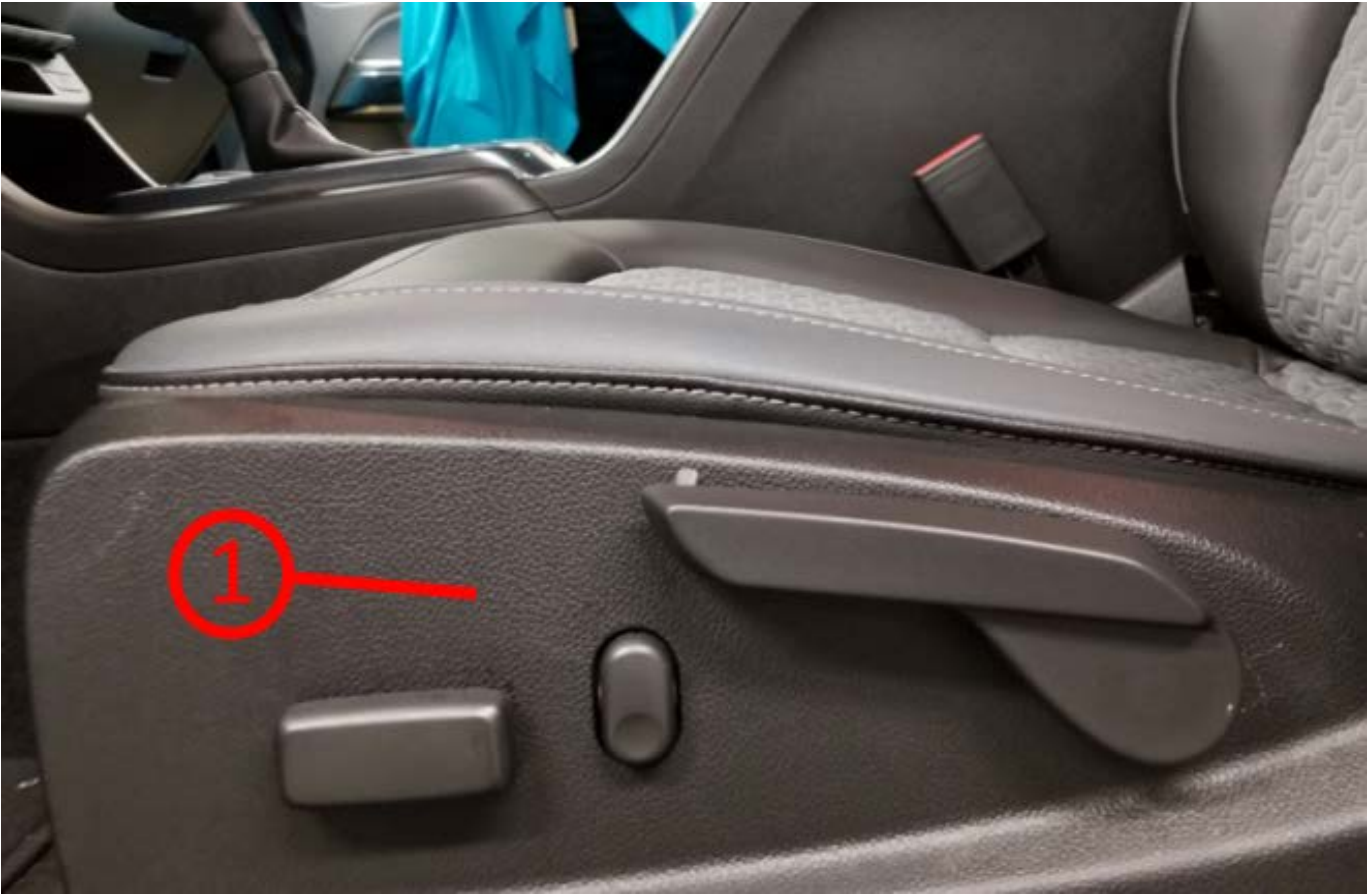
5284489

The graphic examples above shows the different thickness adjustments and controls between the driver seat cushion (1) and the passenger seat cushion (2).
