Service Bulletin

Bulletin No.: 19-NA-051

Subject: Hard-Trifold Tonneau Front and/or Rear Cover Unlatching, Popping Up

Brand:	Model:	Model Year:		VIN:		Engine:	Transmission:
		from	to	from	to		
Chevrolet	Silverado 1500 (New Model)	2019	2019			All	All
GMC	Sierra 1500 (New Model)

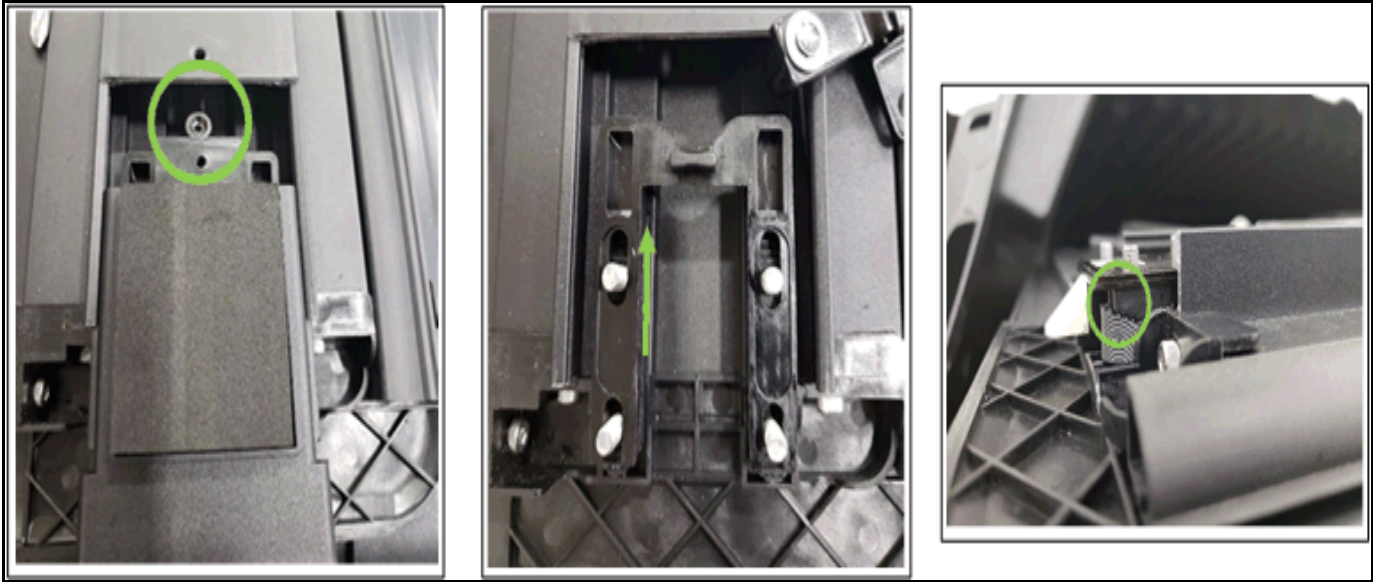
5190626

Important: For the rear passenger corner latch **only**, the latch adjusters cannot be installed at maximum height due to interference between the closeout cap and binding post, which connects the cable to the latch. The new latch adjuster must be installed at 2 steps inward, when compared to the other 3 corners

16. Once rear driver side rework is complete, move to the passenger side and follow the same instructions in steps #6 –12, **with one exception:**

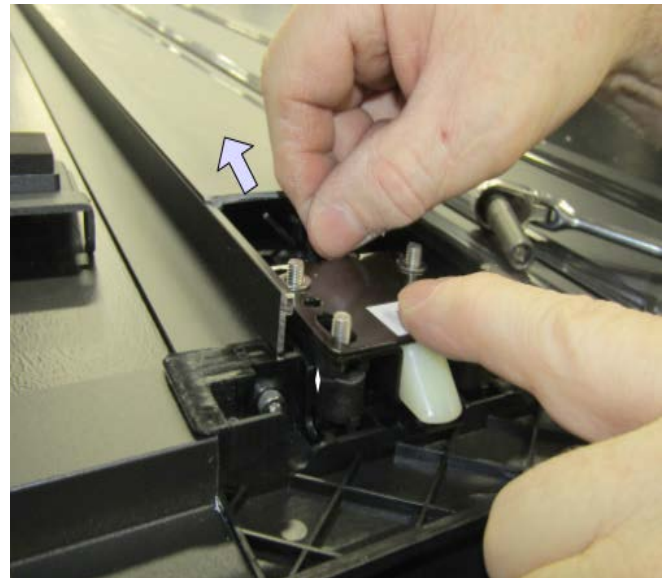
5279888

Note: The 2 step adjustment noted below will drop the latch approximately 2 mm (0.080 in.). Failure to do so could impede latch function, which may result in the rear cover not remaining closed.

- 16.2. Now, with holding down on the outboard end to provide tensions, push the adjuster 2 steps inboard. You should be able to feel, and hear an audible click, on each of the 2 steps.
- 16.3. Holding the U-shaped adjuster securely in position, install the original washers (1) and new nuts (2), and torque to 1 N•m 9 lb-in.
17. Operate the rear panel and ensure that the latches are fully engaging the underbody rail. If not, further adjustment to the latches may be required to ensure maximum engagement.
