# Service Bulletin

Bulletin No.: 19-NA-054

**Subject:** Door Rattle Noise from Outside of Vehicle During High Radio Volume or High Bass Levels

Brand:	Model:	Model Year:		VIN:		Engine:	Transmission:
		from	to	from	to		
Chevrolet	Corvette	2014	2019			All	All

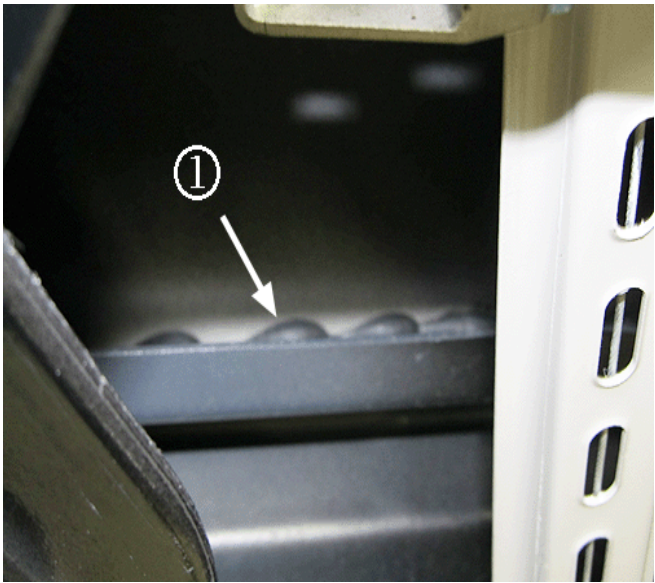
</div> <p style="text-align: right; font-size: small;">3652282</p> <ul style="list-style-type: none"> <li>There could be gaps between the inner door beam and the door skin.</li> <li>The adhesive may have separated from the door skin.</li> </ul>

<b>Involved Region or Country</b>	North America and N.A. Export Regions
<b>Condition</b>	Some customers may comment on hearing a driver or passenger front side door rattle noise during high radio volume or high bass levels. The noise is most commonly described as more evident from outside the vehicle rather than inside.
<b>Cause</b>	<p>The cause of the condition may be one or both of the following:</p> <div style="text-align: center;">

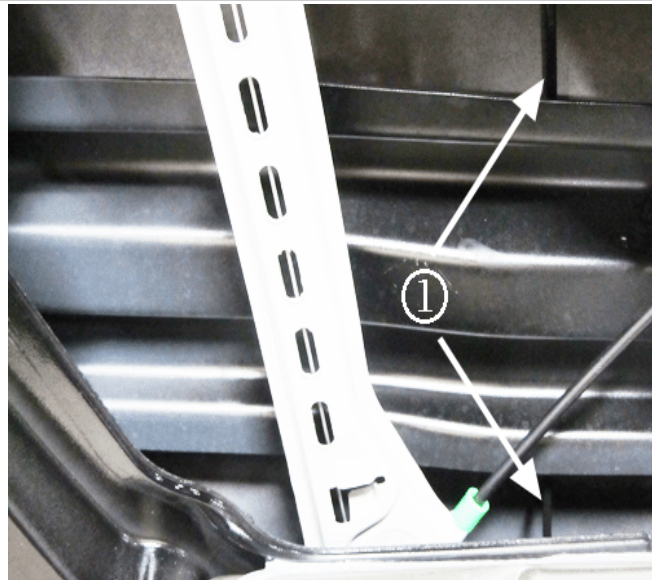
3652284

The graphic above shows an example in which a tie strap (1) was passed through a 15-20 cm (6-8 in) length gap where the adhesive was missing towards the center of the door.

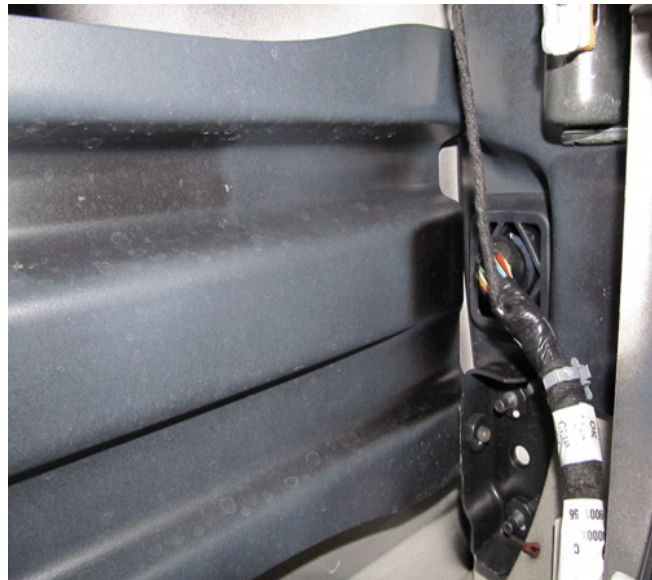
3652286

This can also occur in the front and/or rear area of the door beam; with the condition sometimes more evident in the front area (shown above) where the radio speaker is mounted.
