# Service Bulletin

Bulletin No.: 19-NA-059

**Subject: Rubbing/Popping Noise From Front of Vehicle During Sharp Turns at Low Speed**

Brand:	Model:	Model Year:		VIN:		Engine:	Transmission:
		from	to	from	to		
Chevrolet	Blazer	2019	2019			All	All

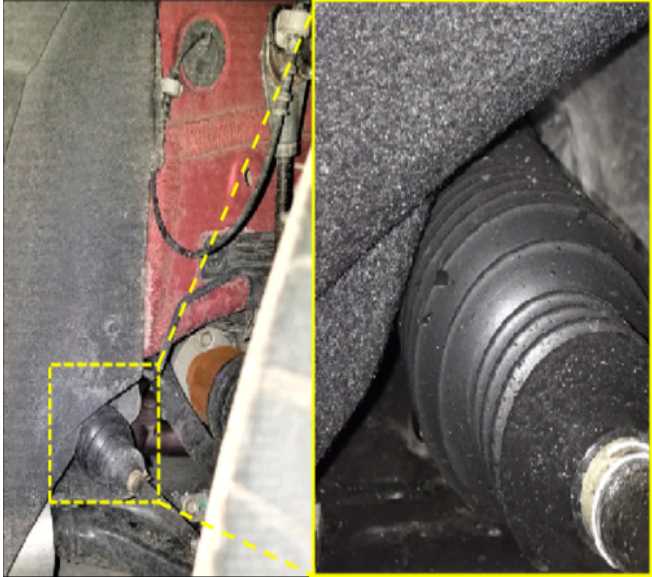
<b>Involved Region or Country</b>	North America, N.A. Export Regions
<b>Additional Options (RPOs)</b>	
<b>Condition</b>	Customer may comment on hearing a rubbing or popping noise coming from the front of the vehicle while making sharp turns at low speed.
<b>Cause</b>	<div style="text-align: right; font-size: small;">5281927</div>

<p>The cause of the condition may be one, or both, of the front wheel house liner(s) is making contact with the steering gear assembly boot, during turns.</p>
<b>Correction</b>	To achieve clearance and eliminate the interference, reposition the bottom of both front wheel house liners, following the service procedure below.
