Service Bulletin

Bulletin No.: 19-NA-067

Subject: Information on Excessive Whine Noise During Regenerative Braking

Brand:	Model:	Model Year:		VIN:		Engine:	Electric Drive Unit:
		from	to	from	to		
Chevrolet	Malibu	2016	2019			1.5L (L3A)	5ET50 (MKV)
	Volt					1.8L (LKN)	5ET50 (MKE)

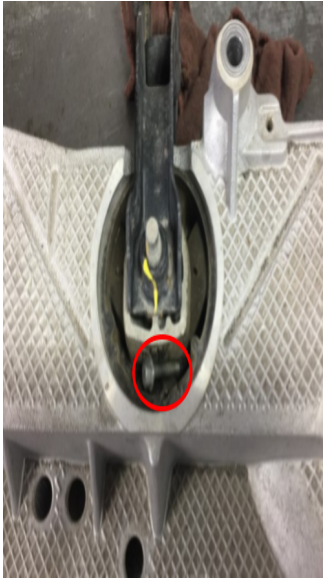
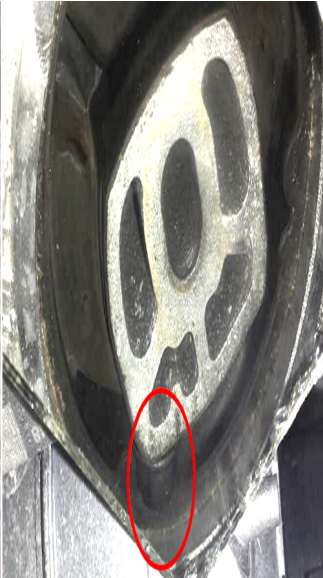
</div> <p style="text-align: right; font-size: small;">5285935</p> <p>This condition may be caused by a stray bolt, nut, gravel or other debris trapped in a powertrain mount.</p> <p>⇒ As the powertrain rotates during regenerative braking from reaction torque, the unwanted debris causes additional structure-borne noise to be transmitted to the cabin.</p>
Correction	<p>Inspect the top side of the rear powertrain mounts and remove any debris found.</p> <p>⇒ If debris is not found, follow regular diagnostics in SI to determine the source of the noise or compare to a like vehicle.</p>

Labor Operation	Description	Labor Time
5080268*	Foreign Object Removal from Mount	0.5 hr
*This is a unique Labor Operation for Bulletin use only.
