Subject: Engineering Information – Pictures of Evap/Fuel Connection Product Issues Covered Under Warranty

Brand:	Model:	Model Year:		VIN:		Engine:	Transmission:
		from	to	from	to		
Cadillac	XT4	2019	2019

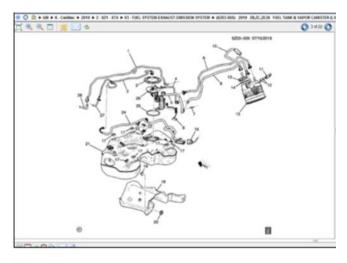
AWD:

2019 Cadillac XT4 ONLY, for any evap or fuel line connection issue (for issues covered under warranty only). Symptoms also may include:

- P0442 Evap emission small leak
- P0455 Evap emission large leak
- P1467/P146C Evap purge pump connections near engine
- Fuel odor/liquid leak in pressurized fuel feed lines

1. A picture showing the issue part location on the vehicle or you can use the evap or fuel part diagrams above for AWD or FWD, circle the area of concern and take a picture of the
