Service Campaign Bulletin

Campaign No. 2019020005, February 2019

SUBJECT: **Model SLC-Class vehicles (172 platforms)**
Model Year 2019

Check right rear underbody, rework if necessary

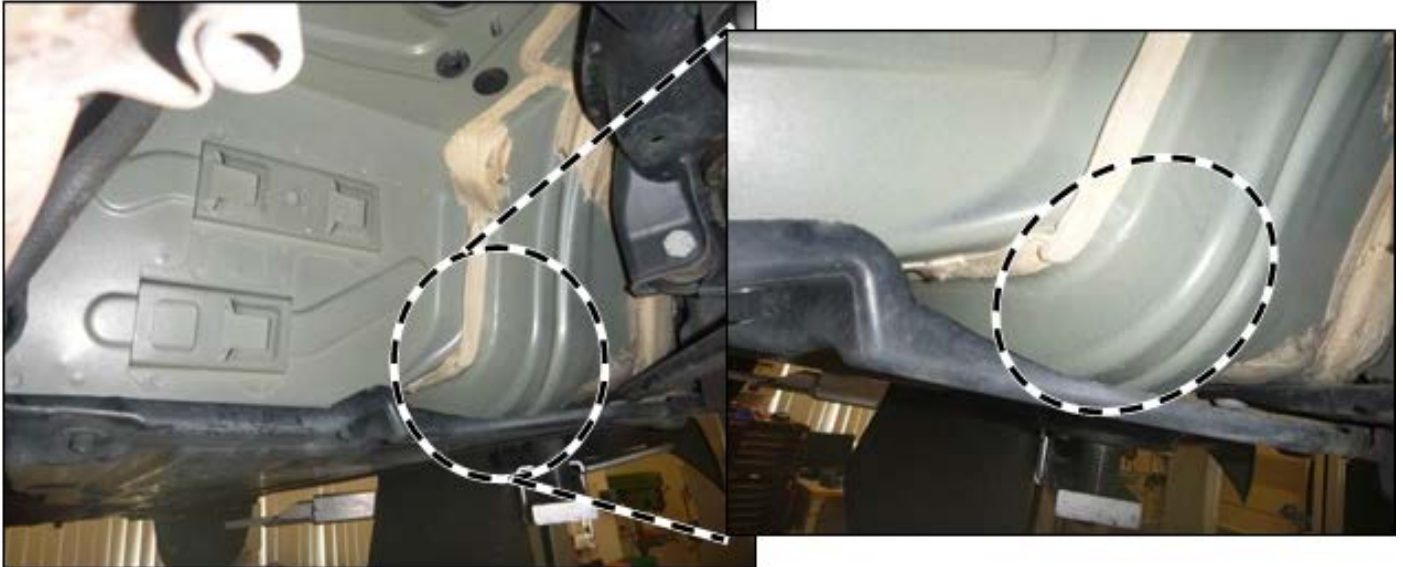
**Figure 1**

Daimler AG ("DAG"), the manufacturer of Mercedes-Benz vehicles, has determined that on certain Model Year ("MY") 2019 SLC-Class vehicles (172 platforms) the underbody may not meet production specifications, which could lead to noise while driving. An authorized Mercedes-Benz will check the rear end floor and rework it if necessary.

1. Lift vehicle with vehicle lift.
i For basic data, see **AR00.60-P-1000V**.
2. Check right rear underbody for crack formation in the marked area (Figure 1).

- a. **If there is** crack formation: Carry out **work procedure**.
- b. If there is **no** crack formation: **End measure**.

16. Drill each end of the cracks using a drill.

17. Weld crack using MIG welding procedure.
