N089NAS1

TECHNICAL BULLETIN

Service Action: Misfueling Protection Device Potentially Damaged

MODEL:	MODEL YEAR:	VIN:	ASSEMBLY PLANT:	APPLICABILITY:
Discovery (LR)	2019	400710-403235	Nitra (Slovakia)	TDV6 3.0L Diesel

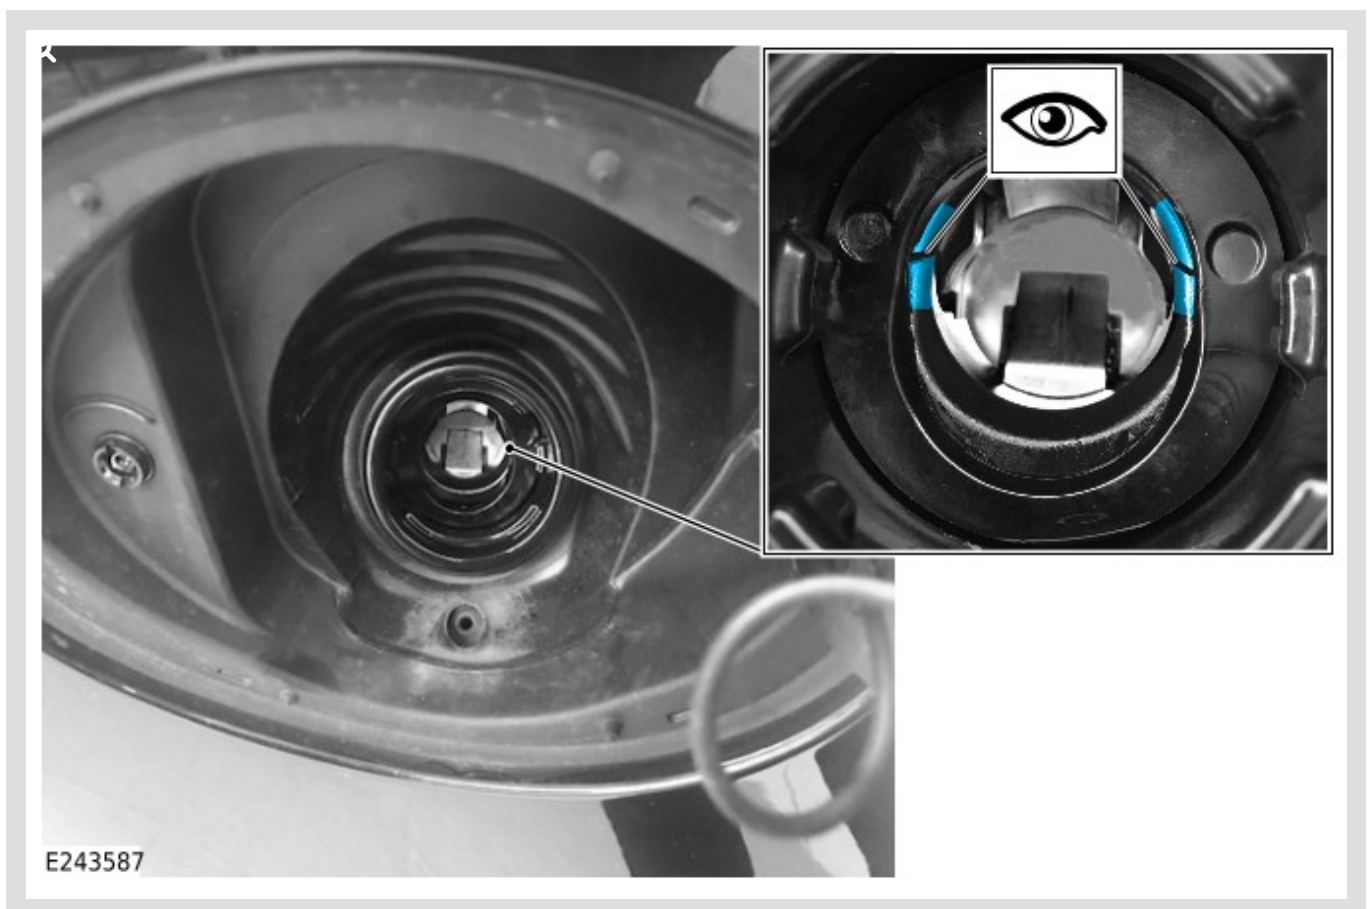
3

A potential issue has been identified on certain vehicles within the listed Affected Vehicle Range which may have a defective misfueling protection device. This may prevent the owner/driver fueling the vehicle.

Inspect the fuel filler neck for signs of cracking as shown.

- If there are not signs of cracking, install the fuel filler cap and close the fuel flap. No further action required.
- If there are signs of cracking, go to Step 4.

Renew the fuel filler neck (see TOPIx Workshop Manual section 310-01: Removal and Installation - Fuel Tank Filler Pipe).
