## LATEST VEHICLE CONCERN FIXES

| High Pressure Fuel Pump Failure P0087 | 17-19MY RR, RRS, Discovery 3.0L TDV6<br>17-19MY XE, XF, F-PACE, RR Velar AJ20D |

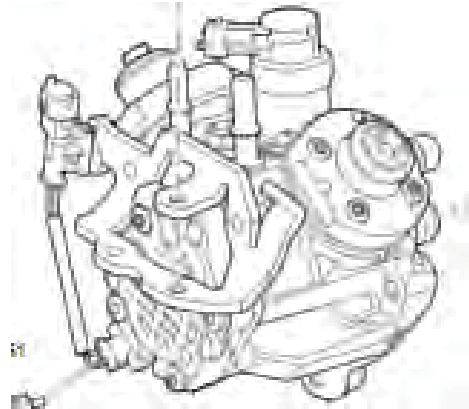
| High Pressure Fuel Pump Failure P0087 | 17-19MY RR, RRS, Discovery 3.0L TDV6<br>17-19MY XE, XF, F-PACE, RR Velar AJ20D |
|---|---|
| <p><u>Customer Voice:</u></p> <ul style="list-style-type: none"><li>– Check Engine Light illuminated, Restricted Performance Message on IPC</li></ul> <p><u>Technical Description:</u></p> <ul style="list-style-type: none"><li>– P0087-22/21 setting for fuel rail pressure sensor</li></ul> <p><u>Status:</u></p> <ul style="list-style-type: none"><li>– Under Investigation</li><li>– Ascertain the following information and include it in your TA submission:<ul style="list-style-type: none"><li>✓ Follow all TOPIx procedures</li><li>✓ 1L fuel sample in a clean container,</li><li>✓ verify fuel quality</li><li>✓ picture of the filter (hold onto the part &amp; inspect for debris),</li><li>✓ inspection of the pump (look for debris, signs rusting etc.),</li><li>✓ find out from the customer last fueling event (how much, location of fueling station, station company, approximate date)</li><li>✓ Diagnose any codes for injectors and hold onto those parts as well.</li><li>✓ Retain all parts replaced for these codes. They will be requested for return</li></ul></li></ul> | |
