April 19, 2019

Warranty Extension: Steering Feels Heavy, EPS Indicator Blinks with No DTCs or Comes On Steady with DTC 32-09, 32-08, or 61-04

Year	Model	Trim	VIN Range
2012-14	TL	ALL	Check the iN VIN status for eligibility.

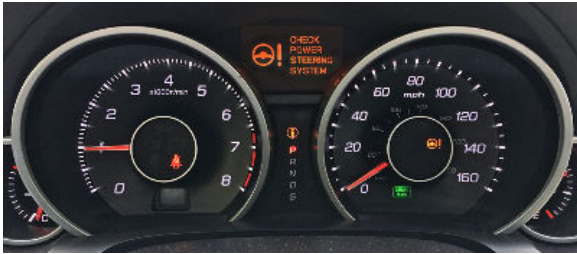
1. Connect the HDS, and check for the following DTCs:
 - 32-09 (motor current correlation)
 - 32-08 (EPS control unit internal circuit [current sensor])
 - 61-04 (motor harness malfunction)
 - If any of the listed DTCs are set, go to the REPAIR PROCEDURE.
 - If none of the listed DTCs are set, go to step 2.
2. Check if there are any other DTCs set.
 - If there are other EPS DTCs set, this bulletin does not apply. Continue with normal system troubleshooting.
 - If there are no other EPS DTCs set, go to step 3.
3. Check if the EPS indicator is blinking.

- If the EPS indicator is blinking, go to REPAIR PROCEDURE.
- If the EPS indicator is not blinking, this bulletin does not apply. Continue with normal system troubleshooting.
