SI B01 21 18
Warranties

UPDATE! N63 ENGINE: OIL CONSUMPTION CLASS ACTION SETTLEMENT DIAGNOSIS AND REPAIR PROCEDURES (VERSION 9.0)

This Service Information bulletin supersedes SI B01 21 18 **dated January 2018**

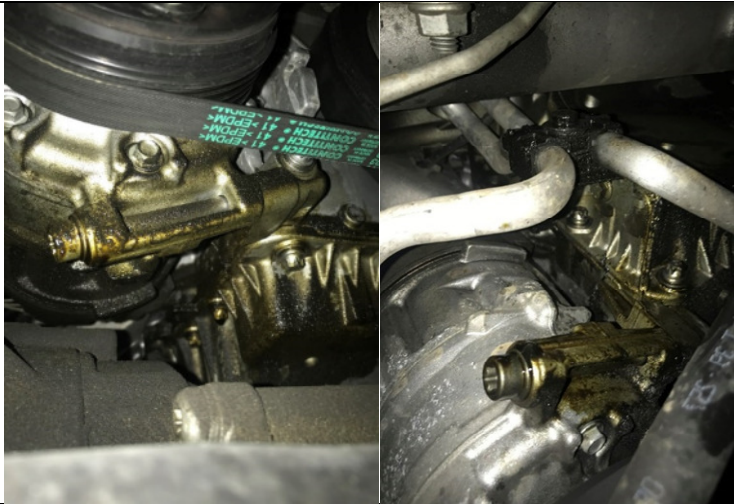
3. Inspect the front engine cover for engine oil leakage.

If the front timing cover is not leaking. Go to step 4.

If the front timing cover is leaking. Go to step 6.

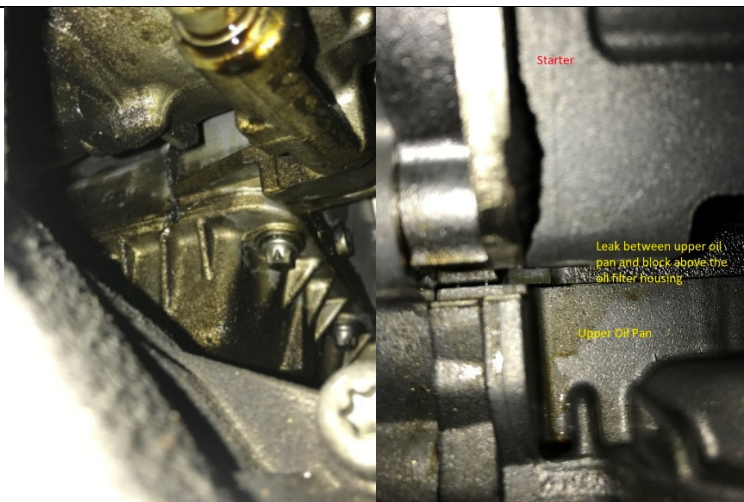
4. Inspect the upper engine oil pan for engine oil leakage.

If the upper engine oil pan is not leaking. Go to step 5.

If the upper engine oil pan is leaking. Go to step 6.

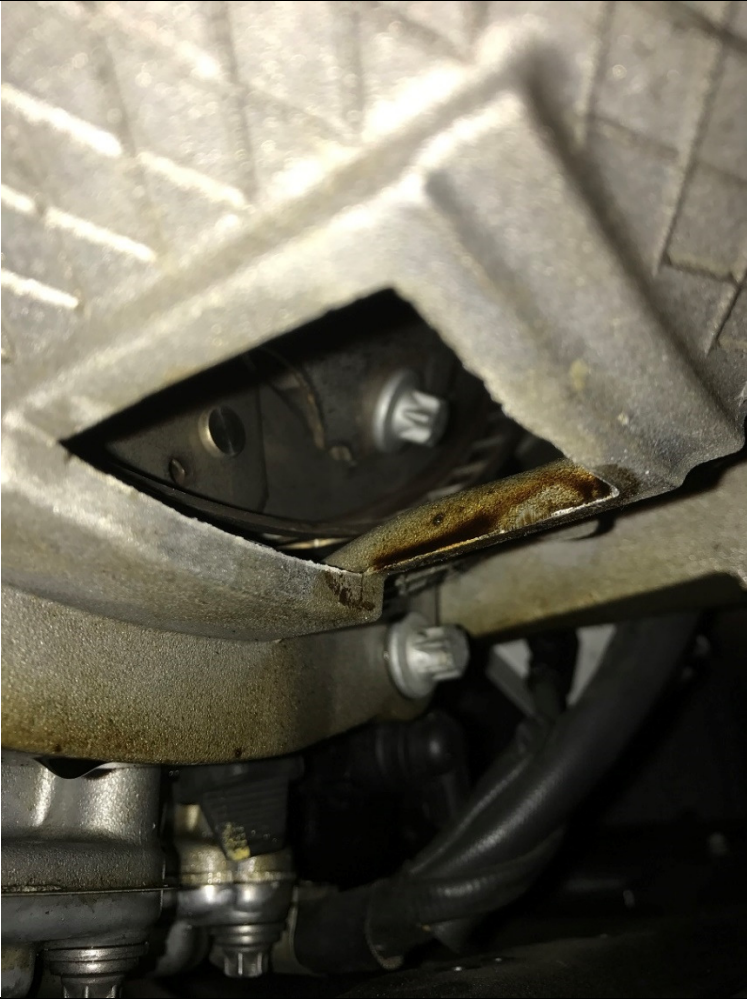
<p>5. Inspect the lower bell housing for engine oil leakage</p>

<p>The lower bell housing is not leaking. Go to step 7.</p> <p>The lower bell housing is leaking. Go to step 6.</p>
<p>6. Turbocharger oil line diagnosis.</p>

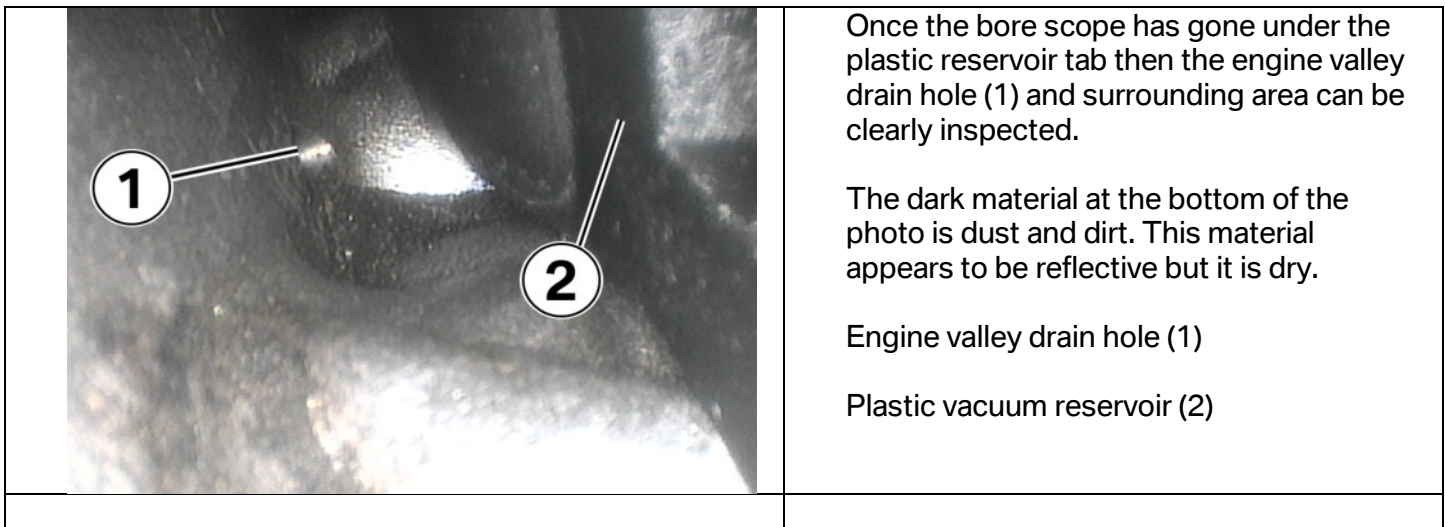
If engine oil is found in the valley area, then the root cause of the engine oil leak resides in the components on top of the engine i.e. turbocharger oil line cover, turbo charger, etc. Further basic diagnosis will be needed to find the root cause this engine oil leak. Do not remove the transmission from the vehicle. Go to Step 7.

If NO engine oil residue is found at the engine valley drain hole, but an original visual inspection indicated leak in the bell housing area, the root cause of the engine leak resides in the rear main seal and rear engine cover. Do not remove transmission from the vehicle. Go to step 7.

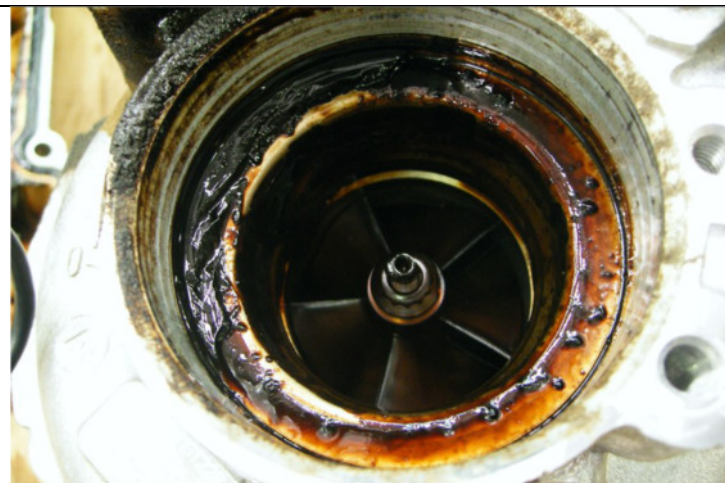
The turbocharger is not OK.
The turbocharger impeller seals are leaking engine oil.

If the turbocharger inspection is "NOT OK", then replace the turbochargers in conjunction with the recommendations in step 10. Go to step 10.

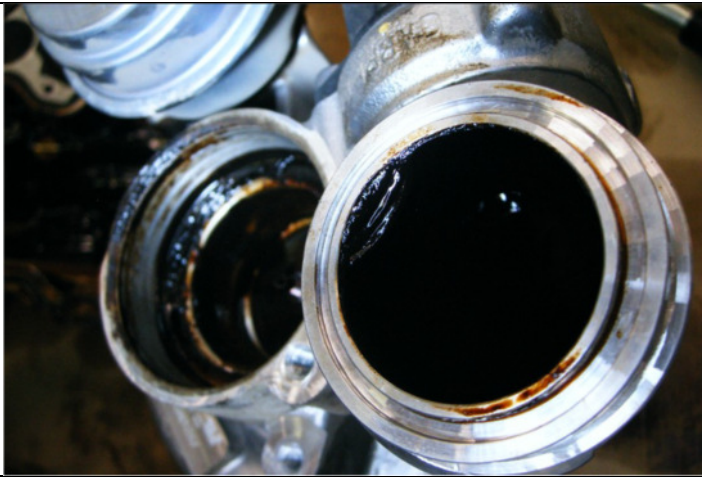
The turbocharger is not OK.

The turbocharger impeller seals are leaking engine oil.

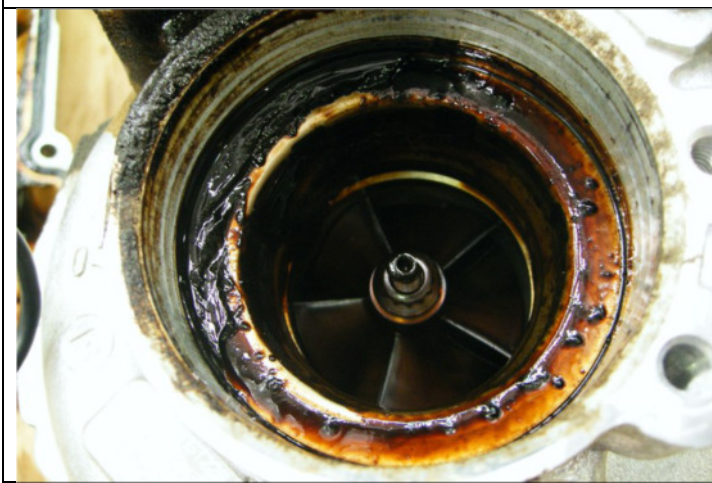
The turbocharger is not OK.
The turbocharger impeller seals are leaking engine oil.

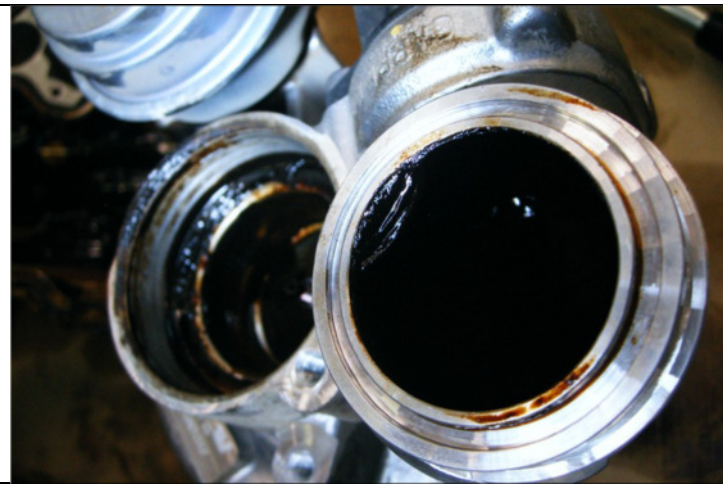
The turbocharger is not OK.

The turbocharger impeller seals are leaking engine oil.

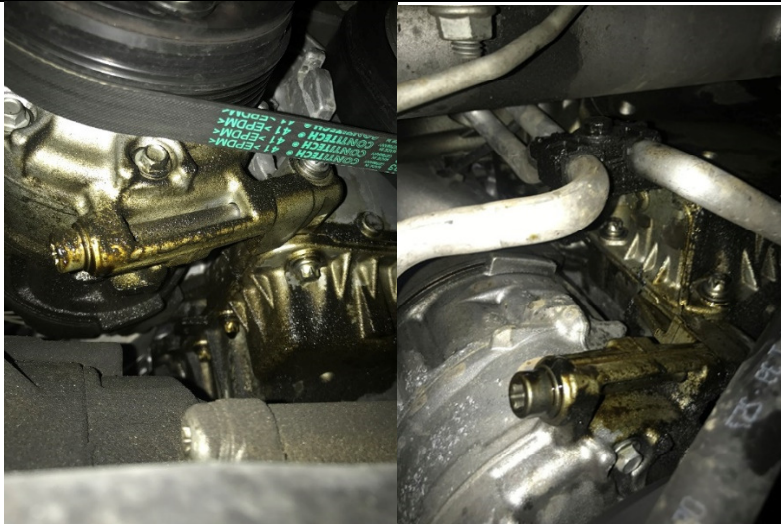
4. Inspect the front engine cover for engine oil leakage.

Front cover is **not** leaking. Go to step 5.

Front cover is leaking. Go to step 7.

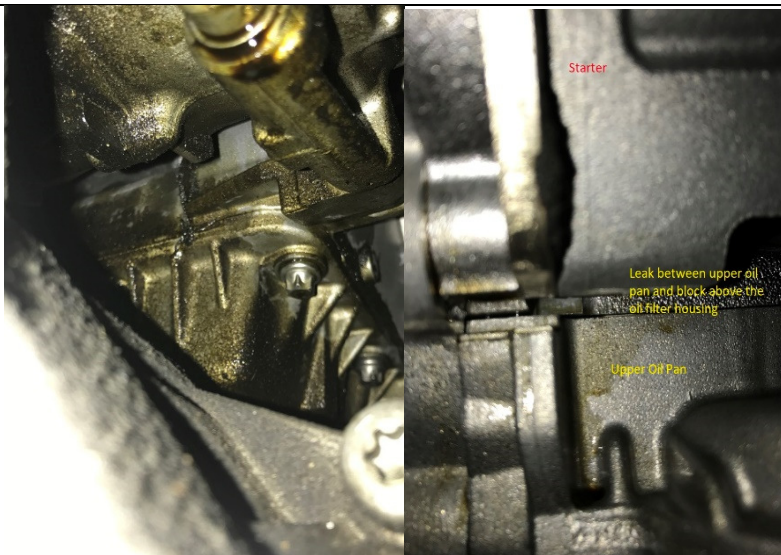
5. Inspect the upper engine oil pan for engine oil leakage.

The upper engine oil pan is **not** leaking. Go to step 6.

The upper engine oil pan is leaking. Go to step 7.

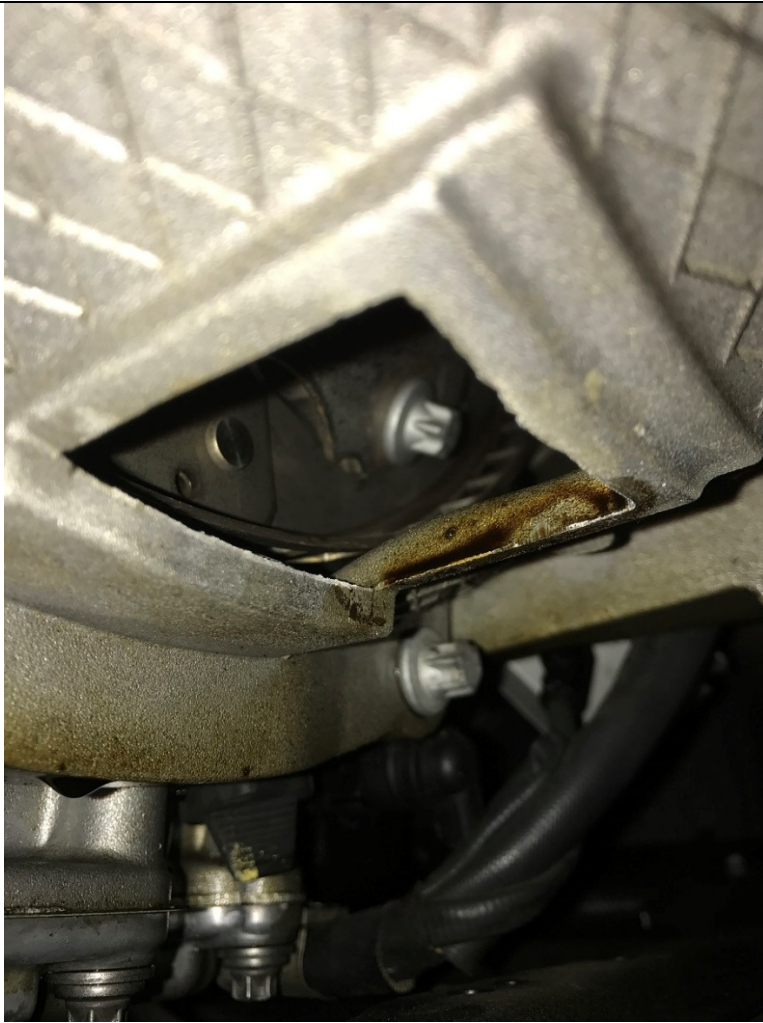
6. Inspect the lower bell housing for engine oil leakage

The lower bell housing is **not** leaking. Go to step 8.

The lower bell housing is leaking. Go to step 7.

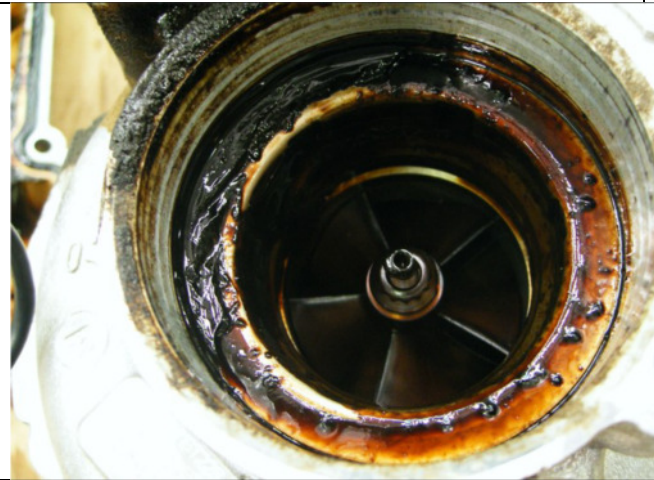
The turbocharger is not OK.
The turbocharger impeller seals are leaking engine oil.

If the turbocharger inspection is “NOT OK”, then replace the turbochargers in conjunction with the recommendations in step 11. Go to step 11.

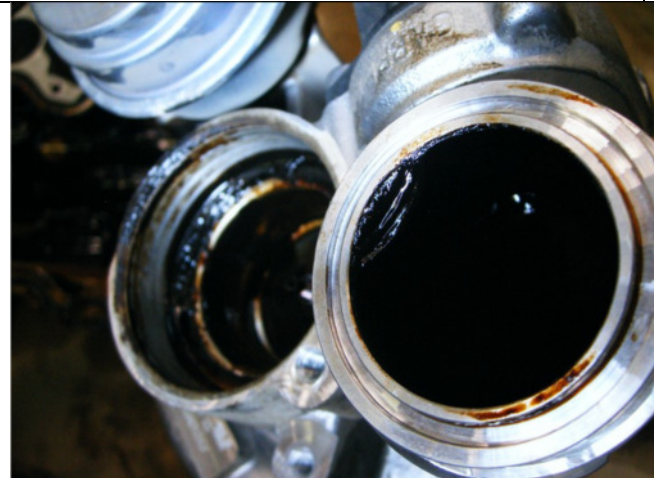
The turbocharger is not OK.
The turbocharger impeller seals are leaking engine oil.

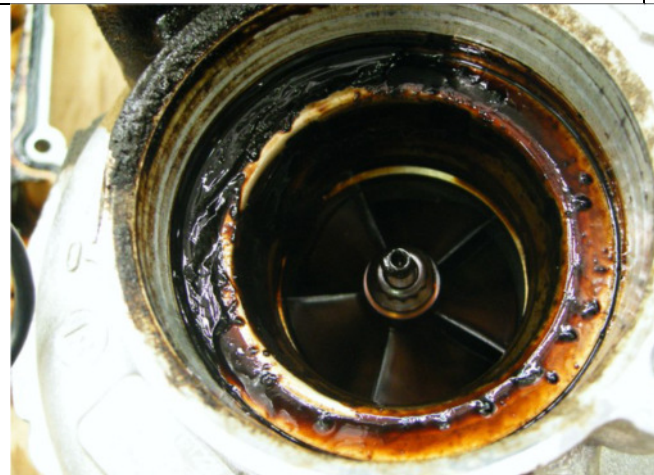
The turbocharger is not OK.
The turbocharger impeller seals are leaking engine oil.

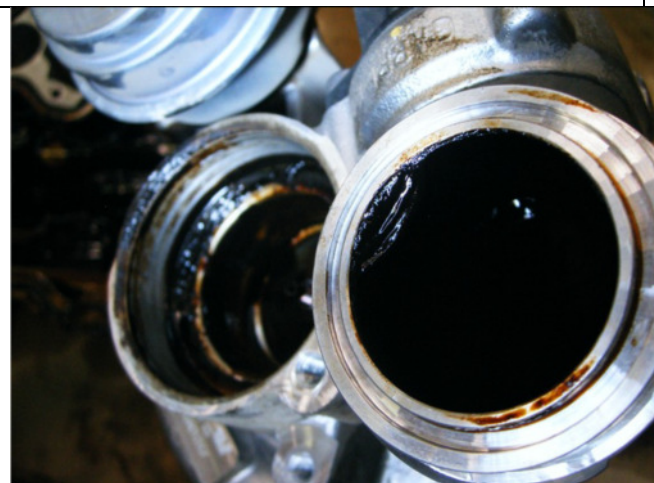
The turbocharger is not OK.
The turbocharger impeller seals are leaking engine oil.
