SI B17 03 18
Cooling Systems

CHECK CONTROL MESSAGE "TOP UP COOLANT" (I12)

I12 (i8)

I15 (i8 Roadster)
----------	---

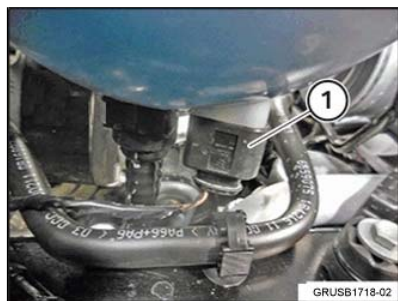
The top up coolant message is displayed in the central display (CC message ID 166). When checking the cooling system there are no leaks found and the expansion tank is filled to the proper level.

1. BDC software error
2. Poor contact in the electrical connector at the coolant level sensor in the expansion tank

Replace the expansion tank and plug connection (1):

Follow Repair Instruction **17 11 100 Remove and install/replace coolant expansion tank (high-temperature cooling system) (I12)**.
