SI B35 01 19  
Pedals

## SERVICE ACTION: CHECK ROUTING OF ACCELERATOR PEDAL MODULE (PWG) WIRING HARNESS

G29 (Z4)

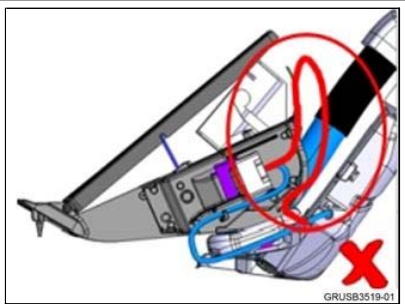
The wiring harness could get damaged by the PWG, or the harness could hang-up on the pedal.

Incorrectly routed wiring harness

<p>Incorrect routing of the wiring harness displayed in the illustration on the left (red harness).</p>
	<p>Another way the wrong harness routing could present itself is, that the wiring is showing above the pedal.</p>

Inspect the routing of the wiring harness for the PWG and correct if needed.

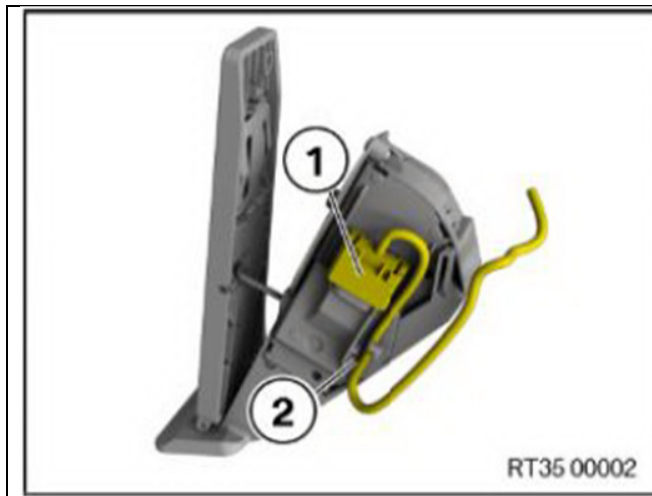
- Check the routing of the wire harness as per the illustration on the left (blue harness)
- Correct the harness routing if needed

The PWG harness has to be routed as shown in the illustration on the left.

- Wire harness must be secured into the holder (2)
