SI B51 10 19  
Body Equipment

## LUGGAGE COMPARTMENT COVER SUPPORT STRAP MISSING

| G01 (X3) | G02 (X3) | | |

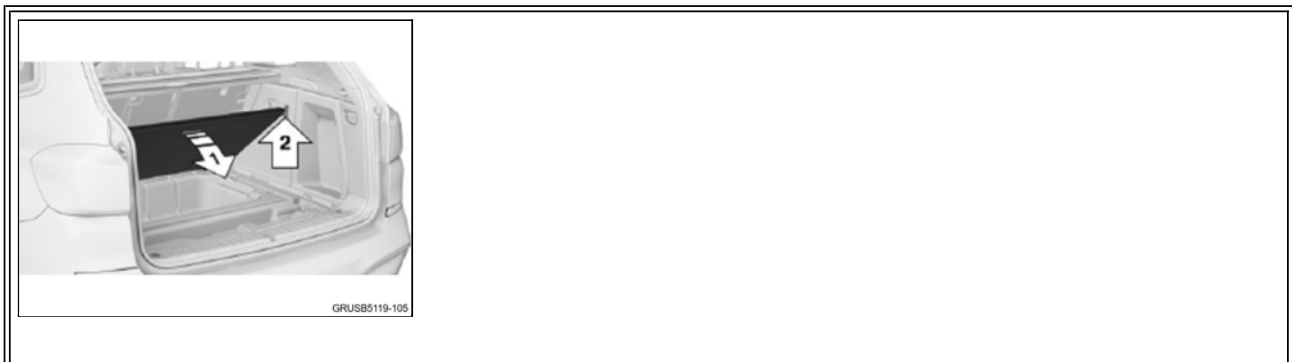
The support strap used to secure the luggage compartment cover in the raised position may be missing.

The incorrect luggage compartment cover may have been installed during production.

1. Inspect the luggage compartment cover at location "2" shown below.

Is the support strap installed on the underside of the luggage compartment cover?

2. Install the correct luggage compartment cover outlined in the parts information section of this bulletin following repair instructions 51 47 102 "**Removing and installing/replacing the luggage compartment floor covering**".
