SI B51 11 19
Body Equipment

SERVICE ACTION: SECURE UNDERBODY PANELING

F30 (3 Series Sedan)	F31 (3 Series Sports Wagon)	F32 (4 Series Coupe)	
----------------------	-----------------------------	----------------------	--

Produced 7/2018-8/2018

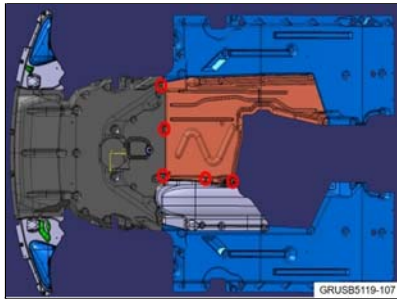
Over time, the mounting clips may fail, allowing the center underbody panel to become loose.

The mounting clips were not sufficiently hardened during production.

Reference the photo below to identify the location of the 5 faulty mounting clips as indicated by the red circles.

Note: The 5 faulty mounting clips are located towards the front of the center underbody panel (under the transmission bell-housing).

1. Replace the 5 mounting clips shown below, following repair instructions **51 47 491 "Removing and installing/replacing rear underbody protection"**.

Only replace the underbody panel if it is found to be damaged or missing.
