SI B61 02 19  
General Electrical Systems

## SERVICE ACTION: CHECKING REAR POWER WINDOW SWITCH

| G20 (3 series) | |

This Service Action involves 1388 G20 (3 Series) vehicles produced 01/07/2019 - 01/17/2019.

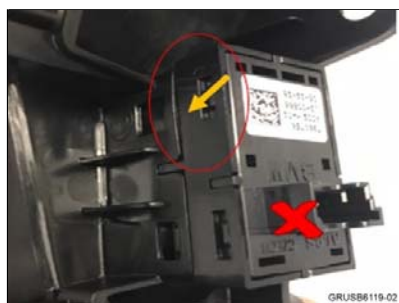
The power window switches are not latched correctly in the left and right rear door trim panels.

During assembly the window switch is not latched completely to the door panel trim.

Ex. The picture shows window switch not latched completely.

3. Disassemble the affected door trim according to repair instructions (Refer to attachment), latch the window switch correctly, reinstall the door panel with new clips and perform functional check.
