SI B63 01 19
LightsMarch 2019
Technical Service

DELIVERY STOP: REWORK TAIL LIGHTS

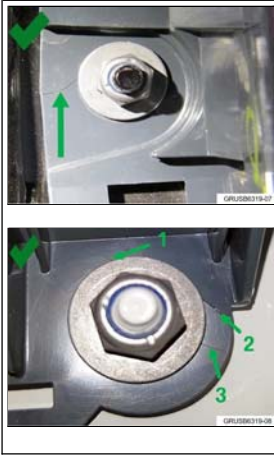
<p>4. Reference the photos shown to the left, which demonstrate acceptable cracking and which require no further correction.</p> <p>Description of picture: 1 – small crack, not circulating, no net of cracks, OK 2 – small crack, not circulating, no net of cracks, OK 3 – weld line, OK Attention: the position of the weld line can vary from model to model</p>

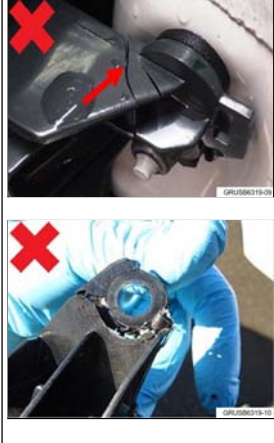
<p>5. Reference the photos to the left showing examples of cracks that are NOT acceptable and which require tail light replacement. Holder broken Eye broken off</p>

7. Remove one or both rear lights, depending on whether one or both lights are found to be damaged following the ISTA repair instructions for the applicable model.

<p>9. With the damaged rear light removed from the vehicle, the tail light mounting studs and vehicle body MUST be cleaned to remove residual manufacturing oil. Using an 80% ethanol/20% water mixture on a clean cloth, clean the mounting studs and body area shown to the left.</p>
--	---

10. Once the vehicle body has completely dried, install a new tail light on the affected side(s). **Replace all of the tail light mounting nuts with new nuts.** The tail light mounting nuts **MUST BE REPLACED if they were removed to replace a tail light.**
