## HEADLIGHT ASSEMBLIES HAVE VISIBLE INTERNAL MOISTURE/CONDENSATION

This Service Information bulletin supersedes SI B63 05 16 dated March 2018

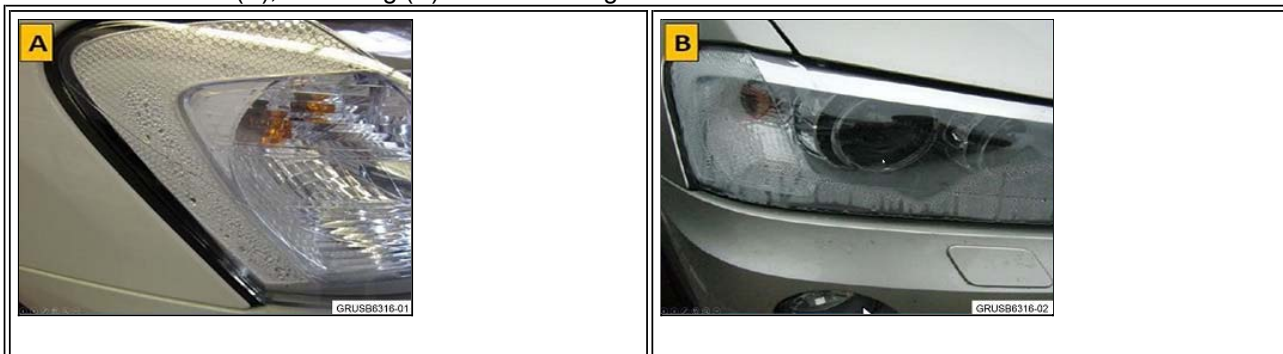
Water on the inside (A), or misting (B) of both headlight lenses that is visible from outside.

Water inside the headlights can be caused by two situations:

- Water/moisture ingress into the headlight housing.
- Thermal conditions that result in the formation of condensation.

**Note :** An important indication that the moisture issue is caused by condensation

rather than a water leak is that both headlights will be affected.

- **UPDATE!** Dry out affected headlights.
- **Only** if there is a permanent stain then replace the affected headlight.
