SI B64 03 19  
Heating and Air Conditioning

## SERVICE ACTION: REAR IHKA PANEL LOOSE

G20 (3 Series)

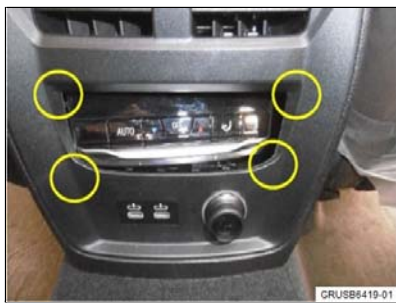
| <p>CRUSSE419-01</p> | <ol style="list-style-type: none"><li>1. Check for tight fit of the rear air conditioning control panel by pressing the four corner areas.</li></ol> <p>Ex: In extreme cases, the control panel can disengage completely</p> |

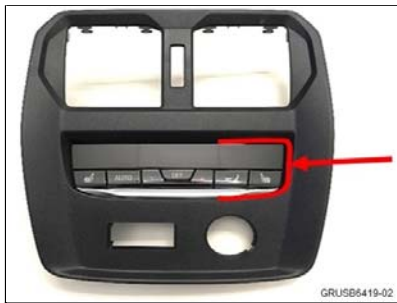
| | <ol style="list-style-type: none"><li>2. Check to see if the control panel is disengaged or a gap is present on the right side?</li></ol> |

| | <p>3. Is the control panel found loose, disengaged or is a gap present?</p> <p><b>YES:</b> Refer to step 4</p> <p><b>NO:</b> No further repair is necessary</p> <p>4. Perform replacement of the rear grille trim (Refer to attachment)</p> |
