SI M63 01 19  
Lights

## SERVICE ACTION: REWORK TAIL LIGHTS

F60 (MINI Countryman)

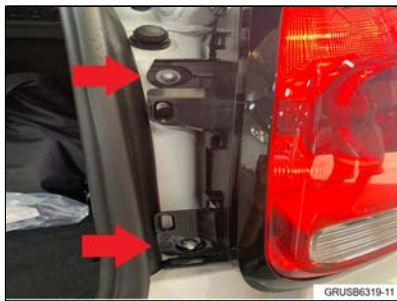
2. Visually inspect the mounting area of the tail light as shown to the left.

1. Unclip the water channel cover from the side of the rear taillight. Reference repair instructions 63 21 275 Remove and install rear left light of side panel for instructions on removal of this water channel only. Do not remove the complete tail light.

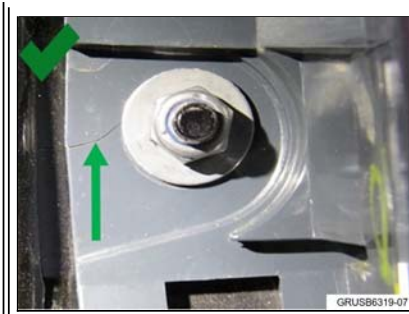
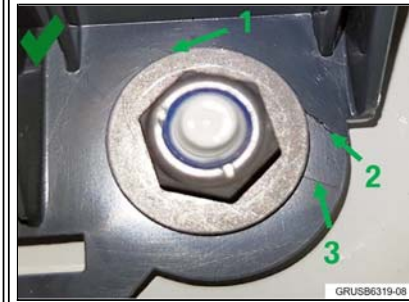
4. Reference the photos shown to the left, which demonstrate **acceptable** cracking and which require no further correction. Single cracks are acceptable.

- 1 – small crack, not circulating, no net of cracks, **OK**
- 2 – small crack, not circulating, no net of cracks, **OK**
- 3 – old line, **OK Attention:** the position of the weld line can vary from model to model

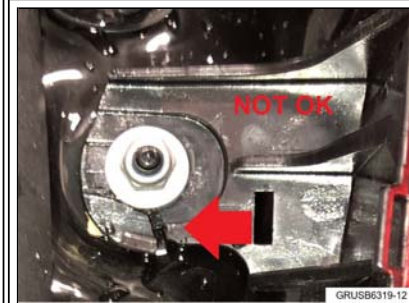
5. Reference the photos to the left showing examples of cracks that are **NOT** acceptable and which require tail light replacement. Holder broken

7. Remove the damaged tail light(s) following repair instructions REP 63 21 275 Remove and install rear left light of side panel.

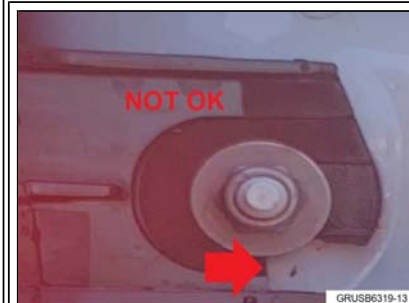
Eye broken off
