Technical Service Bulletin

Topic	Mulsanne rear suspension knock
Market area	Bentley: worldwide (2WBE),Hongkong-Macau (5HK)
Brand	Bentley
Transaction No.	2044308/2
Level	EH
Status	Released for publishing
Release date	Mar 12, 2019

Knock from rear suspension

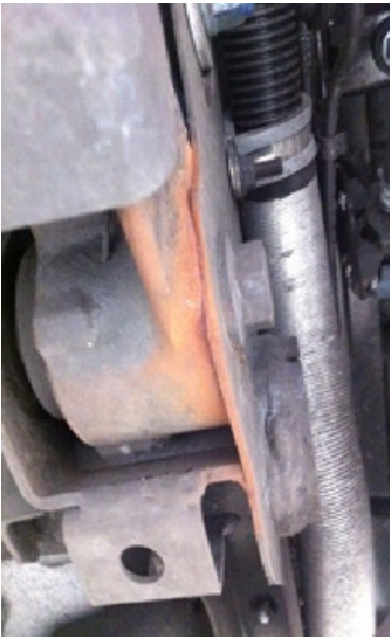
Figure 1

Inner metal sleeve of the rear lower suspension lever inner bush is, by design, not bonded to the elastic element of the bush this in some cases may allow the bush housing on the suspension arm to clash with rear subframe

2. If a clash is evident indicated by red deposits in vicinity of lower lever inner mount (see Figure 1) then remove the lower lever Rep. Gr.42 and inspect each inner bush replace damaged or worn bush as required note inner sleeve of bush is not bonded to elastic element therefore lateral movement in this sleeve within the elastic element is not in isolation grounds for replacing the bush

On receipt of a qualified customer complaint inspect the rear sub frame for evidence of lower lever clash if evident then fit isolation washers as detailed to the inner bushes of both rear suspension lower levers.
