'18 -'19 GL1800 Navi Update

2018 GL1800 Loose Handlebar Repair

SXS1000 - Overheating

SXS700 - Overheating

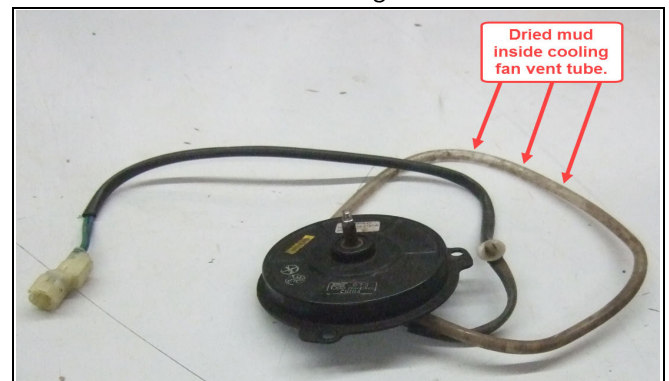
Same engine overheating as above, but a different cause. If a customer complains the cooling fan does not turn on and the engine is overheating, the problem may be due to the cooling fan's clear vent tube end being submerged in water. The temperature differential between the cool water and the hot cooling fan motor draws water into the cooling fan motor through the vent tube, damaging it. To check, follow these the steps below:

1. Check if the cooling fan fuse is blown and for evidence of water or debris in the cooling fan's clear vent tube (see below) - both could be evidence of water ingestion.

- If the cooling fan operates normally, replace the fuse and be sure the vent tube is clean. Replace the vent tube if it cannot be cleaned of debris. Be sure the vent tube is routed correctly and is at least 31 inches above the ground (see below).

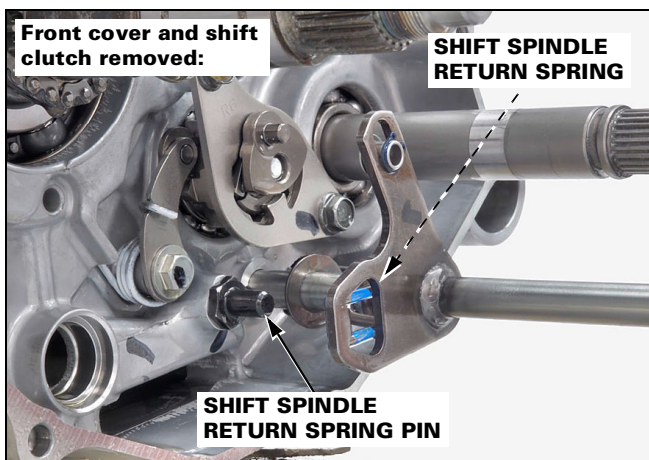
If a customer complains of erratic shifting first verify the shifting problem is repeatable then verify there are no Diagnostic Trouble Codes (DTC). It is possible the gear shift spindle return spring pin may be broken. The pin, along with the shift return spring, returns the shift spindle to its "at rest" position.

You should be able to feel the spring tension from the shift spindle return spring. If there is no tension, the shift spindle return spring pin is broken and needs to be replaced. There is a new part (P/N 24652-HR3-A40) and the torque spec has changed from 24 N m to 29 N m.

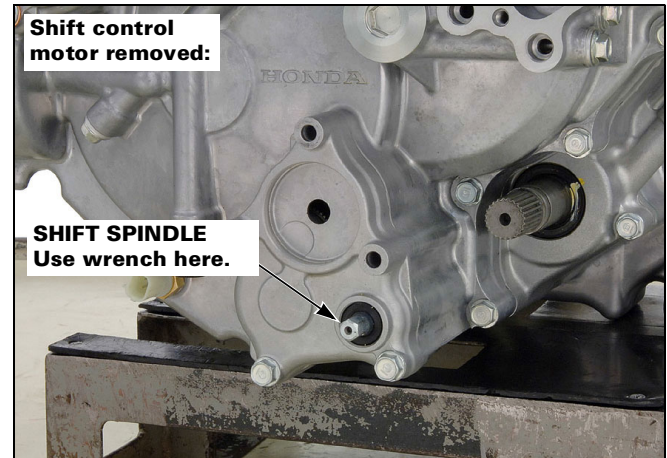
- Remove the shift control motor.
- Then, check for spring tension on the shift spindle by attaching an 8 mm box-end wrench to the end of the spindle and turning the wrench in both directions.

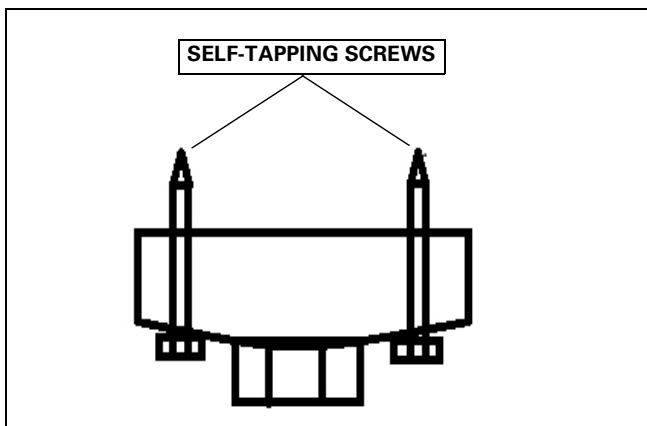
A stuck-on engine oil filter can turn a small job in to a chore. Here are some tips which might help.

- Be sure to use a clean Honda filter wrench.
- Place a thick paper towel between the filter and the wrench to remove any gaps for extra grip.
- Try a different style of filter wrench: socket-style, strap-style.
- Modify a filter wrench. Drill two holes in the face of the wrench then start threading self-tapping screws into the holes (shown below). Insert the filter wrench onto the filter then tighten the screws until they pierce the filter housing. This will provide extra grip to help loosen the filter.
