Service Alert

APPLE CARPLAY™ / ANDROID AUTO™ FREQUENTLY ASKED QUESTIONS (FAQ)

Service Alert No.: SA-001/19

Last Issued: 04/05/2019

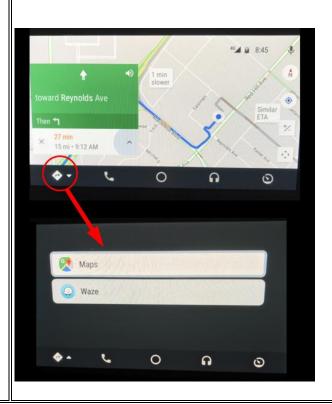
When using the steering wheel Voice Command button to set a navigation destination, Android Auto™ defaults to the last navigation app that was used.

The wrong navigation app opens when using the steering wheel Voice Command button.

Select the "Maps and Navigation" icon to set your default navigation app.

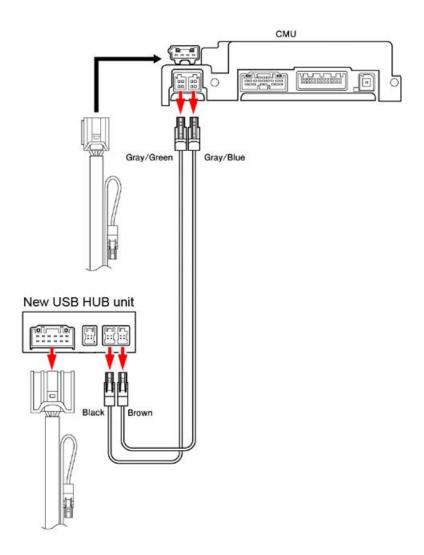
(Cannot install CMU software after smart phone Cable Set Kit (P/N C922-V6-605) installation)

1. Disconnect the new smart phone HUB unit and the new smart phone cables from the CMU.
