Subject: "IN-VEHICLE NETWORK MALFUNCTION" WARNING MESSAGE IN INSTRUMENT CLUSTER WARNING MESSAGE WITH NO DTC	Service Alert No.: SA-014/19
	Last Issued: 04/03/2019

2019 Mazda3

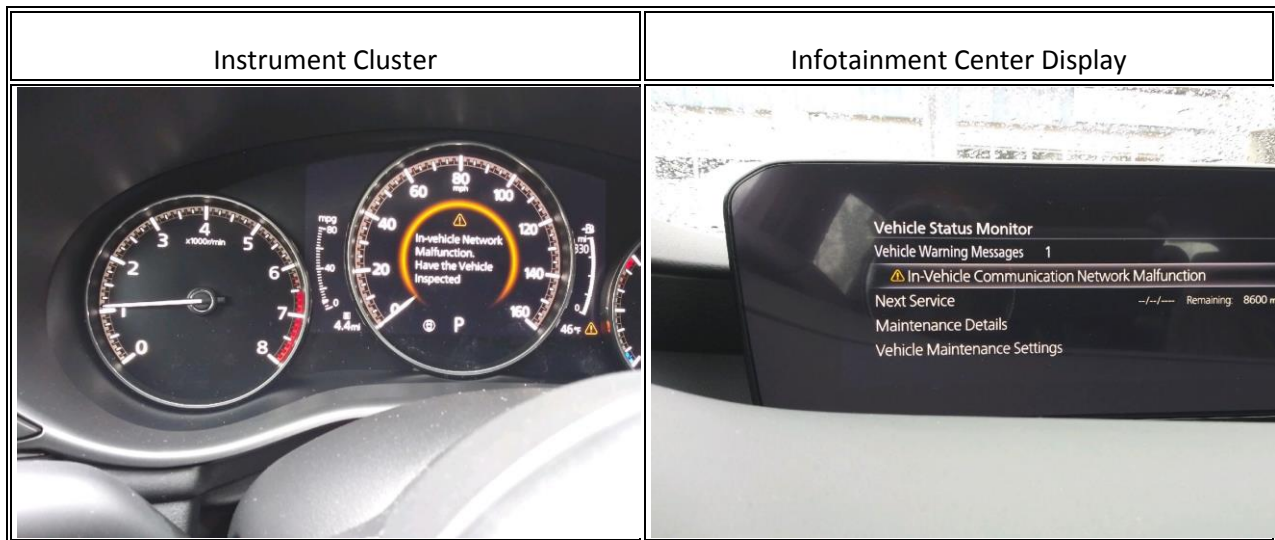
Some customers may experience a warning message in the instrument cluster that says "IN-VEHICLE NETWORK MALFUNCTION" with no DTC's stored.

1. Verify customer concern.
2. Disconnect the negative battery cable and wait 30 minute to clear the KAM.
3. Reconnect the negative battery cable and start the engine.
4. Verify the warning message has not returned and that no DTCs have set using MDARS.

NOTE: Only use MDARS to scan for DTC's. If IDS is used, P0602 will falsely set.
