GROUP Product Improvement	MODEL See Model List on Page 1
	NUMBER PI1802W/X (Rev 5, 04/10/2019)	DATE October 2018
PRODUCT IMPROVEMENT CAMPAIGN		
SUBJECT: ENGINE REPLACEMENT INSTRUCTIONS FOR DTC P1326 (PI1802W/X)

This bulletin provides information related to the Technical Service Bulletin previously published in July 2018 ([PI1802](#), Rev 6, 01/31/2019) titled “Knock Sensor Detection System - ECU Logic Improvement”. Specifically, this bulletin provides instructions on which procedures to follow if, after installation of the KSDS, any one of the subject vehicles below returns to the dealer with Diagnostic Trouble Code (“DTC”), P1326.

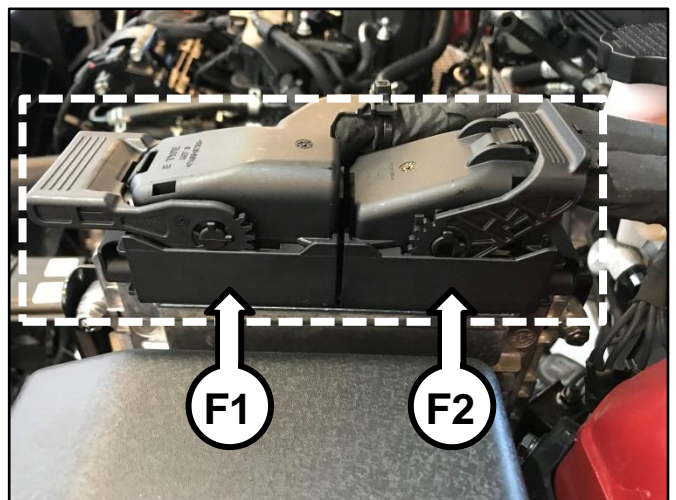
3. Disconnect the ECU connector* (figure F1 or F2) (*see IMPORTANT note below).

Location of the ECU connector may vary from model to model. Refer to the table on page 13 for the ECU connector number and the applicable ETM Manual on KGIS for the location of the ECU connector.

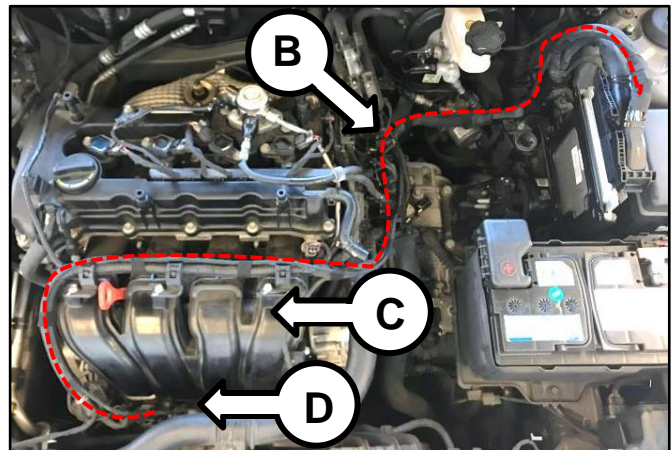
The harness (B) must be routed exactly as shown to prevent related DTCs.

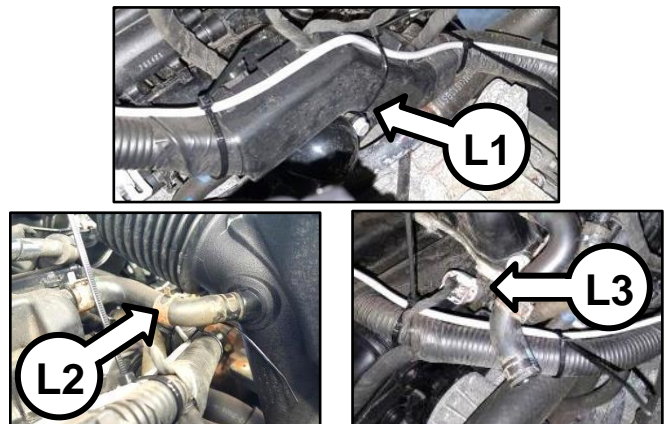
The harness (B) must be routed above and secured to the harness protector (L1) and **UNDER** the Breather Hose (L2) and Camshaft Position Sensor (L3).

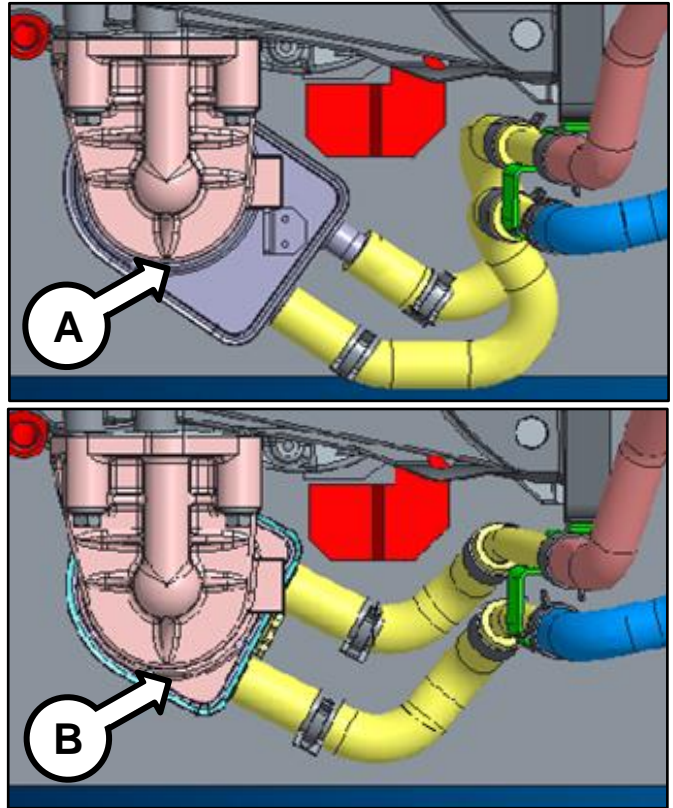
New engines may be supplied with a different oil cooler. Use steps below to determine the need for a replacement oil cooler tube assembly.

- If the new engine's (bigger) oil cooler (A) does not match the old engine's (smaller) oil cooler (B), replace the oil cooler tube assembly with the improved part. See parts table on page 24.
- If the new engine's (bigger) oil cooler (A) matches the old engine's (bigger) oil cooler (A), reuse the old engine's oil cooler tube assembly.
- If the new engine's (smaller) oil cooler (B) matches the old engine's (smaller) oil cooler (B), reuse the old engine's oil cooler tube assembly.

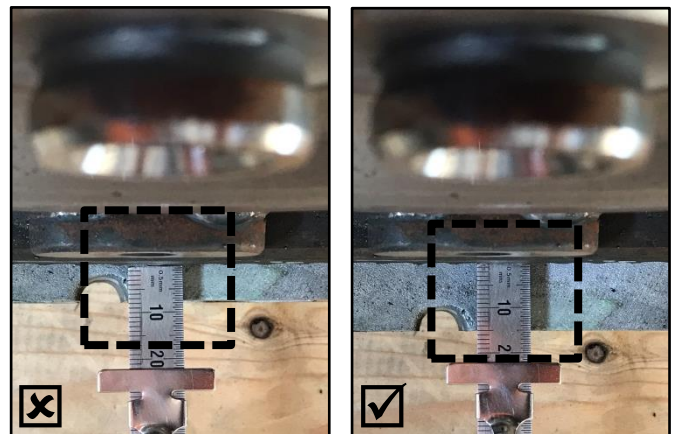
Not Fully Inserted

- If the torque converter has moved from the fully inserted position, carefully push inward while rotating the torque converter until it is recessed approximately 9/16 – 5/8" (14 – 16mm) (☑) into the transaxle case when reinstalling the automatic transaxle.
