| | GROUP Product Improvement | MODEL See Model List on Page 1 |
| | NUMBER PI1803W/X (Rev 3, 04/03/2019) | DATE November 2018 |
| PRODUCT IMPROVEMENT CAMPAIGN | | |
| SUBJECT: ENGINE REPLACEMENT INSTRUCTIONS FOR DTC P1326 (PI1803W/X) | | |

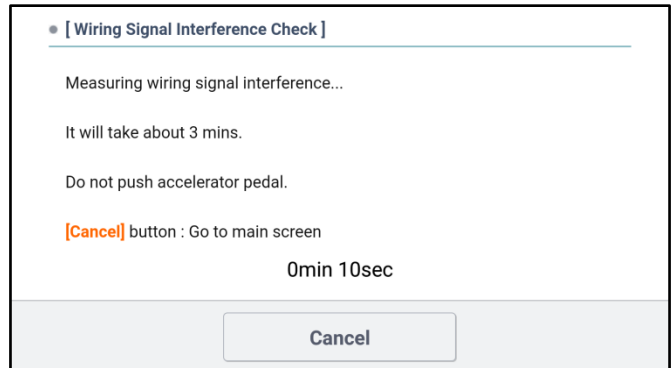
7. Wiring Signal Interference Check test will begin and take about three (3) minutes to complete. **NOTE:** Do not push on the accelerator pedal.

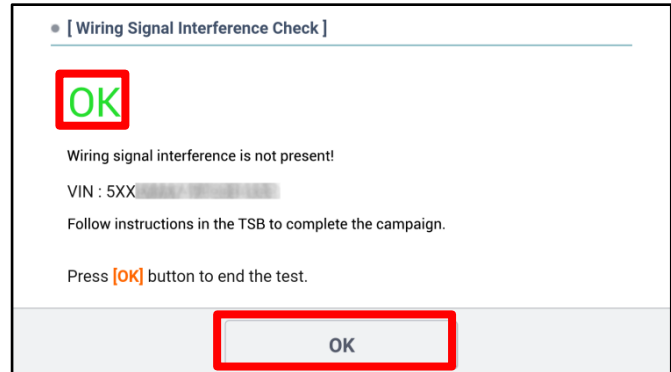
- If the result is “OK”, turn the engine off and proceed to the Engine Noise Inspection procedure below.

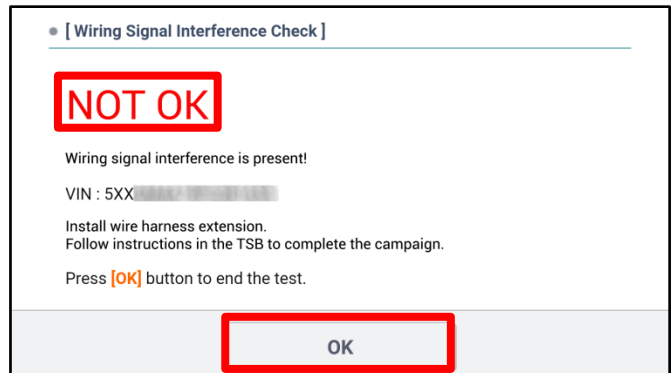
- If the result is “NOT OK”, turn the engine off and proceed to **step 2** of the Knock Sensor (KS) Extension Harness Installation procedure on page 12.

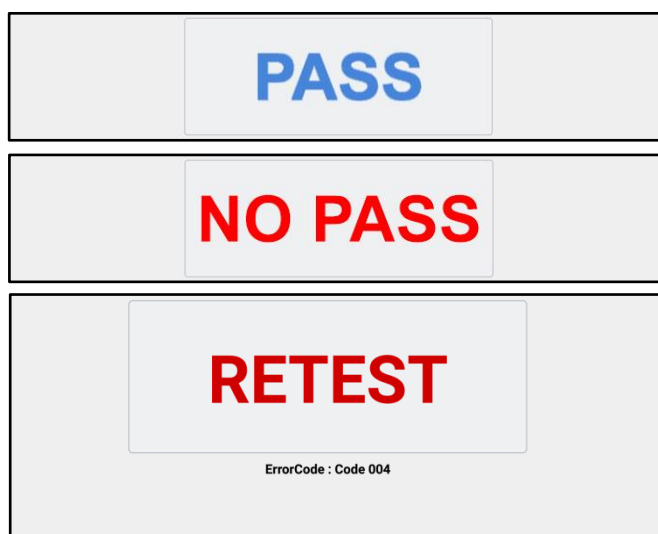
- If the inspection result is "PASS", proceed to the KS Extension Harness Installation procedure on page 12.
- If the inspection result is "NO PASS", proceed to the engine replacement procedure on page 17.
- If the inspection result is "RETEST" with an error code, see Adapter Error Code chart in Appendix 3 on page 35 for corrective action then repeat the inspection procedure starting from step 9.

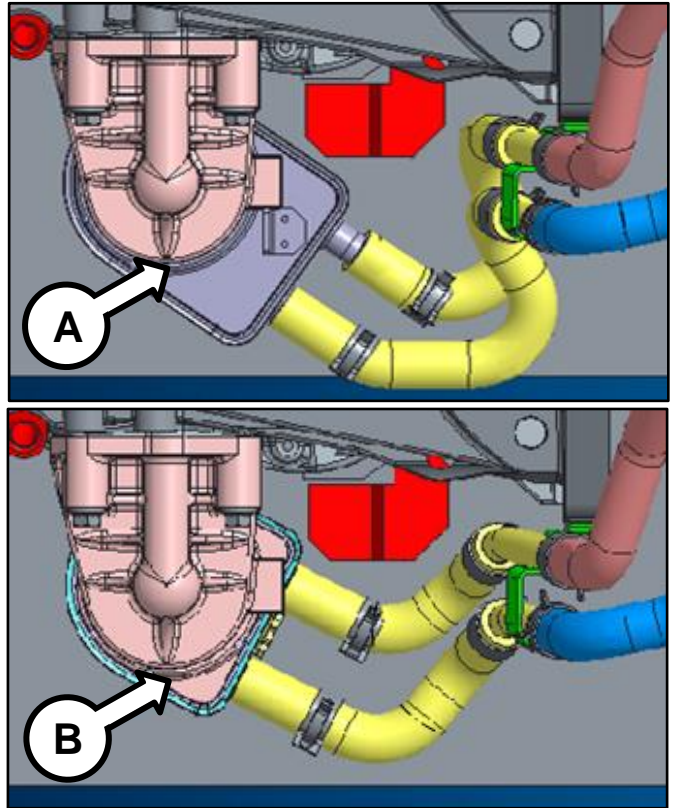
New engines may be supplied with a different oil cooler. Use steps below to determine the need for a replacement oil cooler tube assembly.

- If the new engine's (bigger) oil cooler (A) does not match the old engine's (smaller) oil cooler (B), replace the oil cooler tube assembly with the improved part. See parts table on page 23.
- If the new engine's (bigger) oil cooler (A) matches the old engine's (bigger) oil cooler (A), reuse the old engine's oil cooler tube assembly.
- If the new engine's (smaller) oil cooler (B) matches the old engine's (smaller) oil cooler (B), reuse the old engine's oil cooler tube assembly.
