2017-2019MY
Niro (DE HEV)

PS593

MIL ON WITH DTC U029F00

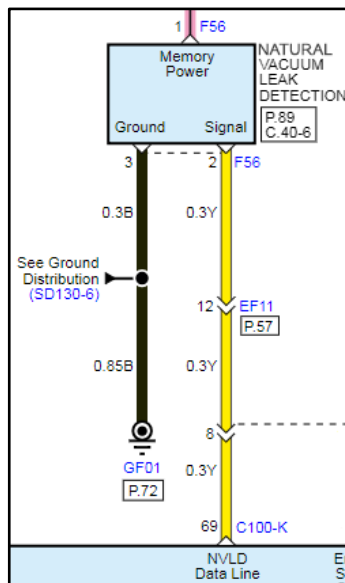
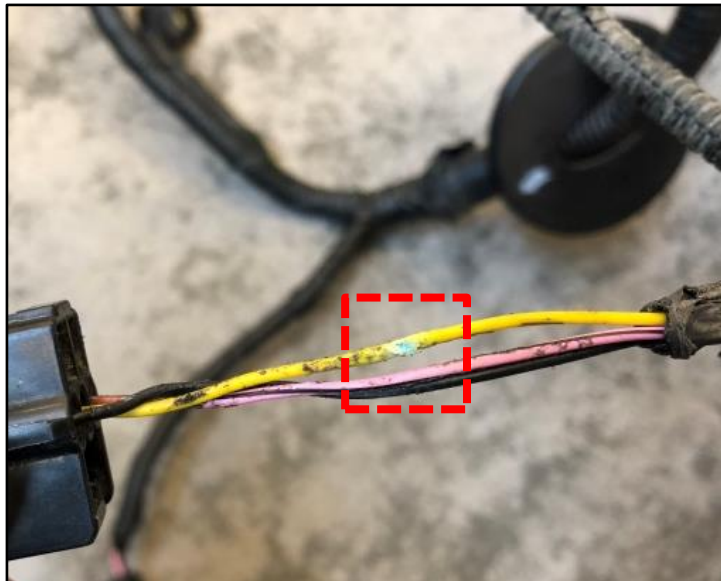
Some 2017-2019MY Niro (DE HEV) vehicles may have a malfunction indicator lamp (MIL) illumination with DTC U029F00 (Lost Communication with Evaporative Emission System Leak Detection Control Module) active. Prior to following the standard diagnostic steps for the DTC as outlined in KGIS, on vehicles built before October 2018, the NVLD signal wire needs to be checked for insulation and/or core damage. Excessive circuit resistance may be present due to damage/corrosion at the (yellow) signal wire of the NVLD connector (F56). A resistance measurement from joint connector EF11 - pin 12 to the NVLD connector F56 - pin 2 should be performed and may result in a high resistance or "open circuit" reading. If so, inspect the harness from the F56 connector (see photo) for a breakdown of the insulation of the wire and for corrosion/cuts in the strands.

Photo for reference use only: Inspect at least 10 inches of the harness from the F56 connector for wire damage.

Repair damaged wiring as required (use appropriate terminals and heat shrink tubing from the Kia wire harness repair kit). Any harness replacement considered necessary due to excessive damage requires DPSM approval.
