GROUP ELE	MODEL 2014-2018MY Forte (YD, YDm)
NUMBER 159	DATE April 2019

TECHNICAL SERVICE BULLETIN

SUBJECT: STEERING WHEEL MOUNTED AUDIO
CONTROL MALFUNCTION

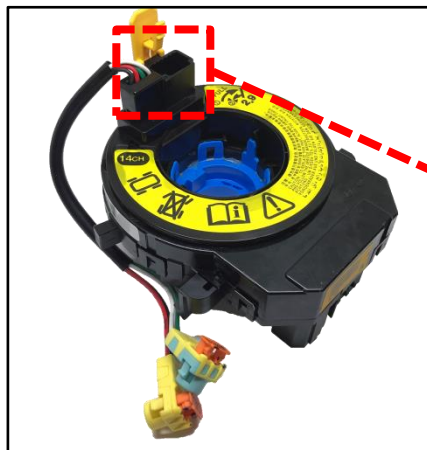
Clock Spring Assembly

This bulletin provides the procedure to inspect and, if necessary, replace the clock spring assembly on some 2014-2018MY Forte (YD/YDm) vehicles, produced from February 20, 2013 through June 30, 2018, which may experience intermittent malfunctioning steering wheel audio controls due to a clock spring connector pin deformation, with no related DTCs for this concern. Note: this does not impair the clock spring airbag function. Follow the procedure in this bulletin to inspect the clock spring female connector and, if necessary, replace the clock spring assembly.

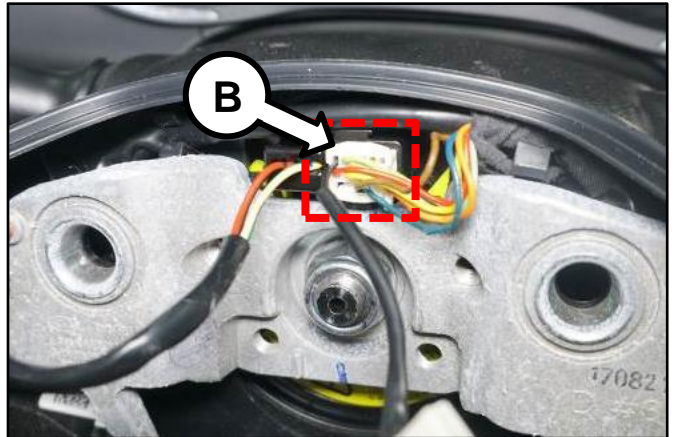
4. Inspect the clock spring female connector pins (C) for any deformation (D).
 - If any pin deformation is visible, proceed to the Replacement Procedure on page 3.
 - If no pin deformation is visible, further diagnosis or repair is required and not covered in this bulletin. File a separate claim if necessary. Perform step 5 below after repair is completed.
5. Verify customer's radio presets were retained or restore, if necessary, using recorded information in step 1.

1. Replace the clock spring by referring to steps 6 through 8 of the “Restraint → Airbag Module → Driver Airbag (DAB) Module and Clock Spring → Repair procedures” chapter in the applicable Shop Manual on KGIS.
2. Verify proper operation of the steering wheel volume and other controls and confirm no airbag-related warning lights are on.
3. Verify customer’s radio presets were retained and restore, if necessary, using recorded information in step 1 of the Inspection Procedure.
