GROUP ELE	MODEL 2018MY Stinger (CK) 2018-2019MY Niro Plug-in (DE PHEV) with UVO 3.0
	NUMBER 162 (Rev 1, 04/24/2019)	DATE December 2018

**SUBJECT:** SERVICE ACTION: UVO 3.0 LOGIC IMPROVEMENT  
FOR BLACK SCREEN (SA366)

**This issue number is SA366.**

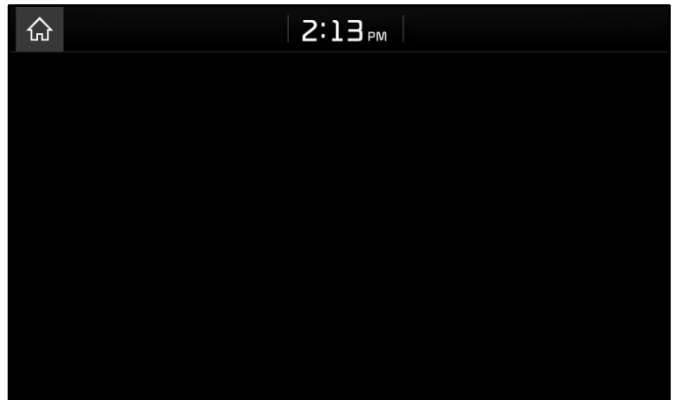
2. Verify the concern:  
If the head unit displays a black screen as shown on the right, proceed to step 3.

3. Press the reset button with a pointed end tool such as a pen or paper clip.

4. Upon startup of the head unit, DO NOT press “Confirm” or “Language”; instead, quickly alternate between pressing the radio and setup hard keys (10-15 repetitions) until display returns on the head unit. Return to the head unit home screen.
