GROUP ELE	MODEL 2020MY Telluride (ON)
	NUMBER 178	DATE April 2019
TECHNICAL SERVICE BULLETIN		
SUBJECT: SERVICE ACTION: TELLURIDE (ON) HEADLAMP INSPECTION (SA380)

This issue number is SA380.

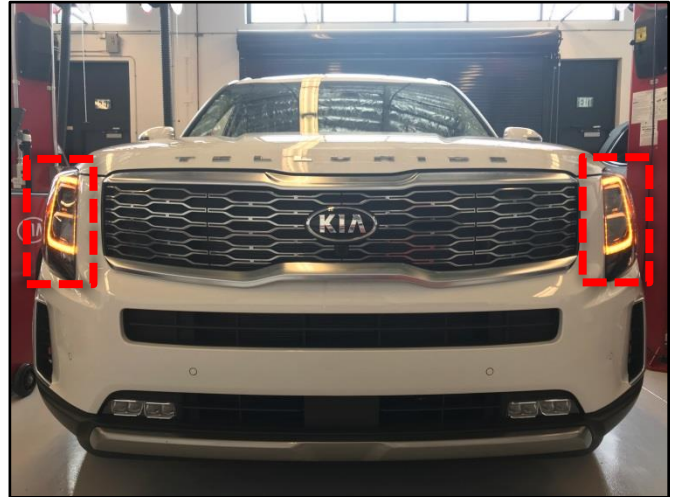
2. Leave the DRLs on for twenty (20) minutes.
 - If one or both DRL(s) is/are not operating as designed, proceed to the Headlamp Replacement Procedure below.
 - If both DRLs are operating as designed, no further action is required.
