MODEL
2011-2013MY
Sorento (XMa)

NUMBER
179

TECHNICAL SERVICE BULLETIN

SUBJECT: HALOGEN LOW BEAM BULB
CONNECTOR REPLACEMENT

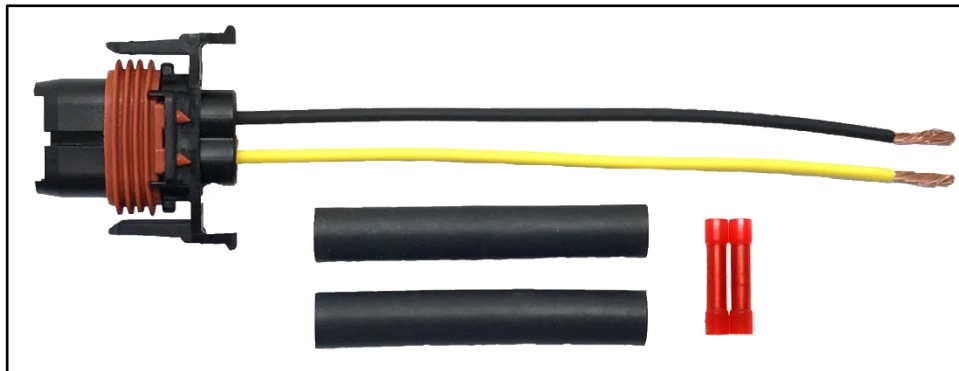
This bulletin provides the procedure to replace the halogen low beam bulb connector on some 2011 - 2013MY Sorento (XMa) vehicles, produced from October 24, 2009 through January 31, 2013, which may experience an inoperable low beam bulb due to poor terminal contact at the low beam bulb connector. This condition on the affected headlamp does not affect the other low beam. In addition, the high beams continue to function at all times. Follow the procedure outlined in this bulletin to replace the low beam bulb connector.

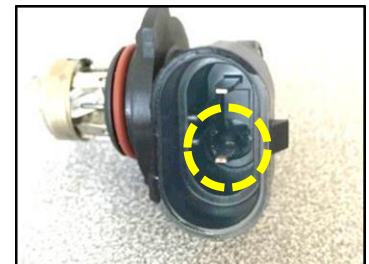
- Remove the affected halogen low beam bulb from the headlamp and take one (1) KVID photo of the damaged bulb terminal(s) (Attachment Type: 'XX'). Ensure the affected area of the terminal is clearly visible in the photo.

This TSB is part of Warranty Extension WTY012. Only the affected headlamp low beam connector should be replaced. If the low beam bulb is inoperative due to damage by the electrical connector from poor terminal contact, replace the low beam bulb after fulfilling the KVID requirement:
