GROUP <b>CHA</b>	MODEL <b>2020MY Telluride (ON)</b>
NUMBER <b>097</b>	DATE <b>April 2019</b>

## TECHNICAL SERVICE BULLETIN

**SUBJECT: SERVICE ACTION: INTERMEDIATE STEERING SHAFT  
UNIVERSAL JOINT INSPECTION (SA383)**

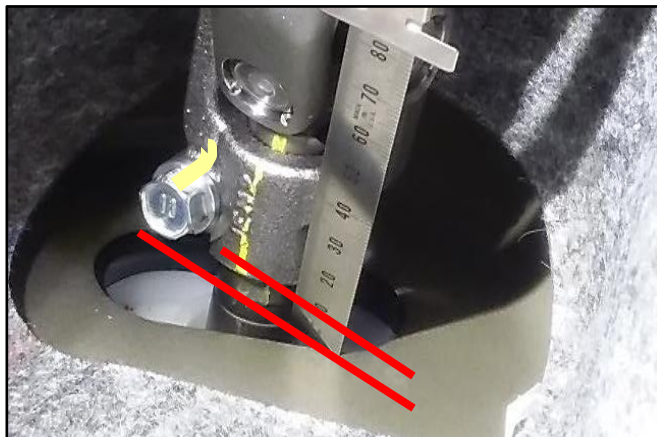
3. Measure from the floor panel to the bottom of the knuckle to ensure the universal joint is fully seated. The measurement from the floor panel to the joint should be less than 20mm (0.78 inch) as shown.

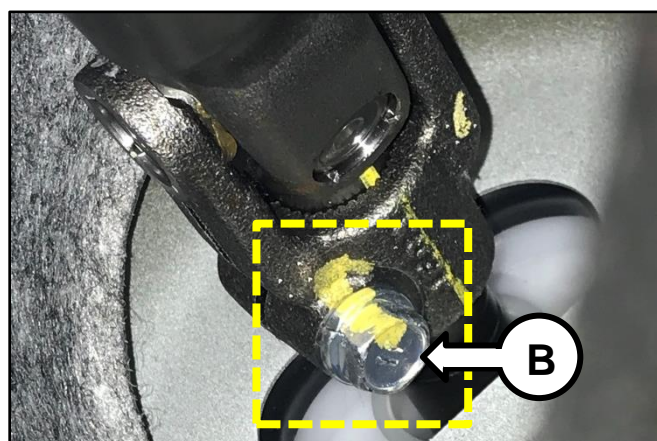
4. Verify that universal joint bolt has a witness mark (may vary in color).

If no mark is present, confirm that the bolt is torqued to specification and open a techline case.

**Tightening torque for bolt (B):**  
**23.9 - 27.5 ft-lb (32.4 - 37.3 N.m,**  
**3.3 - 3.8 Kgf.m.)**

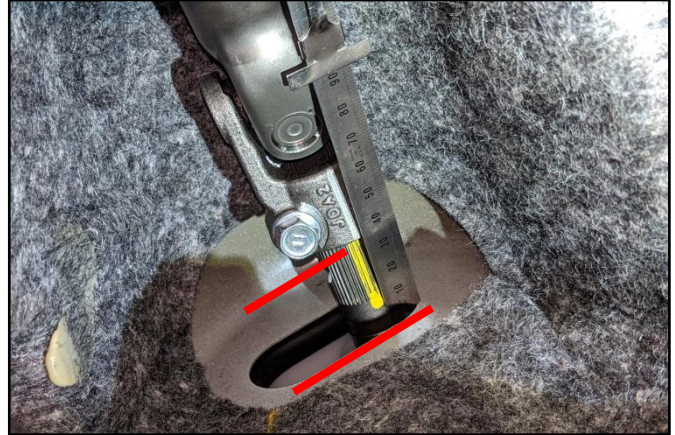
**If the distance between the intermediate steering shaft universal joint and the floor panel is more than 20mm (0.78 inch) as shown, IMMEDIATELY open a Tech Line web case, and do NOT release the vehicle until directed to do so. Additional information will be provided by Techline.**

**Requirement:** Using the Warranty Claim Attachment feature on KVID, take one (1) clear KVID photo showing the ruler and a “joint bottom to floor panel” dimension more than 20 mm (0.78 inch). and complete the Intermediate Steering Shaft Universal Joint Inspection form outlined on Page 5.

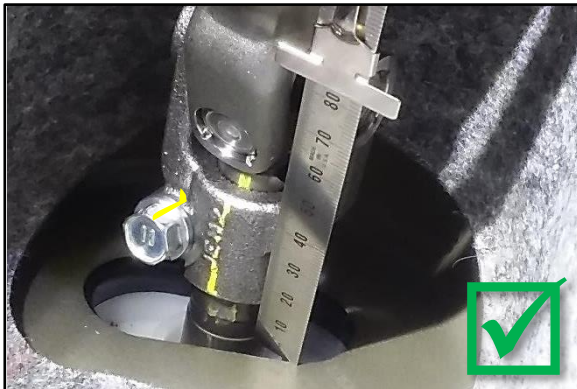
1.

Ensure the universal joint is properly positioned (Bolt in U-Joint must pass through notch in shaft). Verify that the bolt has a witness mark (may vary in color). Measurement from the floor panel to the bottom of the joint should be less than 20mm (0.78 inch).

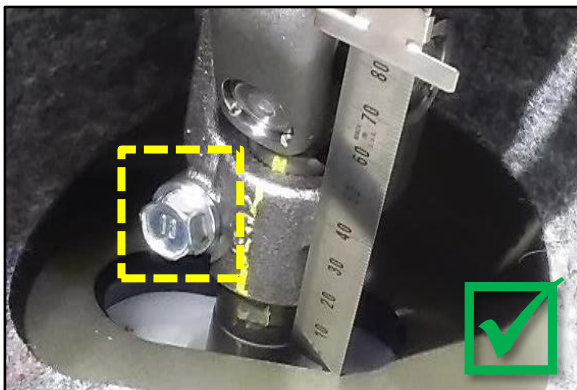
2.

If no mark is present as shown, **verify that the bolt is torqued to 23.9 - 27.5 ft-lb (32.4 - 37.3 N.m, 3.3 - 3.8 Kgf.m.)** and open a techline case.

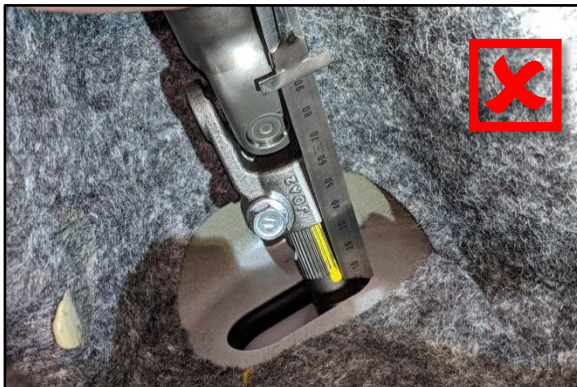
3.

The steering shaft universal joint measured more than 20mm from the floor panel to the bottom of the universal joint.
