MODEL
Multiple Models

NUMBER
074 (Rev 2, 04/29/2019)

TECHNICAL SERVICE BULLETIN

SUBJECT: MDPS FLEXIBLE COUPLING REPLACEMENT

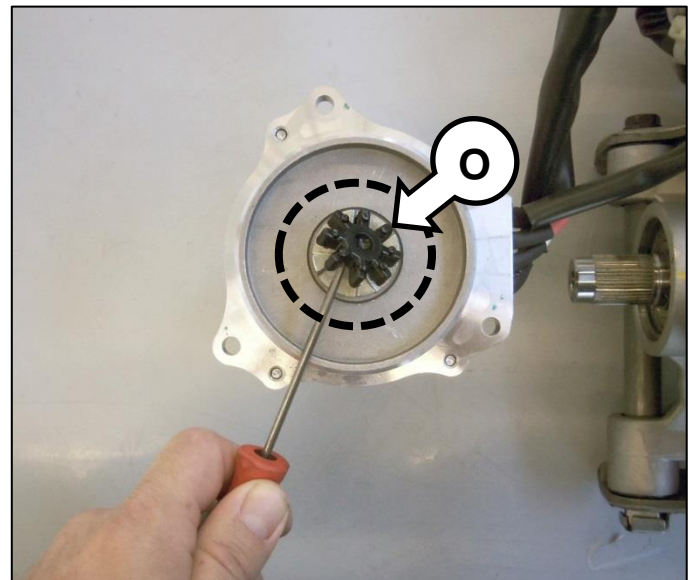
12. Remove the original flexible coupling (O) from the housing. In addition, use an air gun to remove any foreign matter from the motor and/or the housing.

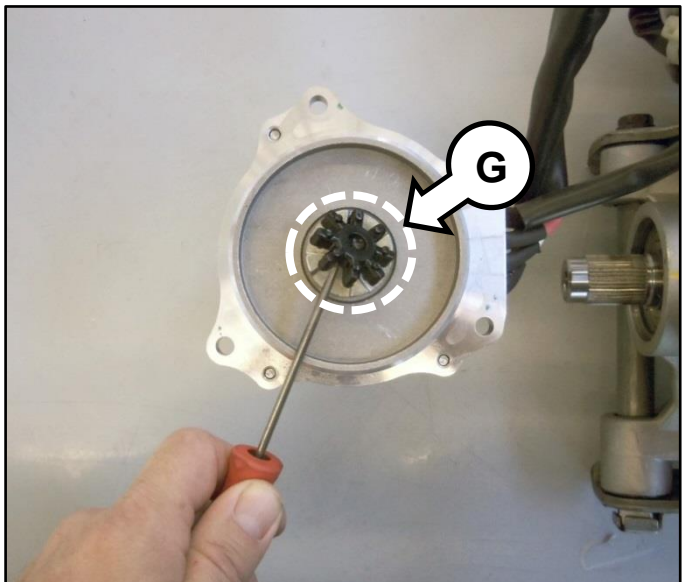
- Remove the original flexible coupling (G) from the motor. In addition, use an air gun to remove any foreign matter from the motor and/or the housing.

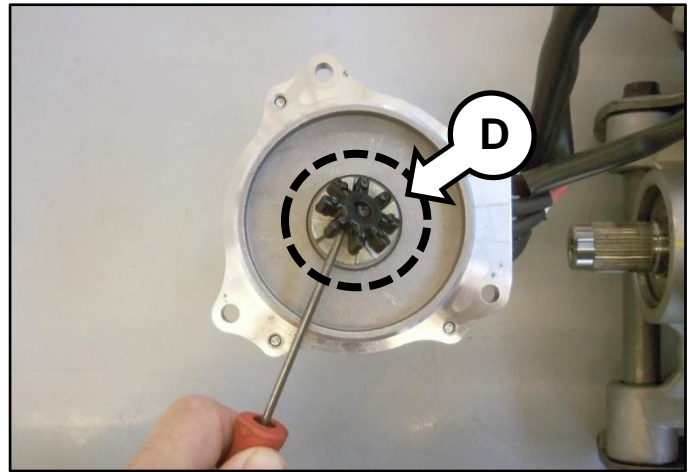
- 4. Remove the original flexible coupling (D) from the motor. In addition, use an air gun to remove any foreign matter from the motor and/or the housing.
