Technical Service Bulletin

REAR DOOR WEATHERSTRIP COMES OFF

Bulletin No.: 09-018/19

2016-2018 CX-9 vehicles with VINs lower than JM3TC*****237357 (produced before June 30, 2018)

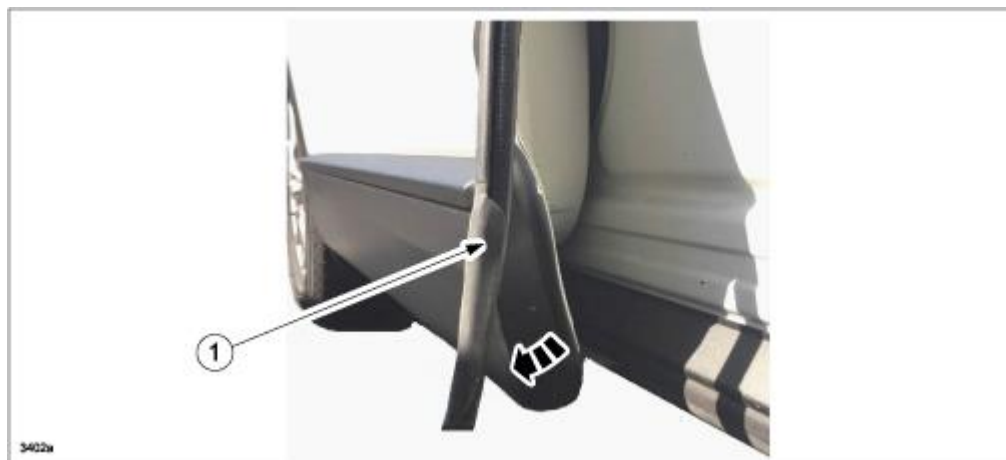
Some customers may complain that the door weatherstrip (1) comes off at the front / lower part of the rear door(s). This concern is caused by insufficient weatherstrip gripping force. To eliminate this concern, the shape of the weatherstrip has been changed.

Customers having this concern should have their vehicle repaired using the following repair procedure.
