Subject: SCRATCH ON SEAT BACK BAR GARNISH FROM CONTACT WITH CONVERTIBLE TOP	Bulletin No.: 09-019/19
	Last Issued: 04/29/2019

2016-2020 MX-5

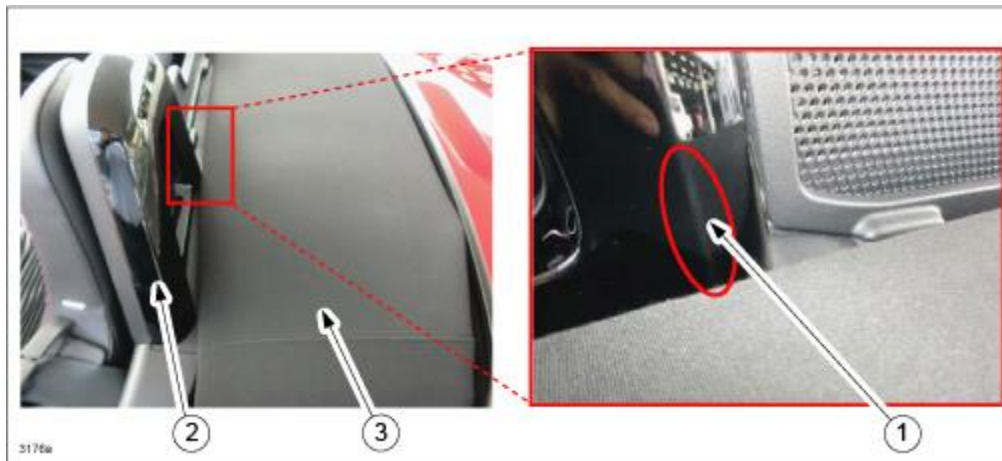
Some vehicles may exhibit scratches (1) on the rear of the seat back bar garnish (2) from contact with the convertible top (3).

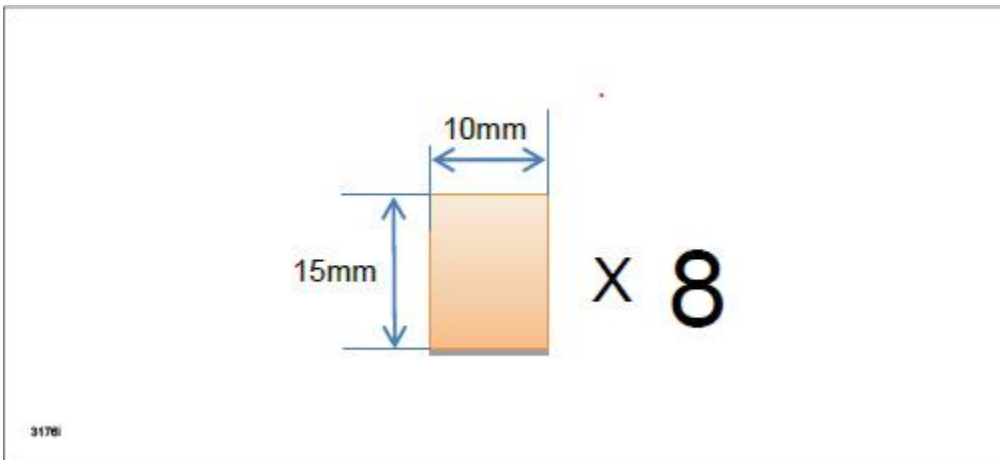
NOTE: The holes may be damaged when removing the metal fasteners of the back trim from the square holes of the seat back crossmember. A loose fit of these fasteners could cause a creak noise.

a. Select a 0.25 mm thickness fabric sheet from the “Noise Repair Kit” (TA01-76-100) and cut out 8 equal squares 15mm x 10mm.
