| REFERENCE: | Nova Bus Manuals |
| RS N°: | MQR 7621-1331 |

| SUBJECT: | Throttle pedal sensor (TPS) cable replacement | | | |
| JUSTIFICATION: | Cummins code 1242 for throttle pedal sensor circuit | | | |

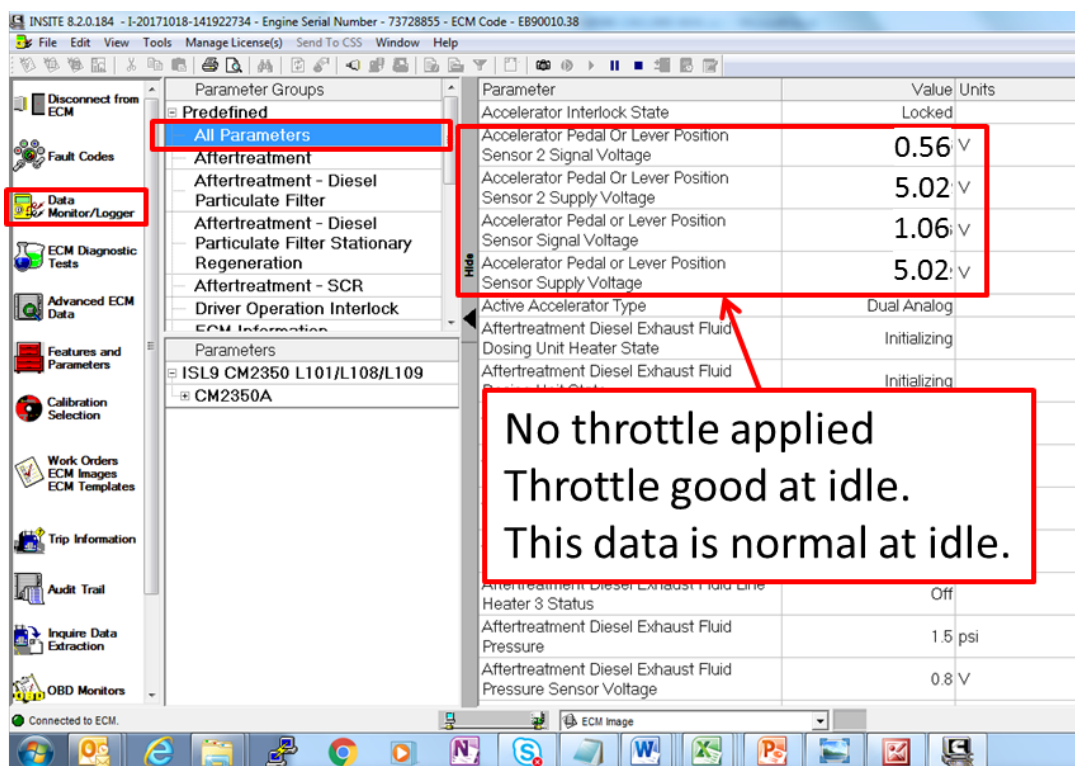
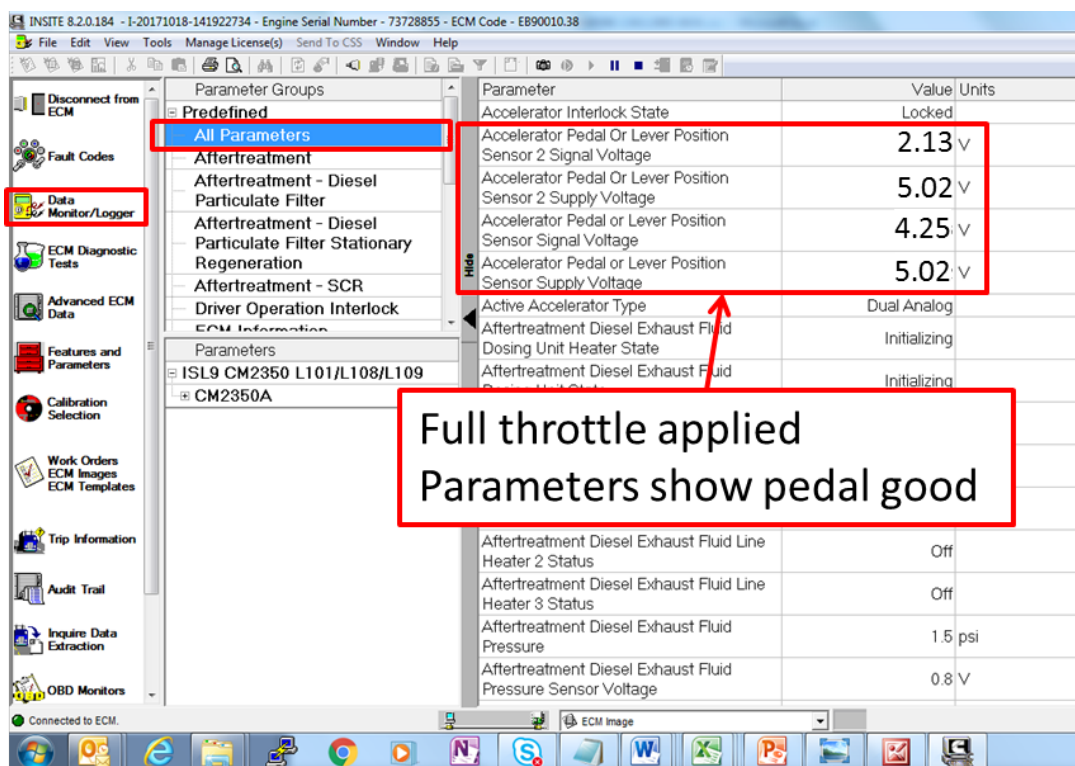
Figure A3.2. Example of INSITE Normal (PASS) Readings at Idle and Full Throttle Positions

Note: Even though the APS 1 and APS 2 throttle pedal sensors are both powered by regulated 5 V voltage sources supplied by the ECM, the APS 1 output signal range is twice that one of APS 2. This is why a full throttle condition corresponds to an APS 1 reading of 4.25 V and to APS 2 reading of 2.13 V in the following figures.

- **Good APS 1 (PASS condition):**
  - ☒ Reading is 4.25 V and steady when throttle pedal fully depressed.
- **Bad APS 1 (FAIL condition):**
  - ☒ Reading is unstable with throttle pedal being held steady.
- **Bad APS 1 (FAIL condition):**
  - ☒ Reading is around 4.19 V (low).
- **Good APS 2 (PASS condition):**
  - ☒ Reading is 2.13 V and steady when throttle pedal fully depressed.
- **Bad APS 2 (FAIL condition):**
  - ☒ Reading is unstable with throttle pedal being held steady.
- **Bad APS 2 (FAIL condition):**
  - ☒ Signal 2 is about 2.03 V (low).

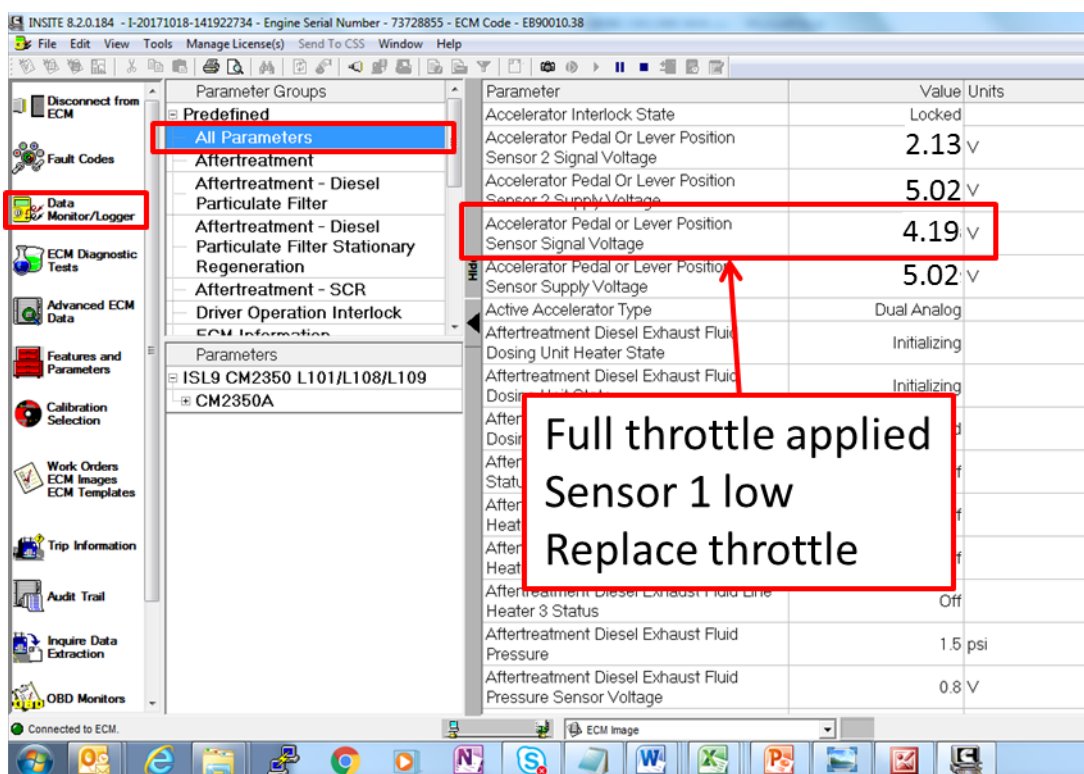
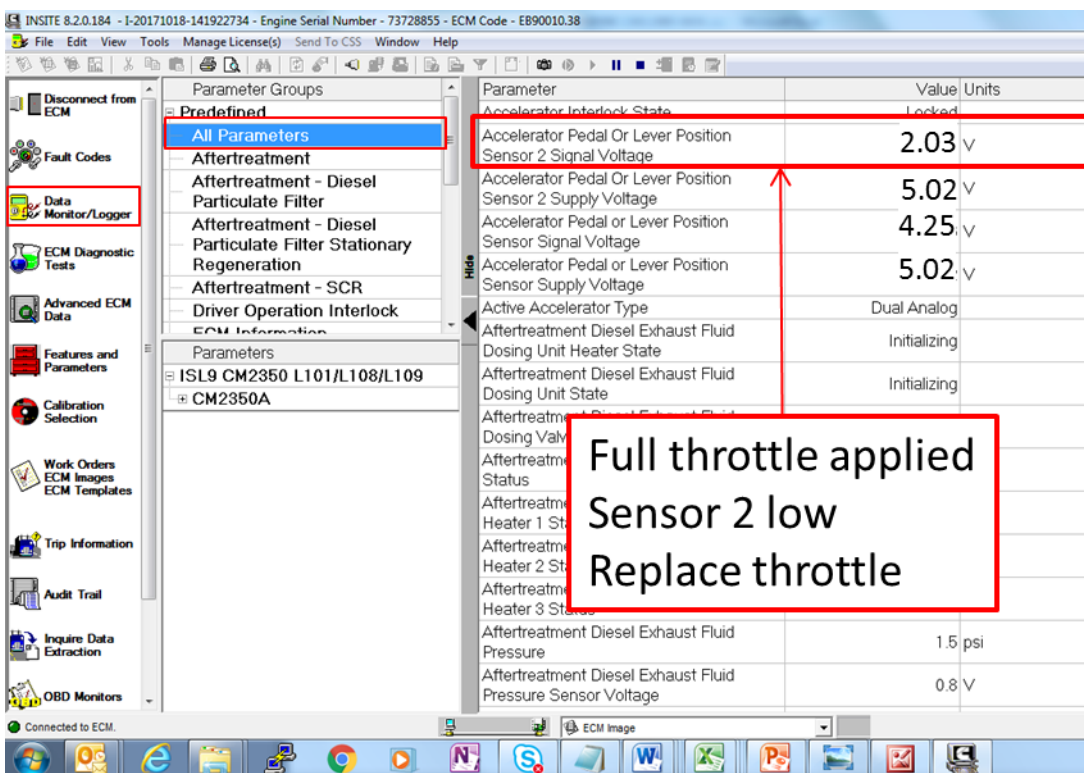
Figure A3.3. Example of INSITE Abnormal (FAIL) Readings at Full Throttle Pedal Position

Note: Any of the abovementioned bad APS readings (FAIL condition) should normally lead to 1242 FC activation.

4. Test the throttle pedal operation (see Appendix 3 for the throttle pedal testing procedure).
    - If the throttle pedal test fails with the 1242 FC, then replace the throttle pedal with a new or spare unit (previously tested / known-good unit), test drive the bus and finally return it to service if the 1242 FC does not return.
